## Orange Unified School District

Facilities Condition Assessment for:

**El Modena High School**  
**3920 Spring Street**  
**Orange, CA 92869**

# Campus Report

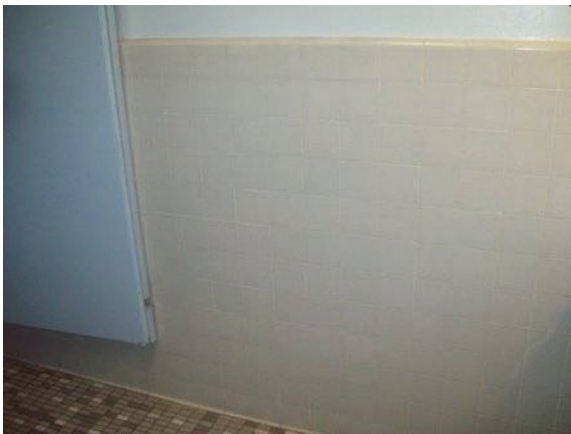
**Location:** Staff and nurse station restroom wall wainscot.  
**Material:** Tile  
**Distress:** Beyond Expected Life  
**Category:** Capital Renewal  
**Priority:** 3 - Necessary/Not Yet Critical (Years 2-5)  
**Correction:** Replace 4" x 4" thin set ceramic tile  
**Qty:** 6-C.S.F.  
**Estimate:** \$9,123.84  
**Assessor Name:** Ann Buerger Linden  
**Date Created:** 01/24/2013

**Notes:** Renovations and reconfiguration for ADA compliance will necessitate replacement of ceramic wall tile.

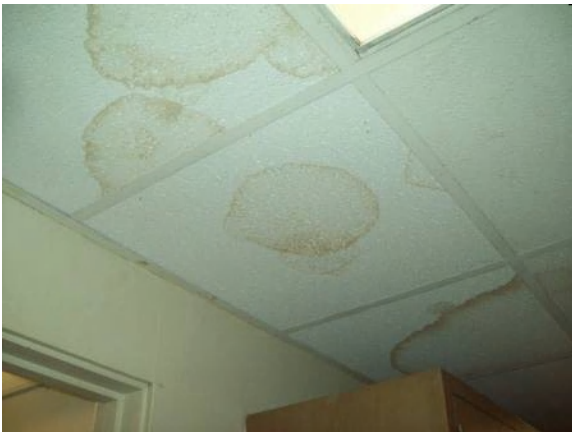
**Location:** Offices, conference, work rooms, nurse rooms, receptions and work rooms.  
**Material:** Acoustic Tile  
**Distress:** Beyond Expected Life  
**Category:** Capital Renewal  
**Priority:** 3 - Necessary/Not Yet Critical (Years 2-5)  
**Correction:** Replace acoustic tile ceiling, non fire-rated  
**Qty:** 47-C.S.F.  
**Estimate:** \$31,335.84  
**Assessor Name:** Ann Buerger Linden  
**Date Created:** 01/22/2013

**Notes:** Acoustical ceiling systems are assumed to be non-original, however have exceeded their expected life.  
Mismatched tile, water stained and dirty tile and grid are common in this building

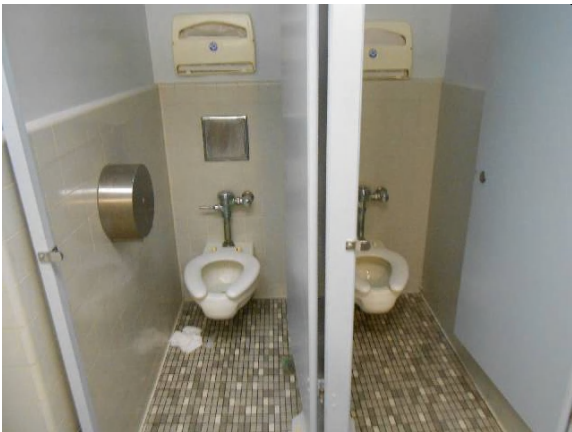
**Location:** Women & Men staff restrooms & Nursery restrooms  
**Material:** Tankless Water Closet  
**Distress:** Beyond Expected Life  
**Category:** Capital Renewal  
**Priority:** 4 - Recommended (Years 6-10)  
**Correction:** Replace tankless water closet  
**Qty:** 5-Ea.  
**Estimate:** \$6,177.31  
**Assessor Name:** Eduardo Lopez  
**Date Created:** 01/22/2013

**Notes:** Replace during next remodel or renovation.

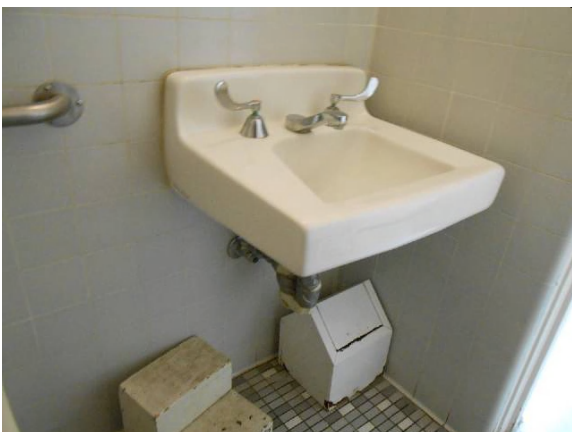
**Location:** Women & Men staff restrooms & Nursery restrooms  
**Material:** Lavatory, Vitreous China  
**Distress:** Beyond Expected Life  
**Category:** Capital Renewal  
**Priority:** 4 - Recommended (Years 6-10)  
**Correction:** Replace lavatory, vitreous china  
**Qty:** 5-Ea.  
**Estimate:** \$5,374.94  
**Assessor Name:** Eduardo Lopez  
**Date Created:** 01/22/2013

**Notes:** Replace during next remodel or renovation.

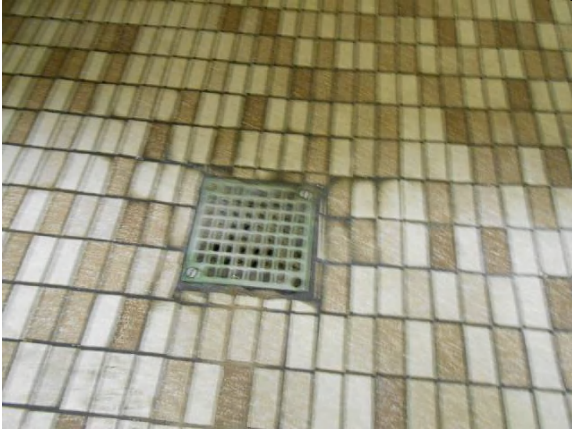
**Location:** Typical for entire building  
**Material:** System  
**Distress:** Beyond Service Life  
**Category:** Capital Renewal  
**Priority:** 4 - Recommended (Years 6-10)  
**Correction:** Renew System  
**Qty:** 1-Ea.  
**Estimate:** \$41,764.28  
**Assessor Name:** Eduardo Lopez  
**Date Created:** 01/24/2013

**Notes:** Replace system during next remodel or renovation.

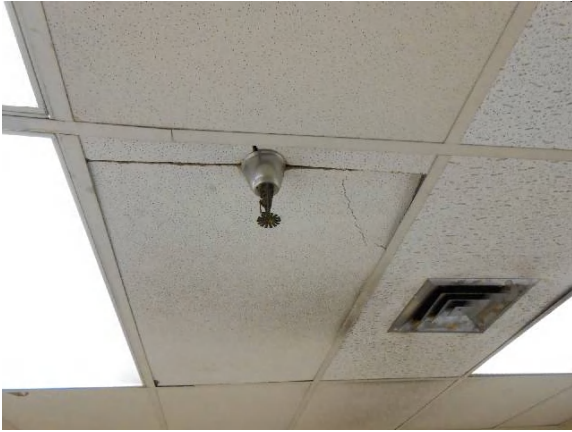
**Location:** Typical for entire building  
**Material:** System  
**Distress:** Beyond Expected Life  
**Category:** Capital Renewal  
**Priority:** 5 - Codes or Standards Compliance  
**Correction:** Renew System  
**Qty:** 1-Ea.  
**Estimate:** \$56,510.21  
**Assessor Name:** Eduardo Lopez  
**Date Created:** 01/24/2013

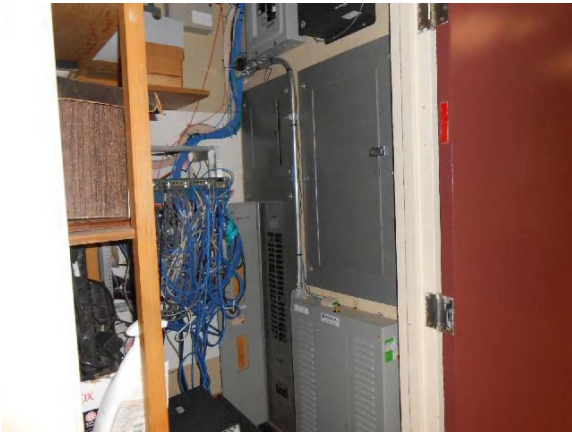
**Location:** Typical for entire building  
**Material:** System  
**Distress:** Beyond Service Life  
**Category:** Capital Renewal  
**Priority:** 4 - Recommended (Years 6-10)  
**Correction:** Renew System  
**Qty:** 1-Ea.  
**Estimate:** \$62,218.32  
**Assessor Name:** Eduardo Lopez  
**Date Created:** 01/24/2013

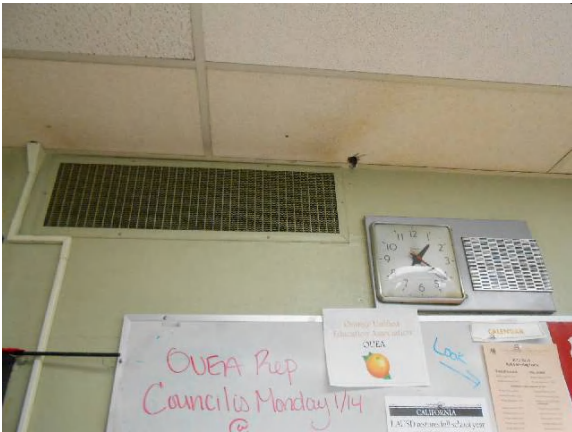
**Location:** Typical for entire building  
**Material:** System  
**Distress:** Beyond Expected Life  
**Category:** Capital Renewal  
**Priority:** 4 - Recommended (Years 6-10)  
**Correction:** Renew System  
**Qty:** 1-Ea.  
**Estimate:** \$9,772.96  
**Assessor Name:** Eduardo Lopez  
**Date Created:** 01/27/2013

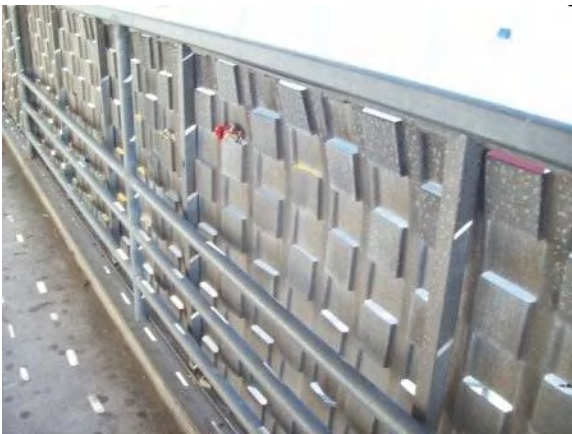
**Location:** Second floor balcony railings.  
**Material:** Balcony Sreen OUSD  
**Distress:** Damaged  
**Category:** Capital Renewal  
**Priority:** 3 - Necessary/Not Yet Critical (Years 2-5)  
**Correction:** Replace balcony wall screening material  
**Qty:** 475-L.F.  
**Estimate:** \$41,860.80  
**Assessor Name:** Ann Buerger Linden  
**Date Created:** 01/26/2013

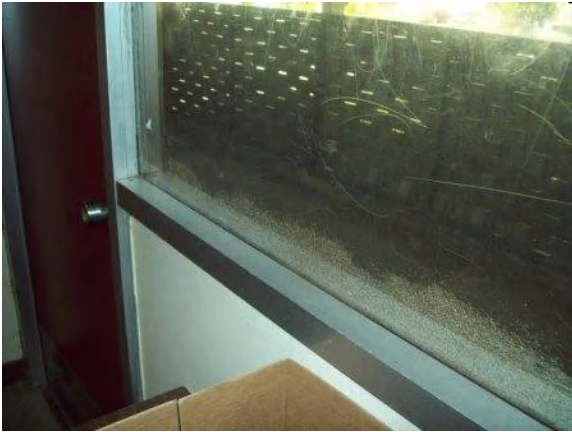
**Location:** Classrooms adjacent to entry doors.  
**Material:** Aluminum Window, Fixed  
**Distress:** Beyond Expected Life  
**Category:** Capital Renewal  
**Priority:** 3 - Necessary/Not Yet Critical (Years 2-5)  
**Correction:** Replace windows OUSD EIMo  
**Qty:** 960-Ea.  
**Estimate:** \$62,208.00  
**Assessor Name:** Ann Buerger Linden  
**Date Created:** 01/25/2013

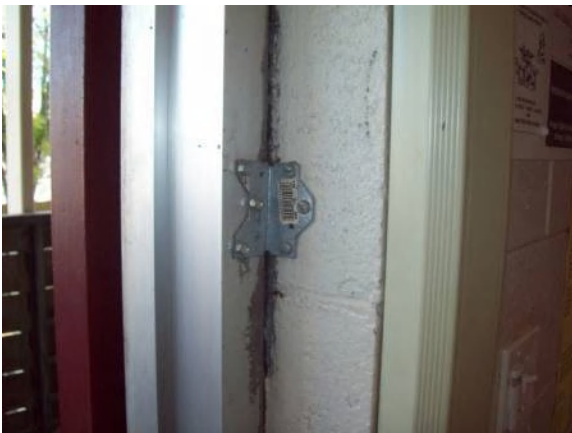
**Location:** All classrooms, restrooms and utility rooms.  
**Material:** System  
**Distress:** Beyond Service Life  
**Category:** Capital Renewal  
**Priority:** 3 - Necessary/Not Yet Critical (Years 2-5)  
**Correction:** Renew System  
**Qty:** 1-Ea.  
**Estimate:** \$201,555.89  
**Assessor Name:** Ann Buerger Linden  
**Date Created:** 01/25/2013

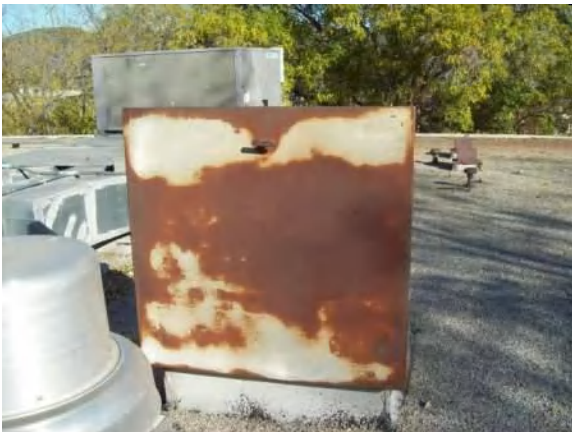
**Location:** Accessed from 2nd floor janitor closet.  
**Material:** System  
**Distress:** Beyond Expected Life  
**Category:** Capital Renewal  
**Priority:** 3 - Necessary/Not Yet Critical (Years 2-5)  
**Correction:** Renew System  
**Qty:** 1-Ea.  
**Estimate:** \$38,469.15  
**Assessor Name:** Eduardo Lopez  
**Date Created:** 01/21/2013

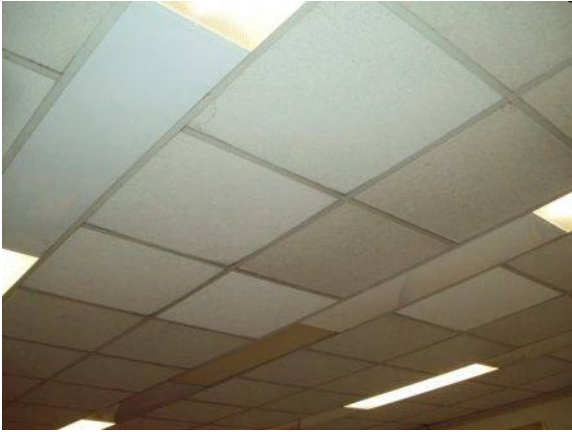
**Location:** All classrooms  
**Material:** Acoustic Tile  
**Distress:** Beyond Expected Life  
**Category:** Capital Renewal  
**Priority:** 1 - Currently Critical (Immediate)  
**Correction:** Replace acoustic tile ceiling, non fire-rated  
**Qty:** 142-C.S.F.  
**Estimate:** \$94,674.24  
**Assessor Name:** Ann Buerger Linden  
**Date Created:** 01/26/2013

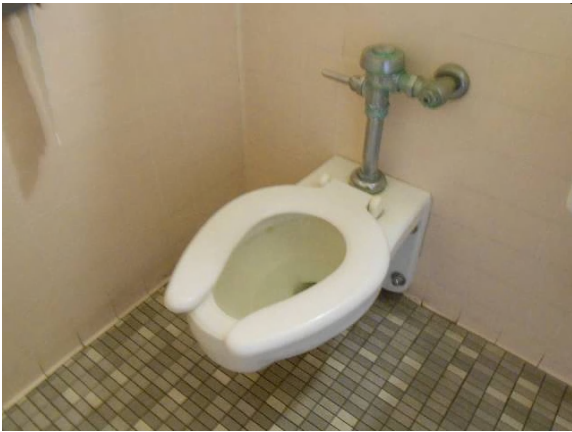
**Location:** Women/Men restrooms & Staff restrooms,  
South end at both levels  
**Material:** Tankless Water Closet  
**Distress:** Beyond Expected Life  
**Category:** Capital Renewal  
**Priority:** 4 - Recommended (Years 6-10)  
**Correction:** Replace tankless water closet  
**Qty:** 16-Ea.  
**Estimate:** \$19,767.40  
**Assessor Name:** Eduardo Lopez  
**Date Created:** 01/22/2013

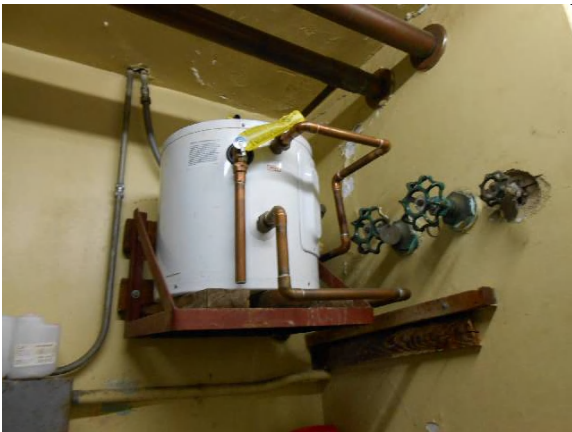
**Location:** Typical for entire building  
**Material:** System  
**Distress:** Beyond Expected Life  
**Category:** Capital Renewal  
**Priority:** 4 - Recommended (Years 6-10)  
**Correction:** Renew System  
**Qty:** 1-Ea.  
**Estimate:** \$28,578.84  
**Assessor Name:** Eduardo Lopez  
**Date Created:** 01/22/2013

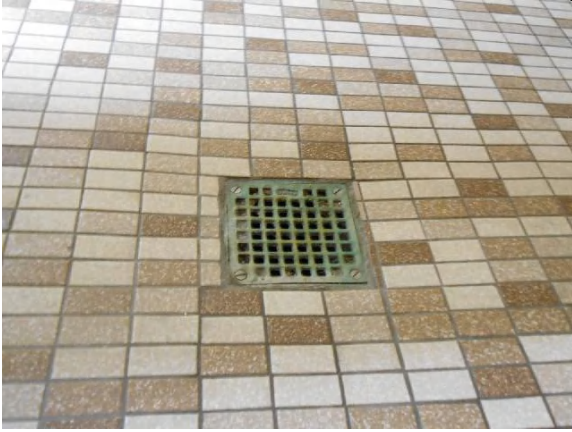
**Location:** Typical for entire building  
**Material:** System  
**Distress:** Beyond Expected Life  
**Category:** Capital Renewal  
**Priority:** 4 - Recommended (Years 6-10)  
**Correction:** Renew System  
**Qty:** 1-Ea.  
**Estimate:** \$97,687.69  
**Assessor Name:** Eduardo Lopez  
**Date Created:** 01/22/2013

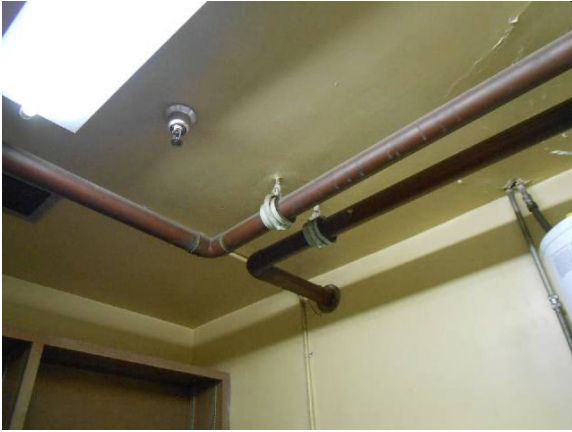
**Location:** Typical for entire building  
**Material:** System  
**Distress:** Beyond Expected Life  
**Category:** Capital Renewal  
**Priority:** 5 - Codes or Standards Compliance  
**Correction:** Renew System  
**Qty:** 1-Ea.  
**Estimate:** \$131,982.30  
**Assessor Name:** Eduardo Lopez  
**Date Created:** 01/22/2013

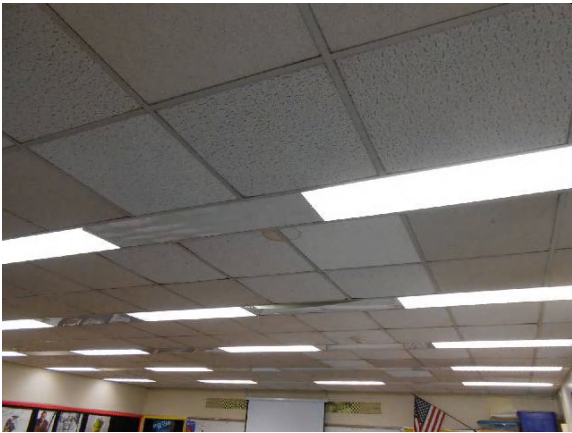
**Location:** Typical for all classrooms  
**Material:** Fluorescent Lighting Fixture, 80 W  
**Distress:** Beyond Expected Life  
**Category:** Capital Renewal  
**Priority:** 4 - Recommended (Years 6-10)  
**Correction:** Replace fixture fluorescent lighting fixture, 80 W  
**Qty:** 318-Ea.  
**Estimate:** \$111,622.75  
**Assessor Name:** Eduardo Lopez  
**Date Created:** 01/23/2013

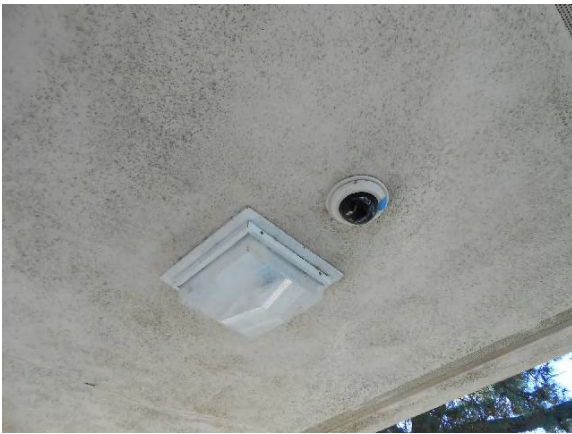
**Location:** Typical for entire building  
**Material:** System  
**Distress:** Beyond Expected Life  
**Category:** Capital Renewal  
**Priority:** 4 - Recommended (Years 6-10)  
**Correction:** Renew System  
**Qty:** 1-Ea.  
**Estimate:** \$22,910.31  
**Assessor Name:** Eduardo Lopez  
**Date Created:** 01/27/2013

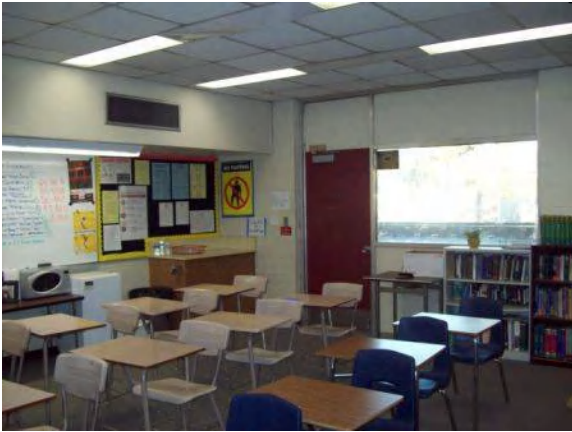
**Location:** Exterior windows at classrooms.  
**Material:** Blinds and Other Window Treatment  
**Distress:** Missing  
**Category:** Capital Renewal  
**Priority:** 1 - Currently Critical (Immediate)  
**Correction:** Replace window blinds  
**Qty:** 288-S.F.  
**Estimate:** \$3,122.84  
**Assessor Name:** Ann Buerger Linden  
**Date Created:** 01/25/2013

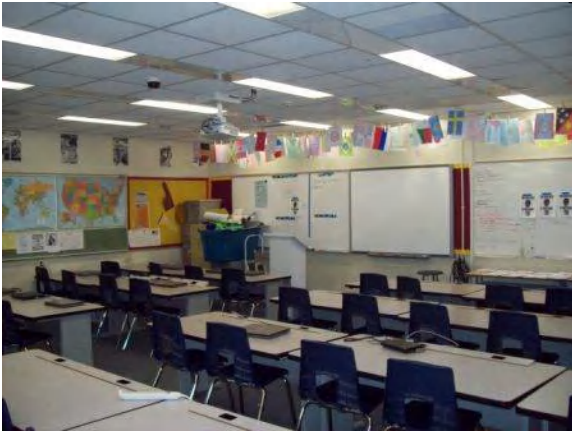
**Location:** Classrooms as required. Janitor closets.  
**Material:** Interior Partitions  
**Distress:** Damaged  
**Category:** Capital Renewal  
**Priority:** 3 - Necessary/Not Yet Critical (Years 2-5)  
**Correction:** Allowance repair/remodel interior partitions  
OUSD  
**Qty:** 1-Job  
**Estimate:** \$14,688.00  
**Assessor Name:** Ann Buerger Linden  
**Date Created:** 01/26/2013

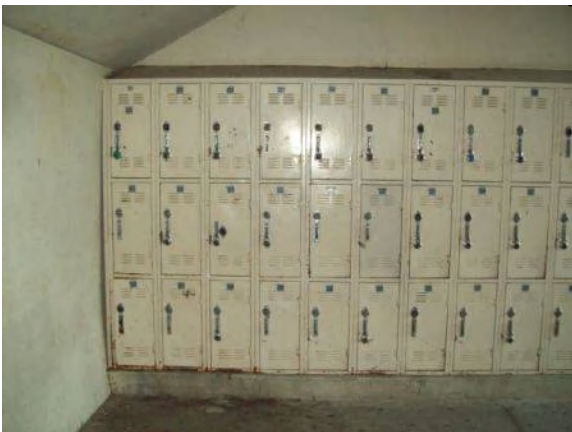
**Location:** Building perimeter 1st floor.  
**Material:** Fixed Furnishings - Lockers  
**Distress:** Beyond Expected Life  
**Category:** Capital Renewal  
**Priority:** 3 - Necessary/Not Yet Critical (Years 2-5)  
**Correction:** Student lockers stacked 2-high  
**Qty:** 500-Ea.  
**Estimate:** \$202,507.20  
**Assessor Name:** Ann Buerger Linden  
**Date Created:** 01/26/2013

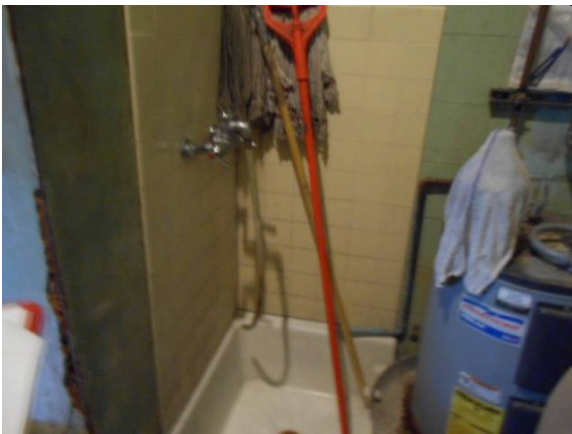
**Location:** Typical for entire building  
**Material:** System  
**Distress:** Beyond Expected Life  
**Category:** Capital Renewal  
**Priority:** 4 - Recommended (Years 6-10)  
**Correction:** Renew System  
**Qty:** 1-Ea.  
**Estimate:** \$68,271.83  
**Assessor Name:** Eduardo Lopez  
**Date Created:** 01/22/2013

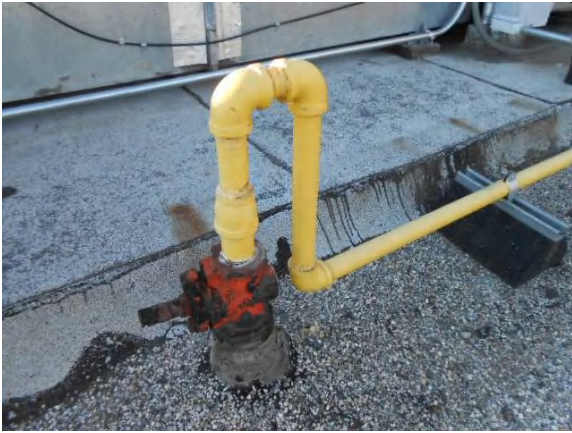
**Location:** Typical for entire building  
**Material:** System  
**Distress:** Beyond Expected Life  
**Category:** Capital Renewal  
**Priority:** 4 - Recommended (Years 6-10)  
**Correction:** Renew System  
**Qty:** 1-Ea.  
**Estimate:** \$18,575.73  
**Assessor Name:** Eduardo Lopez  
**Date Created:** 01/22/2013

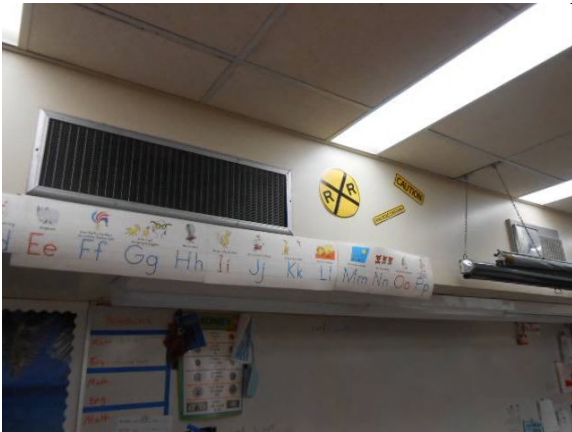
**Location:** Typical for entire building  
**Material:** System  
**Distress:** Beyond Expected Life  
**Category:** Capital Renewal  
**Priority:** 4 - Recommended (Years 6-10)  
**Correction:** Renew System  
**Qty:** 1-Ea.  
**Estimate:** \$271,639.84  
**Assessor Name:** Eduardo Lopez  
**Date Created:** 01/22/2013

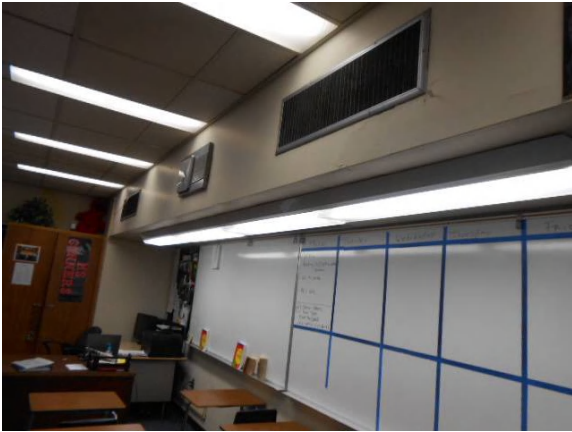
**Location:** Typical for entire building  
**Material:** System  
**Distress:** Beyond Expected Life  
**Category:** Capital Renewal  
**Priority:** 4 - Recommended (Years 6-10)  
**Correction:** Renew System  
**Qty:** 1-Ea.  
**Estimate:** \$16,009.78  
**Assessor Name:** Eduardo Lopez  
**Date Created:** 01/27/2013

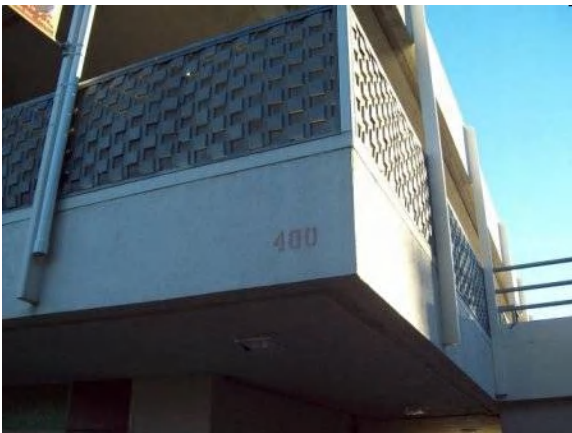
**Location:** Second floor exterior balconies.  
**Material:** Balcony Sreen OUSD  
**Distress:** Beyond Expected Life  
**Category:** Capital Renewal  
**Priority:** 3 - Necessary/Not Yet Critical (Years 2-5)  
**Correction:** Replace balcony wall screening material  
**Qty:** 430-L.F.  
**Estimate:** \$37,895.04  
**Assessor Name:** Ann Buerger Linden  
**Date Created:** 01/27/2013

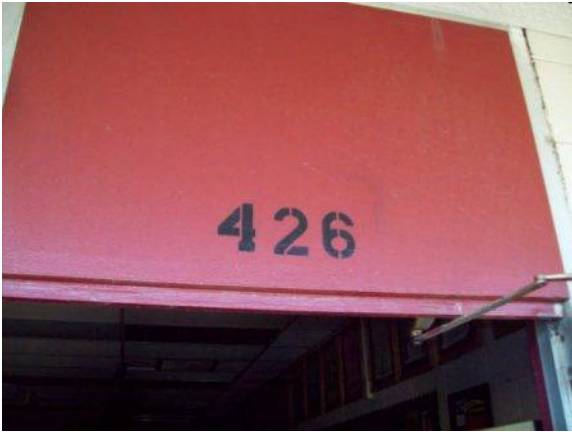
**Location:** Building wide.  
**Material:** Signage  
**Distress:** Beyond Expected Life  
**Category:** Capital Renewal  
**Priority:** 3 - Necessary/Not Yet Critical (Years 2-5)  
**Correction:** Replace/Install code compliant signage  
**Qty:** 13,763-S.F.  
**Estimate:** \$2,972.81  
**Assessor Name:** Ann Buerger Linden  
**Date Created:** 01/27/2013

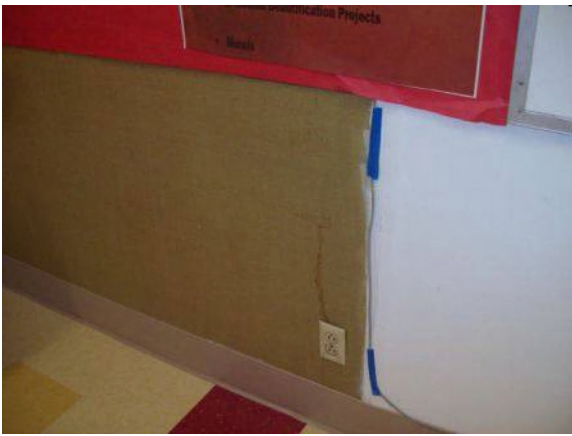
**Location:** Building wide.  
**Material:** System  
**Distress:** Beyond Expected Life  
**Category:** Capital Renewal  
**Priority:** 3 - Necessary/Not Yet Critical (Years 2-5)  
**Correction:** Renew System  
**Qty:** 1-Ea.  
**Estimate:** \$145,845.96  
**Assessor Name:** Eduardo Lopez  
**Date Created:** 01/21/2013

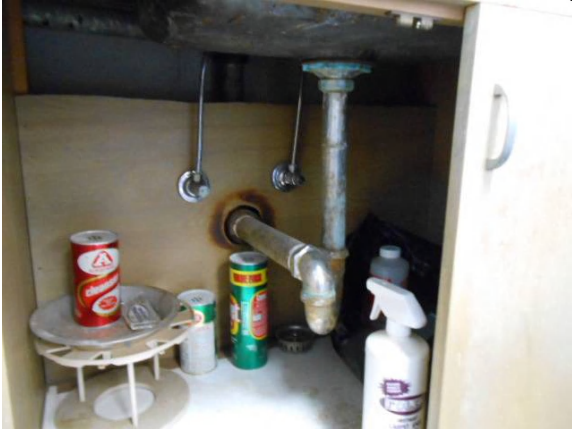
**Location:** Typical for entire building  
**Material:** System  
**Distress:** Beyond Service Life  
**Category:** Capital Renewal  
**Priority:** 4 - Recommended (Years 6-10)  
**Correction:** Renew System  
**Qty:** 1-Ea.  
**Estimate:** \$71,069.93  
**Assessor Name:** Eduardo Lopez  
**Date Created:** 01/24/2013

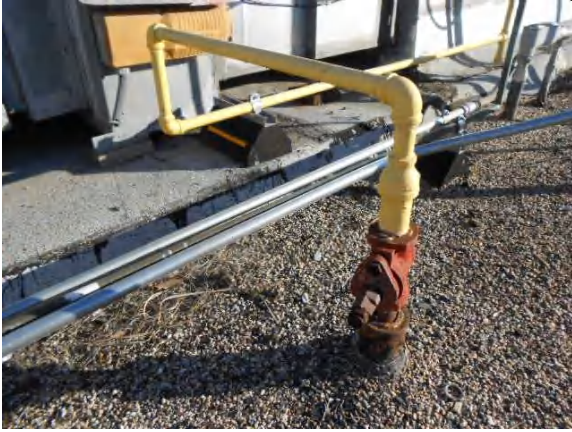
**Location:** Typical for entire building  
**Material:** System  
**Distress:** Beyond Service Life  
**Category:** Capital Renewal  
**Priority:** 4 - Recommended (Years 6-10)  
**Correction:** Renew System  
**Qty:** 1-Ea.  
**Estimate:** \$19,402.53  
**Assessor Name:** Eduardo Lopez  
**Date Created:** 01/24/2013

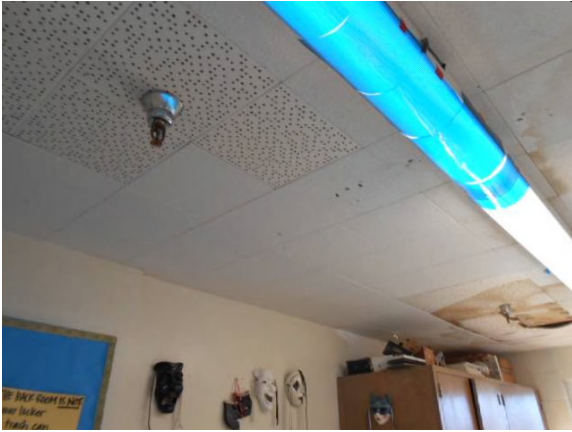
**Location:** Typical for entire building  
**Material:** System  
**Distress:** Beyond Expected Life  
**Category:** Capital Renewal  
**Priority:** 5 - Codes or Standards Compliance  
**Correction:** Renew System  
**Qty:** 1-Ea.  
**Estimate:** \$96,358.62  
**Assessor Name:** Eduardo Lopez  
**Date Created:** 01/24/2013

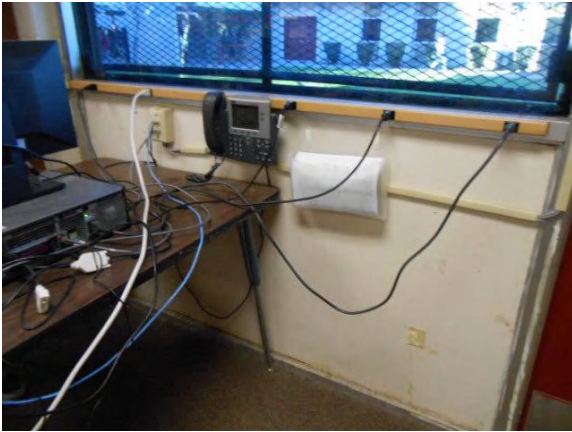
**Location:** Typical for entire building  
**Material:** System  
**Distress:** Beyond Service Life  
**Category:** Capital Renewal  
**Priority:** 4 - Recommended (Years 6-10)  
**Correction:** Renew System  
**Qty:** 1-Ea.  
**Estimate:** \$365,813.93  
**Assessor Name:** Eduardo Lopez  
**Date Created:** 01/24/2013

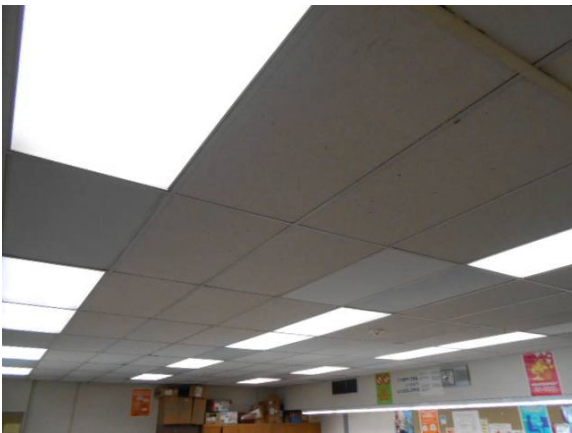
**Location:** Classrooms at both levels and student center/business pract. room 402  
**Material:** Fluorescent Lighting Fixture, 80 W  
**Distress:** Beyond Expected Life  
**Category:** Capital Renewal  
**Priority:** 4 - Recommended (Years 6-10)  
**Correction:** Replace fixture fluorescent lighting fixture, 80 W  
**Qty:** 173-Ea.  
**Estimate:** \$63,282.79  
**Assessor Name:** Eduardo Lopez  
**Date Created:** 01/23/2013

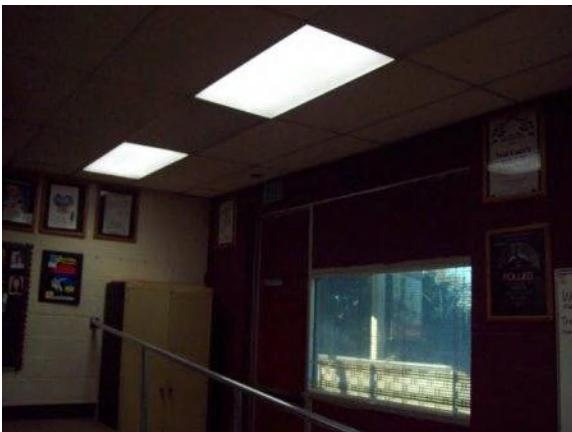
**Location:** Exterior windows.  
**Material:** Blinds and Other Window Treatment  
**Distress:** Beyond Expected Life  
**Category:** Capital Renewal  
**Priority:** 1 - Currently Critical (Immediate)  
**Correction:** Replace window blinds  
**Qty:** 420-S.F.  
**Estimate:** \$4,554.14  
**Assessor Name:** Ann Buerger Linden  
**Date Created:** 01/28/2013

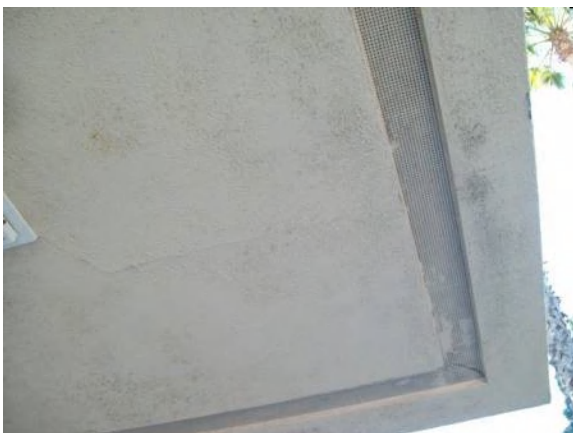
**Location:** Exterior soffits.  
**Material:** Plaster Soffits  
**Distress:** Beyond Expected Life  
**Category:** Capital Renewal  
**Priority:** 3 - Necessary/Not Yet Critical (Years 2-5)  
**Correction:** Replace plaster soffits  
**Qty:** 3,700-S.F.  
**Estimate:** \$232,513.92  
**Assessor Name:** Ann Buerger Linden  
**Date Created:** 01/28/2013

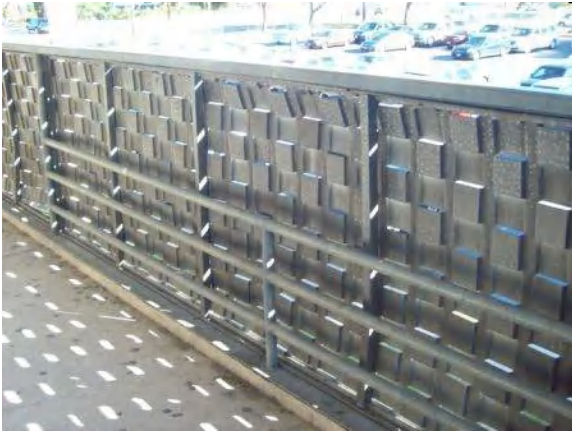
**Location:** Second floor balconies.  
**Material:** Balcony Sreen OUSD  
**Distress:** Beyond Service Life  
**Category:** Capital Renewal  
**Priority:** 3 - Necessary/Not Yet Critical (Years 2-5)  
**Correction:** Replace balcony wall screening material  
**Qty:** 475-L.F.  
**Estimate:** \$41,860.80  
**Assessor Name:** Ann Buerger Linden  
**Date Created:** 01/28/2013

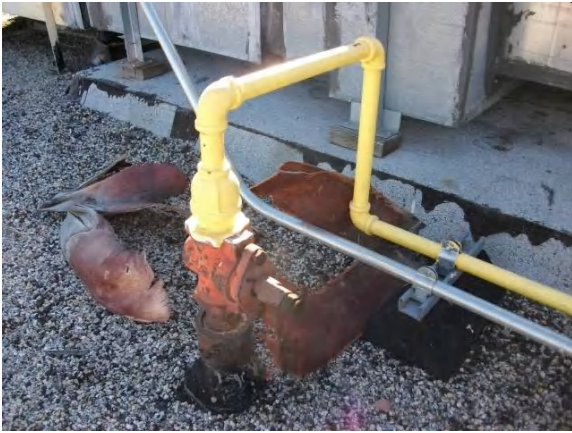
**Location:** Typical for entire building  
**Material:** System  
**Distress:** Beyond Service Life  
**Category:** Capital Renewal  
**Priority:** 4 - Recommended (Years 6-10)  
**Correction:** Renew System  
**Qty:** 1-Ea.  
**Estimate:** \$23,786.25  
**Assessor Name:** Eduardo Lopez  
**Date Created:** 01/24/2013

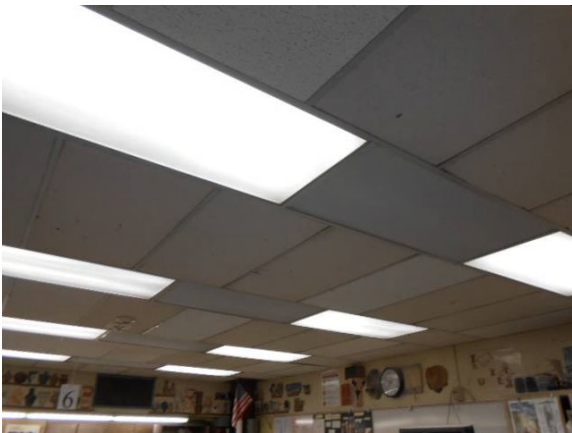
**Location:** Typical for entire building  
**Material:** System  
**Distress:** Beyond Expected Life  
**Category:** Capital Renewal  
**Priority:** 4 - Recommended (Years 6-10)  
**Correction:** Renew System  
**Qty:** 1-Ea.  
**Estimate:** \$20,509.23  
**Assessor Name:** Eduardo Lopez  
**Date Created:** 01/27/2013

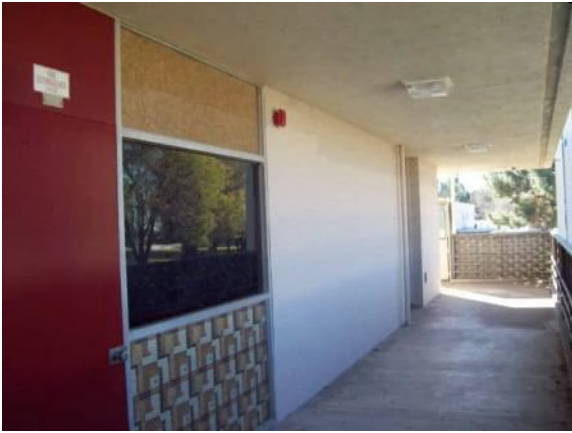
**Location:** At exterior windows.  
**Material:** Blinds and Other Window Treatment  
**Distress:** Missing  
**Category:** Capital Renewal  
**Priority:** 1 - Currently Critical (Immediate)  
**Correction:** Replace window blinds  
**Qty:** 252-S.F.  
**Estimate:** \$2,732.49  
**Assessor Name:** Ann Buerger Linden  
**Date Created:** 01/28/2013

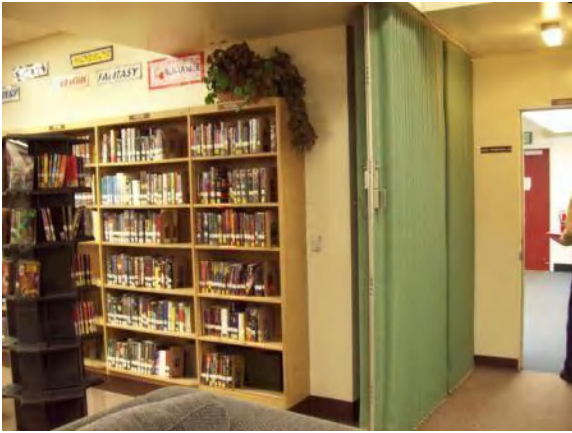
**Location:** Interior walls  
**Material:** Interior Partitions  
**Distress:** Beyond Expected Life  
**Category:** Capital Renewal  
**Priority:** 3 - Necessary/Not Yet Critical (Years 2-5)  
**Correction:** Allowance repair/remodel interior partitions  
OUSD  
**Qty:** 1-Job  
**Estimate:** \$22,032.00  
**Assessor Name:** Ann Buerger Linden  
**Date Created:** 01/28/2013

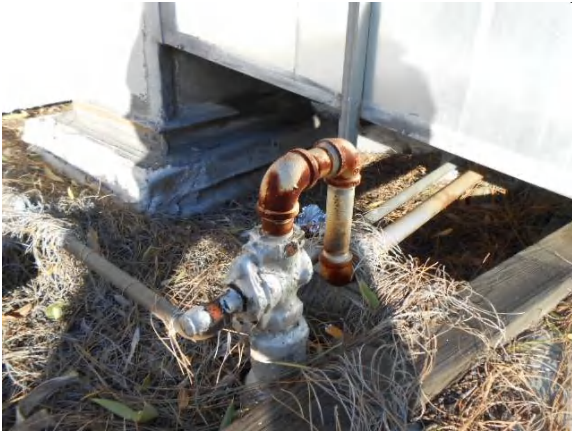
**Location:** Typical for entire building  
**Material:** System  
**Distress:** Beyond Service Life  
**Category:** Capital Renewal  
**Priority:** 4 - Recommended (Years 6-10)  
**Correction:** Renew System  
**Qty:** 1-Ea.  
**Estimate:** \$13,180.24  
**Assessor Name:** Eduardo Lopez  
**Date Created:** 01/24/2013

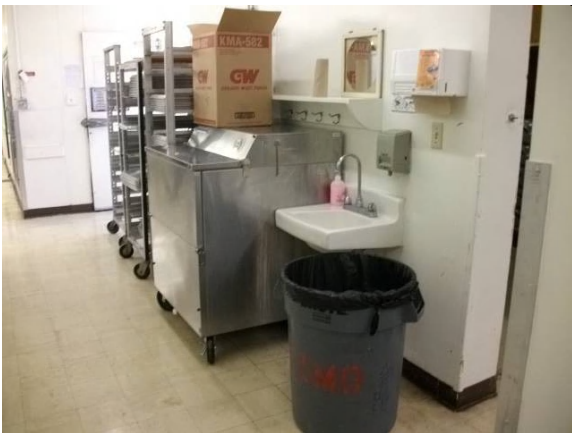
**Location:** Kitchen and Kitchen Storage  
**Material:** Lavatory, Vitreous China  
**Distress:** Beyond Expected Life  
**Category:** Capital Renewal  
**Priority:** 4 - Recommended (Years 6-10)  
**Correction:** Replace lavatory, vitreous china  
**Qty:** 2-Ea.  
**Estimate:** \$2,149.98  
**Assessor Name:** Eduardo Lopez  
**Date Created:** 01/22/2013

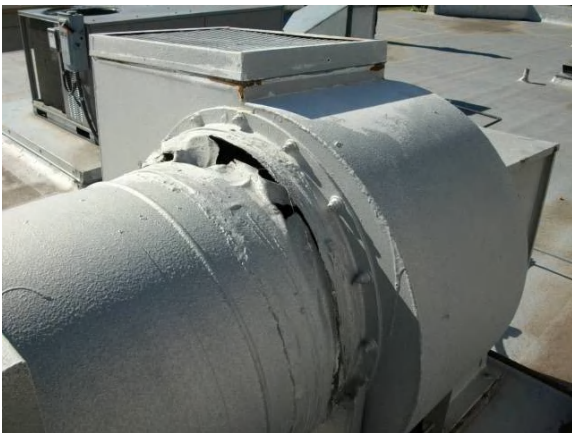
**Location:** Typical for entire building  
**Material:** System  
**Distress:** Beyond Service Life  
**Category:** Capital Renewal  
**Priority:** 4 - Recommended (Years 6-10)  
**Correction:** Renew System  
**Qty:** 1-Ea.  
**Estimate:** \$400,984.21  
**Assessor Name:** Eduardo Lopez  
**Date Created:** 01/24/2013

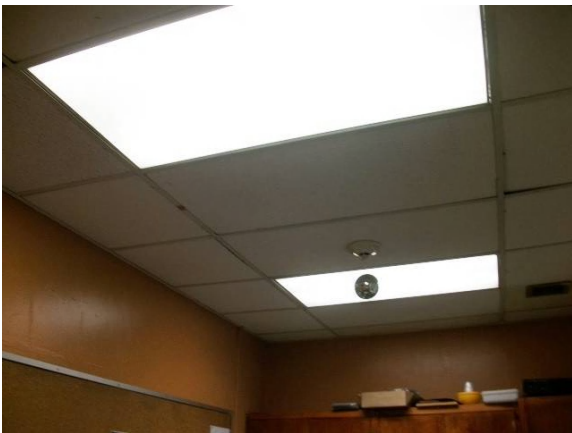
**Location:** Offices, Storage and Practice Rooms from Classroom 701 & 702, Dressing Rooms  
**Material:** Fluorescent Lighting Fixture, 80 W  
**Distress:** Beyond Expected Life  
**Category:** Capital Renewal  
**Priority:** 4 - Recommended (Years 6-10)  
**Correction:** Replace fixture fluorescent lighting fixture, 80 W  
**Qty:** 15-Ea.  
**Estimate:** \$9,792.68  
**Assessor Name:** Eduardo Lopez  
**Date Created:** 01/23/2013

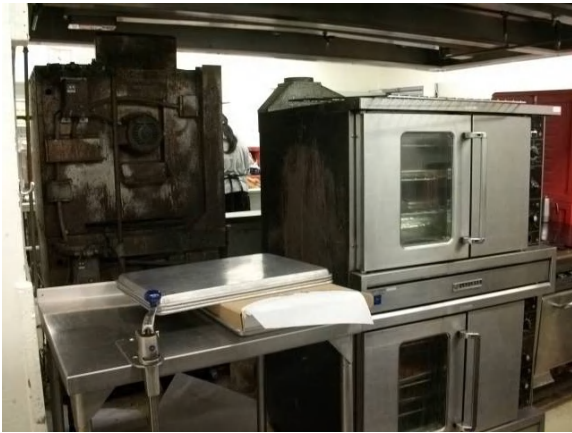
**Location:** Kitchen  
**Material:** System  
**Distress:** Beyond Service Life  
**Category:** Capital Renewal  
**Priority:** 4 - Recommended (Years 6-10)  
**Correction:** Renew System  
**Qty:** 1-Ea.  
**Estimate:** \$356,905.30  
**Assessor Name:** Eduardo Lopez  
**Date Created:** 01/25/2013

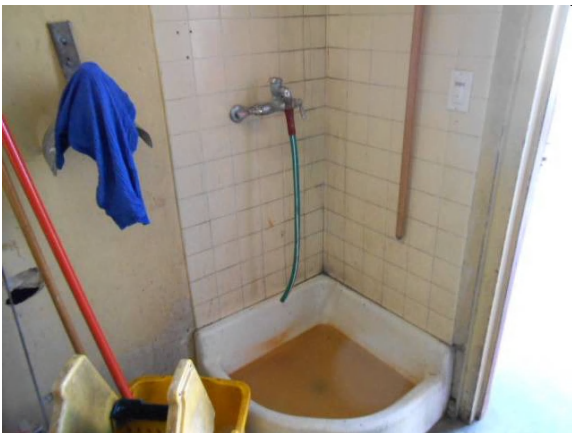
**Location:** Typical for entire building  
**Material:** System  
**Distress:** Beyond Service Life  
**Category:** Capital Renewal  
**Priority:** 4 - Recommended (Years 6-10)  
**Correction:** Renew System  
**Qty:** 1-Ea.  
**Estimate:** \$114,167.12  
**Assessor Name:** Eduardo Lopez  
**Date Created:** 01/24/2013

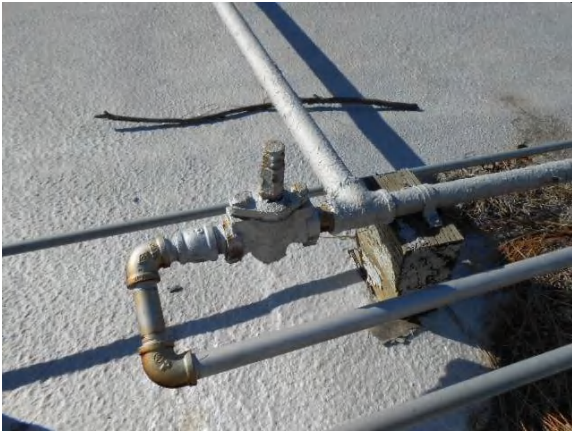
**Location:** Typical for entire building  
**Material:** System  
**Distress:** Beyond Service Life  
**Category:** Capital Renewal  
**Priority:** 4 - Recommended (Years 6-10)  
**Correction:** Renew System  
**Qty:** 1-Ea.  
**Estimate:** \$31,209.24  
**Assessor Name:** Eduardo Lopez  
**Date Created:** 01/24/2013

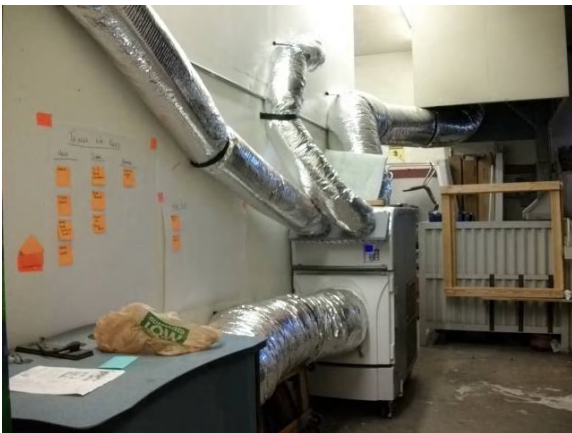
**Location:** Classroom 806A/B & 807  
**Material:** Heating/Cooling Air Handlings Units  
**Distress:** Inadequate  
**Category:** Capital Renewal  
**Priority:** 3 - Necessary/Not Yet Critical (Years 2-5)  
**Correction:** Replace AHU - single zone unit 40k  
**Qty:** 2-Ea.  
**Estimate:** \$22,280.83  
**Assessor Name:** Eduardo Lopez  
**Date Created:** 01/27/2013

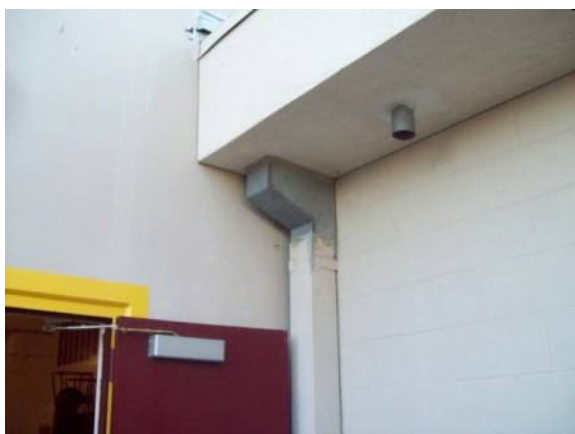
**Location:** Exterior soffits.  
**Material:** Plaster Soffits  
**Distress:** Beyond Expected Life  
**Category:** Capital Renewal  
**Priority:** 3 - Necessary/Not Yet Critical (Years 2-5)  
**Correction:** Replace plaster soffits  
**Qty:** 3,500-S.F.  
**Estimate:** \$27,296.64  
**Assessor Name:** Ann Buerger Linden  
**Date Created:** 01/29/2013

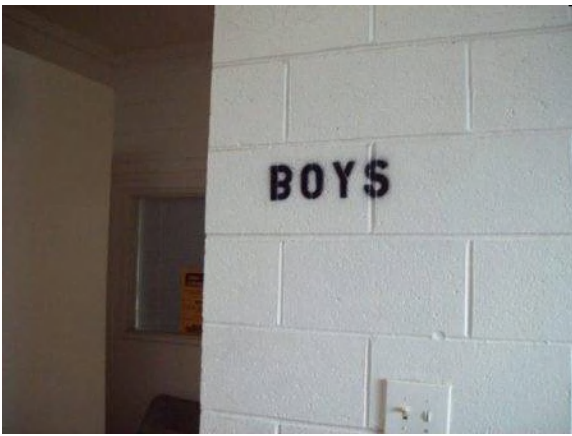
**Location:** Building wide.  
**Material:** Signage  
**Distress:** Beyond Expected Life  
**Category:** Capital Renewal  
**Priority:** 3 - Necessary/Not Yet Critical (Years 2-5)  
**Correction:** Replace/Install code compliant signage  
**Qty:** 30,246-S.F.  
**Estimate:** \$6,533.14  
**Assessor Name:** Ann Buerger Linden  
**Date Created:** 01/29/2013
