Orange Unified School District

Facilities Condition Assessment for:

Villa Park High School
18042 Taft Avenue
Villa Park, CA 92861

Campus Report

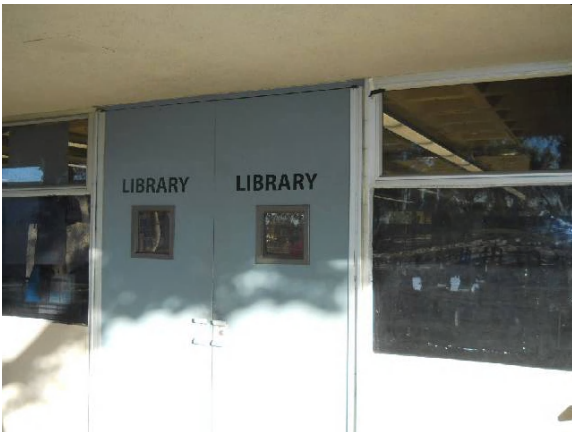
Location: All exterior doors, classrooms, offices, Restrooms, others
Material: System
Distress: Beyond Service Life
Category: Capital Renewal
Priority: 3 - Necessary/Not Yet Critical (Years 2-5)
Correction: Renew System
Qty: 1-Ea.
Estimate: \$497,673.35
Assessor Name: Dave Cunningham
Date Created: 01/25/2013

Notes: All exterior doors are original construction. Doors are aged, beyond expected life, and are not ADA compliant. Provide interior locking hardware at all classroom doors for security. Recommend replacement during school renovations.

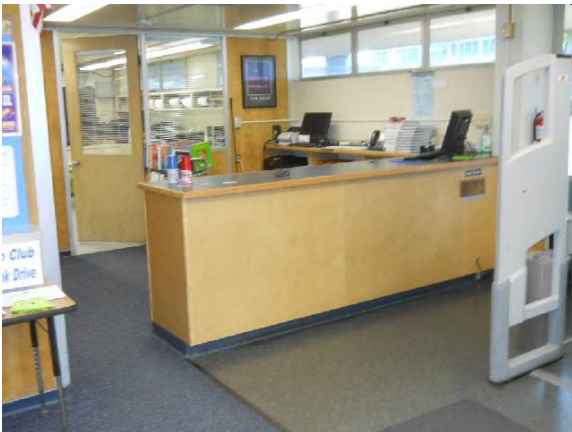
Location: All interior doors
Material: System
Distress: Beyond Service Life
Category: Capital Renewal
Priority: 3 - Necessary/Not Yet Critical (Years 2-5)
Correction: Renew System
Qty: 1-Ea.
Estimate: \$54,458.08
Assessor Name: Dave Cunningham
Date Created: 01/25/2013

Notes: Interior door systems are original construction, beyond expected service life, and are not ADA compatible. Recommend replacement during school renovations.

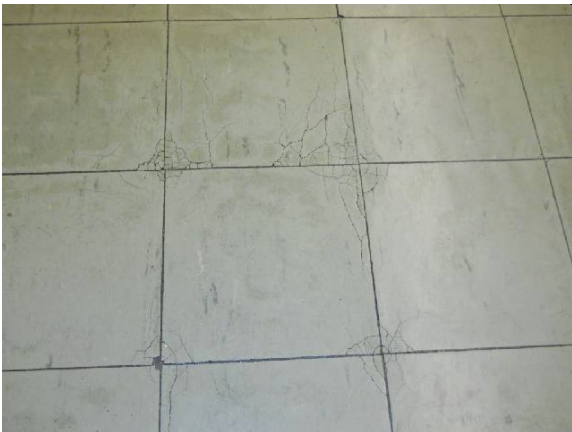
Location: Throughout the building, most classrooms are VAT or old VCT floor tile

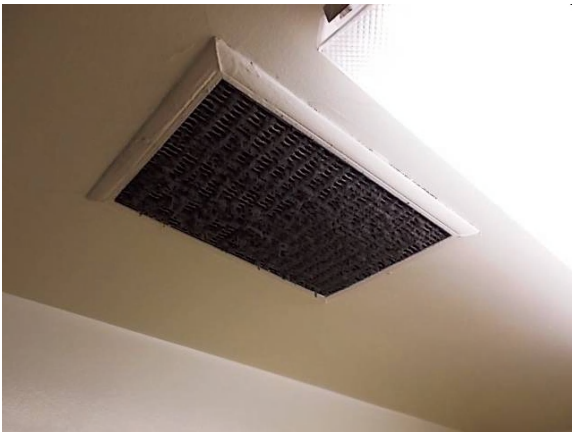
Location: Typical for all locations system wide.
Material: Exhaust & Ventilating Systems
Distress: Inadequate
Category: Capital Renewal
Priority: 4 - Recommended (Years 6-10)
Correction: Replace exhaust system
Qty: 1-Ea.
Estimate: \$399,872.59
Assessor Name: Sonny Satterfield
Date Created: 01/22/2013

Notes: HVAC system was partially renewed in 2007 with new chillers/AHU and boilers; however most of the HVAC duct, exhaust fans and fresh air supply is recommended to be upgraded and components replaced as required during the next major renovation.

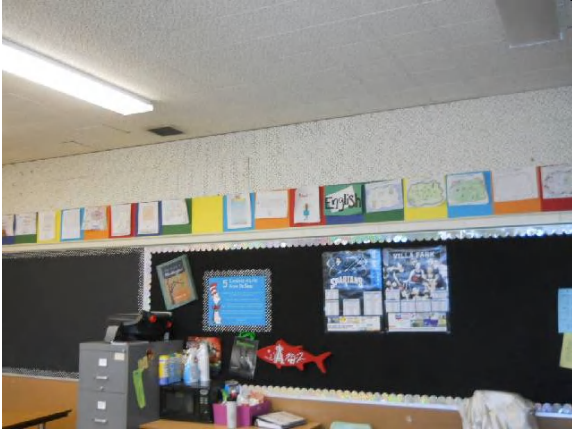
Location: All classrooms
Material: Other Institutional Equipment
Distress: Inadequate
Category: Capital Renewal
Priority: 4 - Recommended (Years 6-10)
Correction: Smartboards whiteboards tackboards
Qty: 28-Ea.
Estimate: \$312,483.63
Assessor Name: Dave Cunningham
Date Created: 01/30/2013

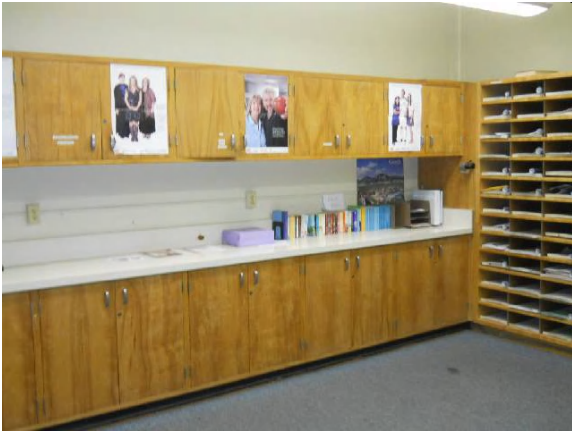
Location: Career Center, Principals office, Attendance 08, Office 07, work room 14
Material: Fixed Casework
Distress: Beyond Service Life
Category: Deferred Maintenance
Priority: 4 - Recommended (Years 6-10)
Correction: Replace Casework OUSD
Qty: 90-L.F.
Estimate: \$40,926.38
Assessor Name: Dave Cunningham
Date Created: 01/28/2013

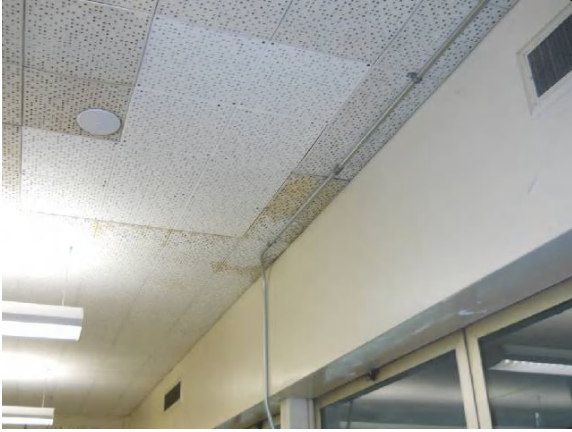
Location: Throughout the building
Material: System
Distress: Beyond Expected Life
Category: Capital Renewal
Priority: 3 - Necessary/Not Yet Critical (Years 2-5)
Correction: Renew System
Qty: 1-Ea.
Estimate: \$279,916.56
Assessor Name: Dave Cunningham
Date Created: 01/28/2013

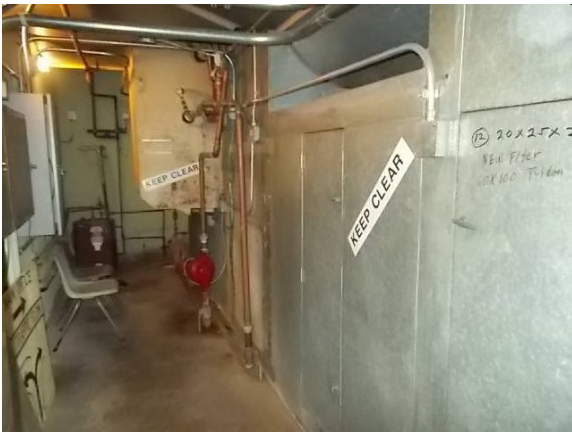
Location: Typical for all locations system wide.
Material: System
Distress: Beyond Expected Life
Category: Capital Renewal
Priority: 4 - Recommended (Years 6-10)
Correction: Renew System
Qty: 1-Ea.
Estimate: \$386,527.68
Assessor Name: Sonny Satterfield
Date Created: 01/23/2013

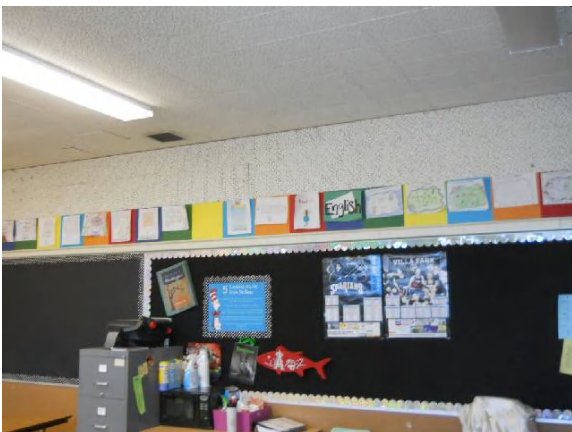
Location: All Classrooms
Material: Other Institutional Equipment
Distress: Inadequate
Category: Capital Renewal
Priority: 3 - Necessary/Not Yet Critical (Years 2-5)
Correction: Smartboards whiteboards tackboards
Qty: 9-Ea.
Estimate: \$100,441.17
Assessor Name: Dave Cunningham
Date Created: 01/30/2013

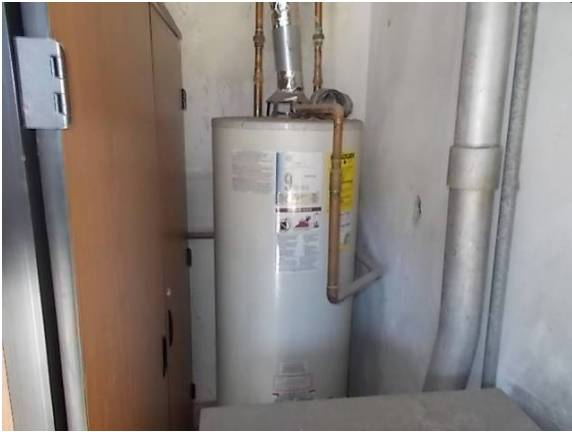
Location: Typical for all required locations system wide.
Material: System
Distress: Beyond Service Life
Category: Capital Renewal
Priority: 4 - Recommended (Years 6-10)
Correction: Renew System
Qty: 1-Ea.
Estimate: \$89,143.08
Assessor Name: Sonny Satterfield
Date Created: 01/23/2013

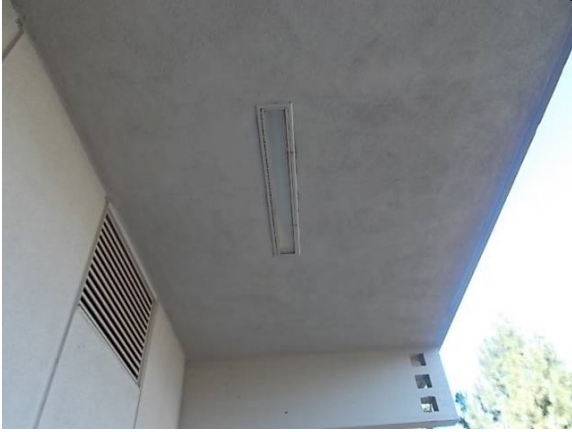
Location: Typical for all canopy walkway locations
Material: HP Sodium Fixture, 250 W
Distress: Beyond Expected Life
Category: Capital Renewal
Priority: 4 - Recommended (Years 6-10)
Correction: Replace fixture H.P. sodium fixture, 250 W
Qty: 8-Ea.
Estimate: \$10,970.96
Assessor Name: Sonny Satterfield
Date Created: 01/24/2013

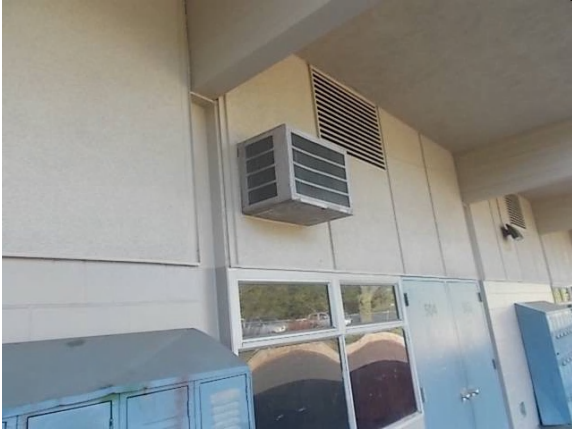
Location: Classroom 504
Material: Air Conditioner, Window 4 Ton
Distress: Beyond Expected Life
Category: Deferred Maintenance
Priority: 3 - Necessary/Not Yet Critical (Years 2-5)
Correction: Replace air conditioner, 4 ton, window
Qty: 1-Ea.
Estimate: \$11,425.75
Assessor Name: Sonny Satterfield
Date Created: 01/24/2013

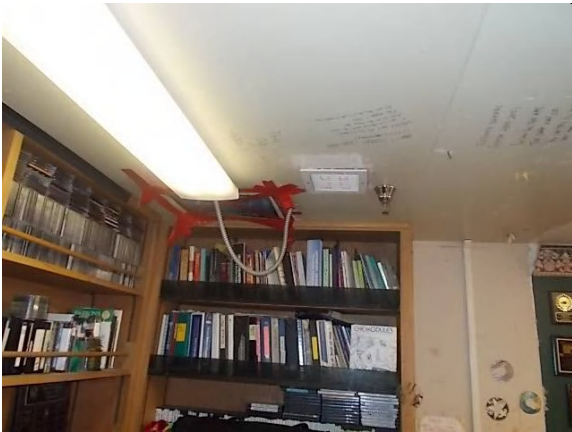
Location: Typical for all required locations system wide.
Material: System
Distress: Beyond Service Life
Category: Capital Renewal
Priority: 5 - Codes or Standards Compliance
Correction: Renew System
Qty: 1-Ea.
Estimate: \$111,300.48
Assessor Name: Sonny Satterfield
Date Created: 01/24/2013

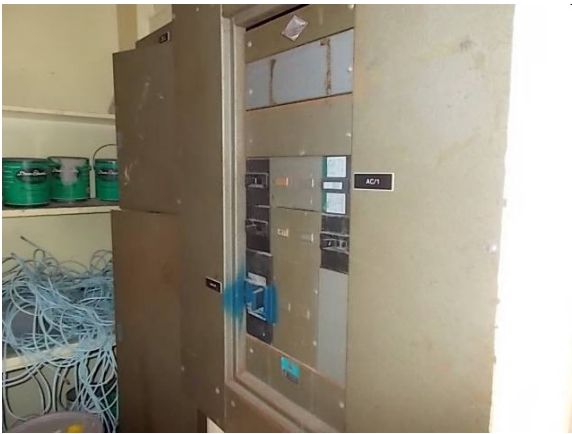
Location: Typical for all required locations system wide.
Material: System
Distress: Beyond Service Life
Category: Capital Renewal
Priority: 4 - Recommended (Years 6-10)
Correction: Renew System
Qty: 1-Ea.
Estimate: \$89,925.58
Assessor Name: Sonny Satterfield
Date Created: 01/24/2013

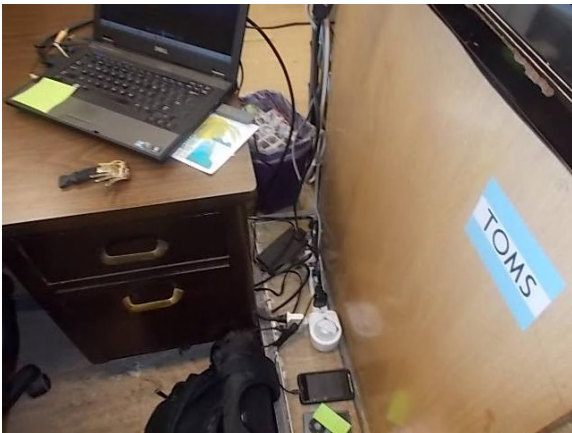
Location: Typical for all required locations system wide.
Material: System
Distress: Beyond Service Life
Category: Capital Renewal
Priority: 4 - Recommended (Years 6-10)
Correction: Renew System
Qty: 1-Ea.
Estimate: \$321,469.63
Assessor Name: Sonny Satterfield
Date Created: 01/24/2013

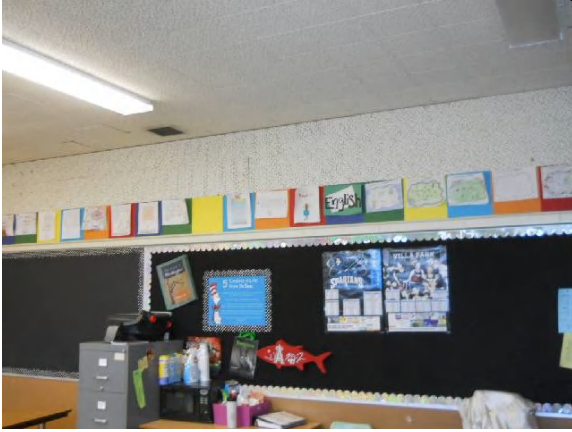
Location: All Classrooms
Material: Other Institutional Equipment
Distress: Inadequate
Category: Capital Renewal
Priority: 4 - Recommended (Years 6-10)
Correction: Smartboards whiteboards tackboards
Qty: 5-Ea.
Estimate: \$55,800.65
Assessor Name: Dave Cunningham
Date Created: 01/30/2013

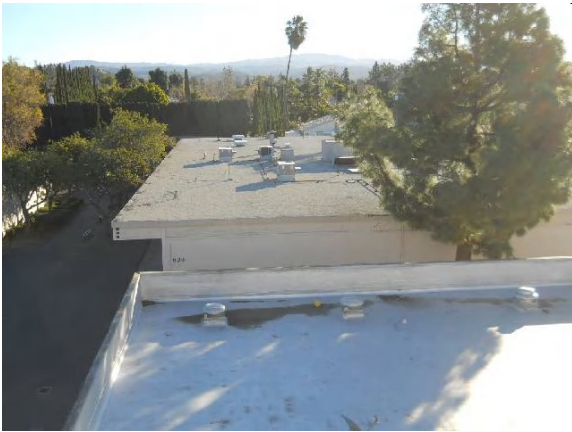
Location: roof
Material: System
Distress: Missing
Category: Capital Renewal
Priority: 3 - Necessary/Not Yet Critical (Years 2-5)
Correction: Renew System
Qty: 1-Ea.
Estimate: \$21,910.33
Assessor Name: Dave Cunningham
Date Created: 01/28/2013

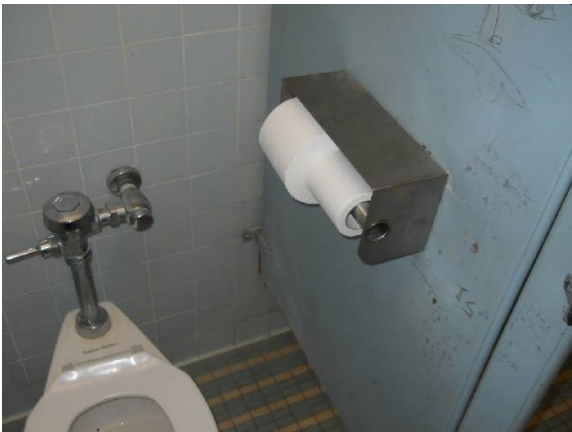
Location: Throughout the building
Material: System
Distress: Beyond Expected Life
Category: Capital Renewal
Priority: 3 - Necessary/Not Yet Critical (Years 2-5)
Correction: Renew System
Qty: 1-Ea.
Estimate: \$37,181.17
Assessor Name: Dave Cunningham
Date Created: 01/28/2013

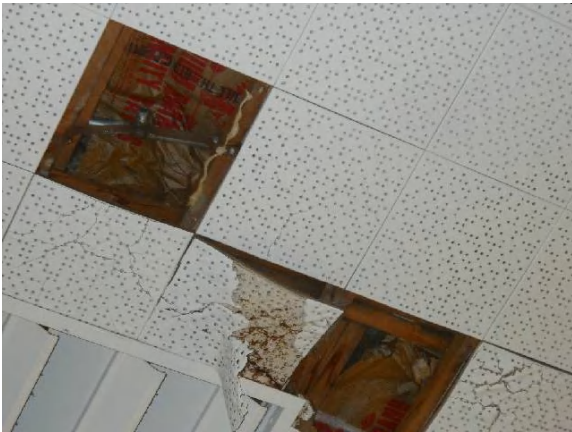
Location: Throughout the building
Material: System
Distress: Beyond Expected Life
Category: Capital Renewal
Priority: 4 - Recommended (Years 6-10)
Correction: Renew System
Qty: 1-Ea.
Estimate: \$369,377.21
Assessor Name: Dave Cunningham
Date Created: 01/28/2013

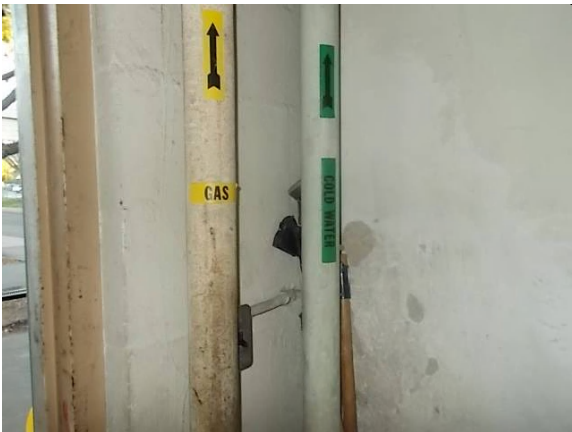
Location: Typical for all required locations system wide.
Material: System
Distress: Beyond Service Life
Category: Capital Renewal
Priority: 4 - Recommended (Years 6-10)
Correction: Renew System
Qty: 1-Ea.
Estimate: \$27,664.56
Assessor Name: Sonny Satterfield
Date Created: 01/24/2013

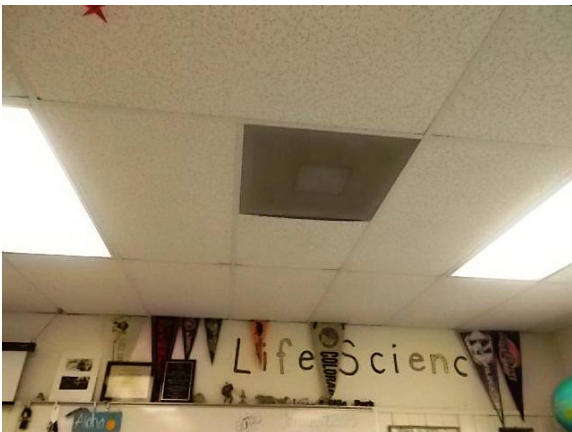
Location: Typical for all required locations system wide.
Material: System
Distress: Beyond Service Life
Category: Capital Renewal
Priority: 4 - Recommended (Years 6-10)
Correction: Renew System
Qty: 1-Ea.
Estimate: \$28,992.46
Assessor Name: Sonny Satterfield
Date Created: 01/24/2013

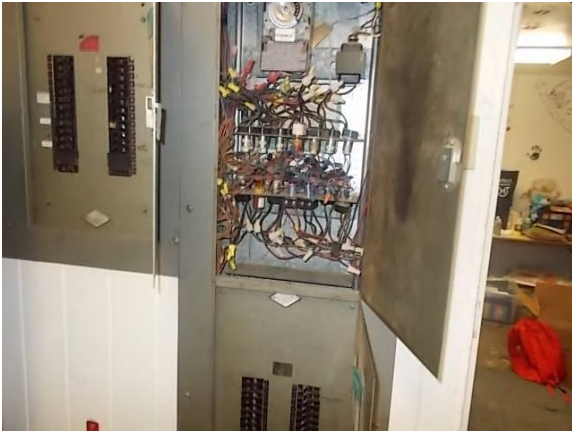
Location: Typical for all required locations system wide.
Material: System
Distress: Beyond Service Life
Category: Capital Renewal
Priority: 4 - Recommended (Years 6-10)
Correction: Renew System
Qty: 1-Ea.
Estimate: \$415,189.72
Assessor Name: Sonny Satterfield
Date Created: 01/24/2013

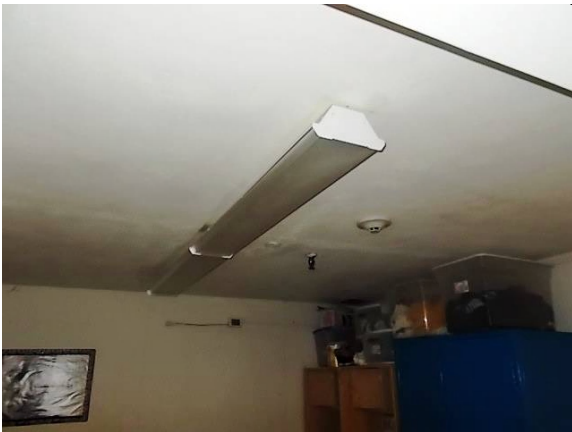
Location: Classrooms 603, 605, 606, office spaces and storage areas.
Material: System
Distress: Beyond Service Life
Category: Capital Renewal
Priority: 4 - Recommended (Years 6-10)
Correction: Renew System
Qty: 1-Ea.
Estimate: \$344,368.44
Assessor Name: Sonny Satterfield
Date Created: 01/24/2013

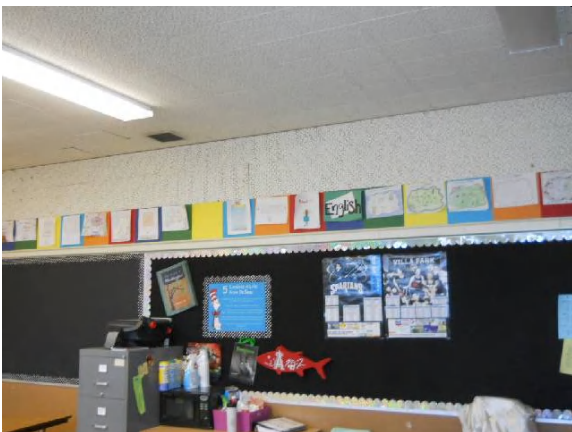
Location: All Classrooms
Material: Other Institutional Equipment
Distress: Inadequate
Category: Capital Renewal
Priority: 4 - Recommended (Years 6-10)
Correction: Smartboards whiteboards tackboards
Qty: 5-Ea.
Estimate: \$55,800.65
Assessor Name: Dave Cunningham
Date Created: 01/30/2013

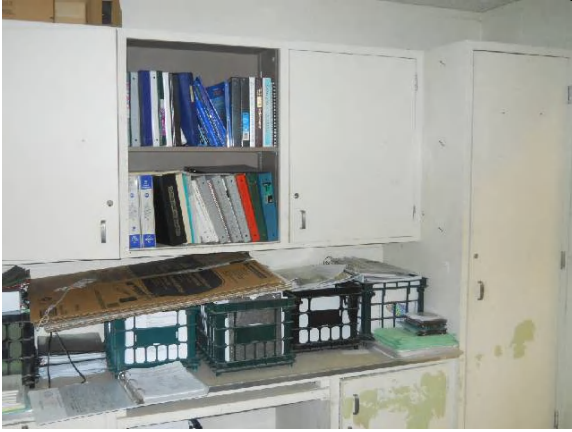
Location: Classroom 600, 602, Testing, storage rooms
Material: System
Distress: Beyond Expected Life
Category: Capital Renewal
Priority: 4 - Recommended (Years 6-10)
Correction: Renew System
Qty: 1-Ea.
Estimate: \$383,984.09
Assessor Name: Dave Cunningham
Date Created: 01/28/2013

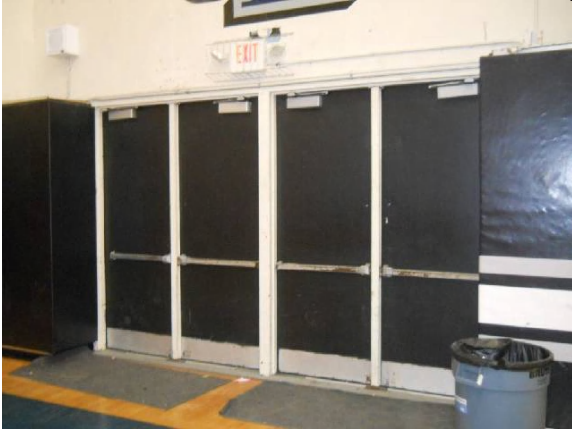
Location: All exterior door systems
Material: System
Distress: Beyond Expected Life
Category: Capital Renewal
Priority: 3 - Necessary/Not Yet Critical (Years 2-5)
Correction: Renew System
Qty: 1-Ea.
Estimate: \$182,397.60
Assessor Name: Dave Cunningham
Date Created: 01/29/2013

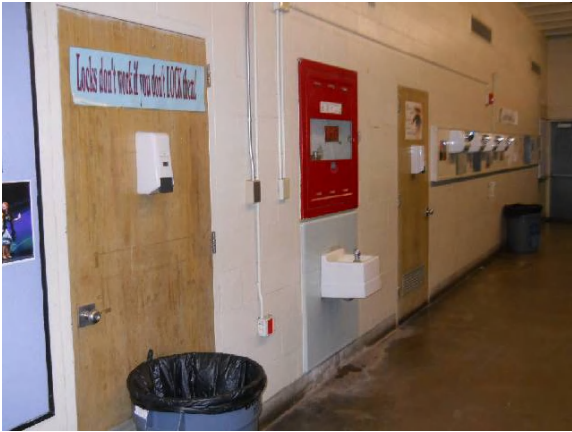
Location: All interior doors
Material: System
Distress: Beyond Expected Life
Category: Capital Renewal
Priority: 3 - Necessary/Not Yet Critical (Years 2-5)
Correction: Renew System
Qty: 1-Ea.
Estimate: \$54,846.72
Assessor Name: Dave Cunningham
Date Created: 01/29/2013

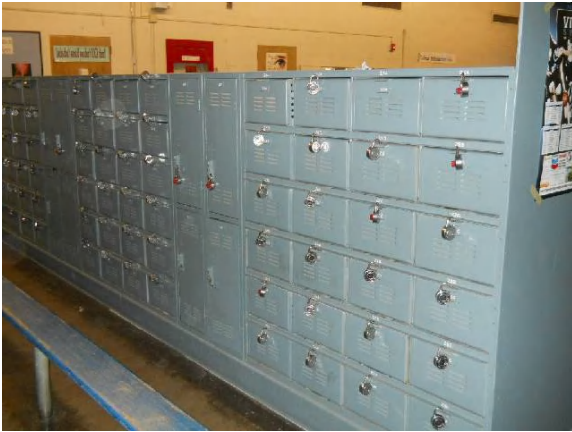
Location: Throughout the building
Material: System
Distress: Beyond Expected Life
Category: Capital Renewal
Priority: 4 - Recommended (Years 6-10)
Correction: Renew System
Qty: 1-Ea.
Estimate: \$219,007.96
Assessor Name: Dave Cunningham
Date Created: 01/29/2013

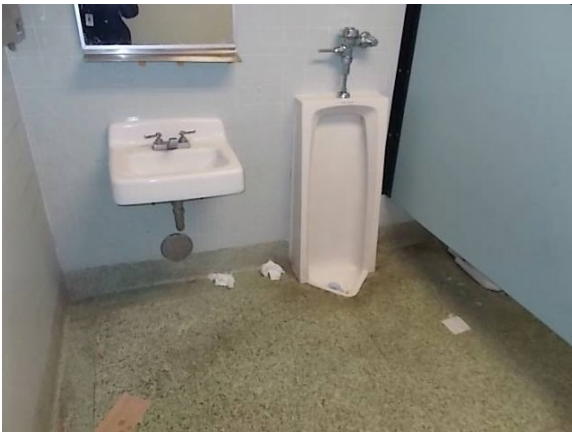
Location: Typical for all required locations system wide.
Material: System
Distress: Beyond Expected Life
Category: Capital Renewal
Priority: 4 - Recommended (Years 6-10)
Correction: Renew System
Qty: 1-Ea.
Estimate: \$439,041.72
Assessor Name: Sonny Satterfield
Date Created: 01/25/2013

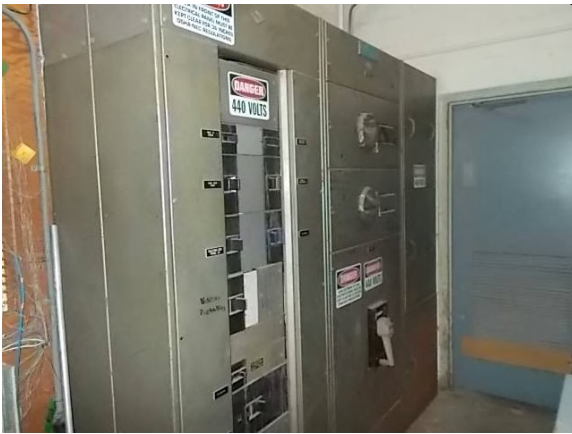
Location: Gym-Main electrical room
Material: System
Distress: Beyond Expected Life
Category: Capital Renewal
Priority: 4 - Recommended (Years 6-10)
Correction: Renew System
Qty: 1-Ea.
Estimate: \$1,370,587.81
Assessor Name: Sonny Satterfield
Date Created: 01/25/2013

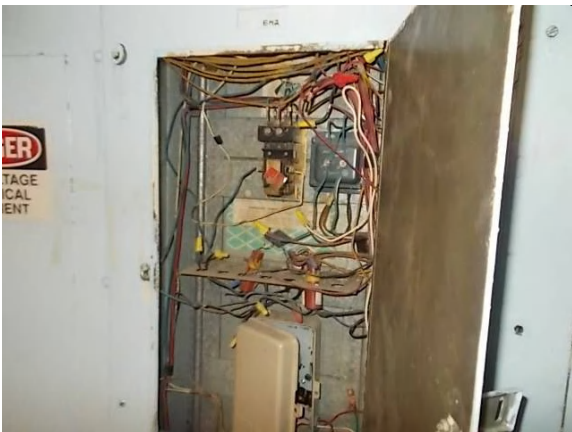
Location: Typical for all required locations system wide.
Material: System
Distress: Beyond Expected Life
Category: Capital Renewal
Priority: 3 - Necessary/Not Yet Critical (Years 2-5)
Correction: Renew System
Qty: 1-Ea.
Estimate: \$770,887.50
Assessor Name: Sonny Satterfield
Date Created: 01/25/2013

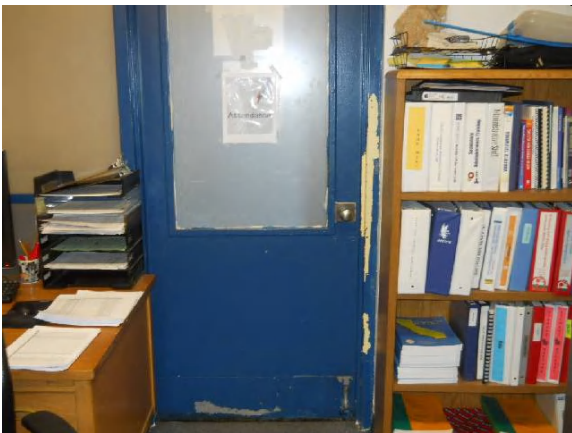
Location: All interior door systems
Material: System
Distress: Beyond Expected Life
Category: Capital Renewal
Priority: 3 - Necessary/Not Yet Critical (Years 2-5)
Correction: Renew System
Qty: 1-Ea.
Estimate: \$109,706.43
Assessor Name: Dave Cunningham
Date Created: 01/29/2013

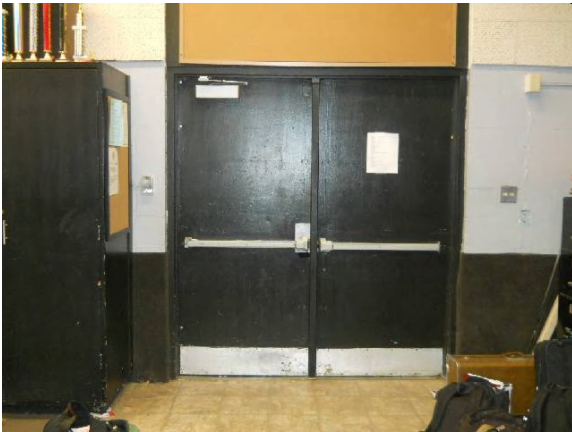
Location: Throughout the building
Material: System
Distress: Beyond Expected Life
Category: Capital Renewal
Priority: 4 - Recommended (Years 6-10)
Correction: Renew System
Qty: 1-Ea.
Estimate: \$268,214.05
Assessor Name: Dave Cunningham
Date Created: 01/29/2013

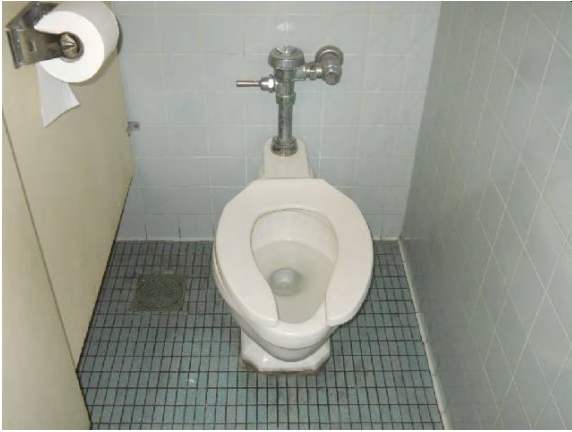
Location: Restrooms
Material: System
Distress: Beyond Expected Life
Category: Capital Renewal
Priority: 4 - Recommended (Years 6-10)
Correction: Renew System
Qty: 1-Ea.
Estimate: \$15,098.69
Assessor Name: Dave Cunningham
Date Created: 01/29/2013

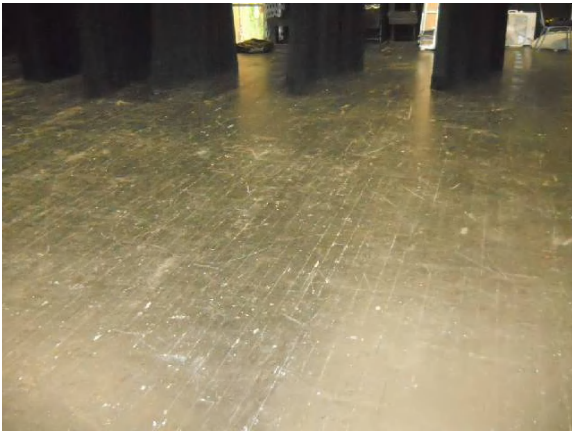
Location: Multiipurpose room stage
Material: System
Distress: Beyond Expected Life
Category: Capital Renewal
Priority: 3 - Necessary/Not Yet Critical (Years 2-5)
Correction: Renew System
Qty: 1-Ea.
Estimate: \$63,613.44
Assessor Name: Dave Cunningham
Date Created: 01/29/2013

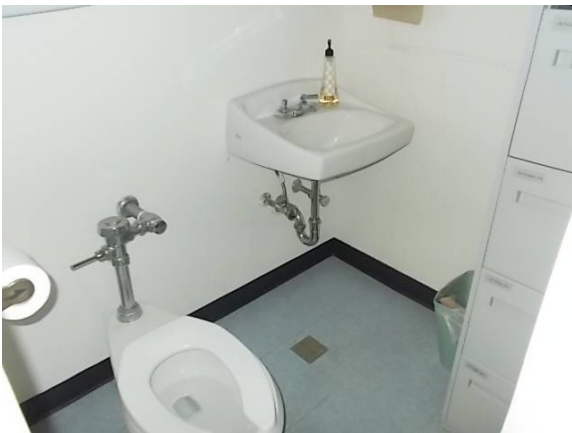
Location: Typical for all locations
Material: System
Distress: Beyond Expected Life
Category: Capital Renewal
Priority: 4 - Recommended (Years 6-10)
Correction: Renew System
Qty: 1-Ea.
Estimate: \$233,967.51
Assessor Name: Sonny Satterfield
Date Created: 01/25/2013

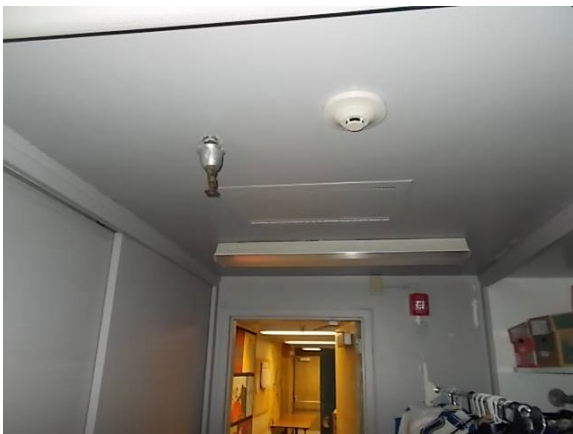
Location: Typical for all required locations system wide.
Material: System
Distress: Beyond Expected Life
Category: Capital Renewal
Priority: 5 - Codes or Standards Compliance
Correction: Renew System
Qty: 1-Ea.
Estimate: \$177,294.03
Assessor Name: Sonny Satterfield
Date Created: 01/25/2013

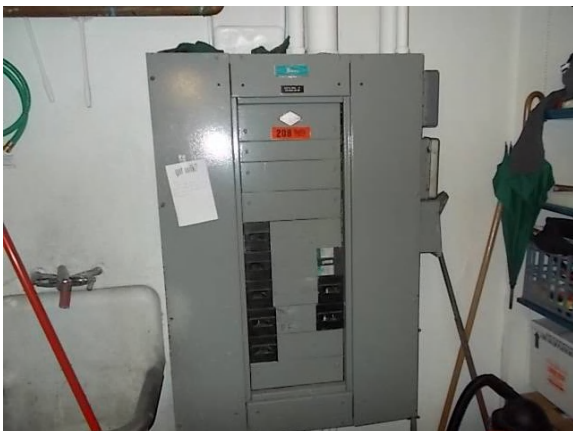
Location: Kitchen
Material: System
Distress: Beyond Expected Life
Category: Capital Renewal
Priority: 4 - Recommended (Years 6-10)
Correction: Renew System
Qty: 1-Ea.
Estimate: \$266,698.71
Assessor Name: Sonny Satterfield
Date Created: 01/25/2013

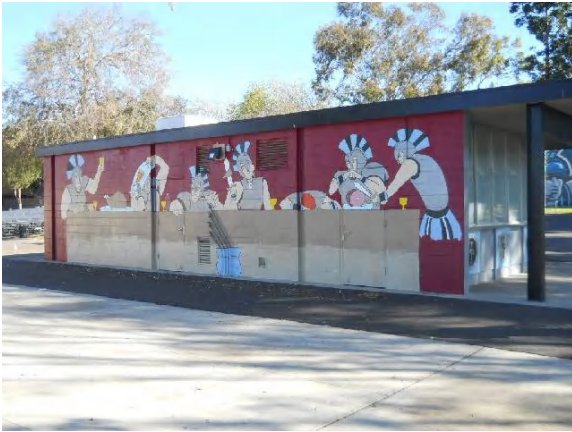
Location: Exterior door system
Material: System
Distress: Beyond Expected Life
Category: Capital Renewal
Priority: 3 - Necessary/Not Yet Critical (Years 2-5)
Correction: Renew System
Qty: 1-Ea.
Estimate: \$1,348.24
Assessor Name: Dave Cunningham
Date Created: 01/28/2013

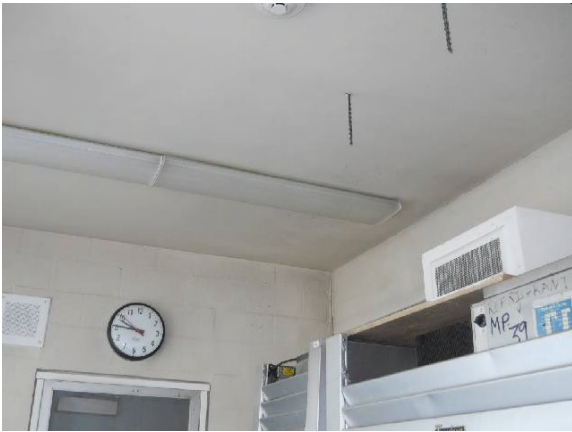
Location: interior wall finishes
Material: System
Distress: Beyond Expected Life
Category: Capital Renewal
Priority: 3 - Necessary/Not Yet Critical (Years 2-5)
Correction: Renew System
Qty: 1-Ea.
Estimate: \$5,425.83
Assessor Name: Dave Cunningham
Date Created: 01/28/2013

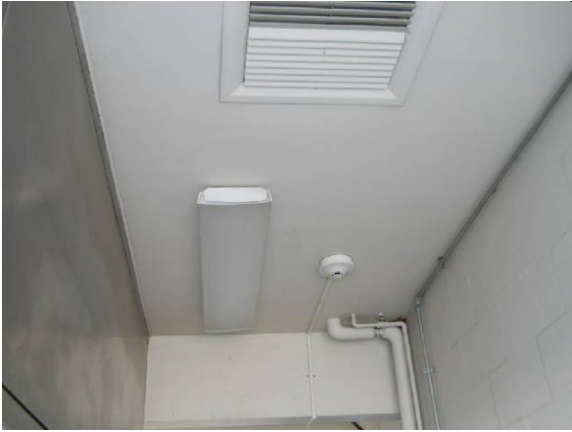
Location: All rooms
Material: System
Distress: Beyond Expected Life
Category: Capital Renewal
Priority: 3 - Necessary/Not Yet Critical (Years 2-5)
Correction: Renew System
Qty: 1-Ea.
Estimate: \$6,193.12
Assessor Name: Dave Cunningham
Date Created: 01/28/2013

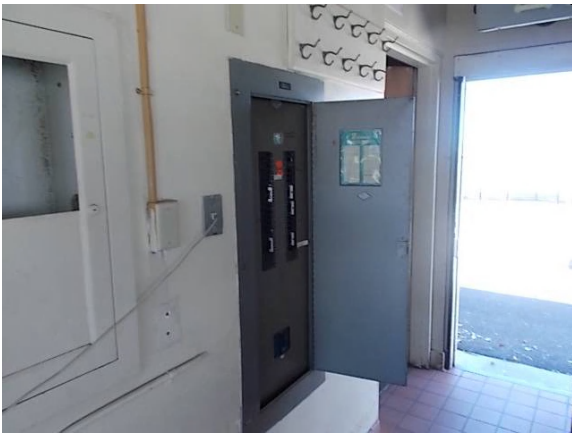
Location: Typical for all required locations system wide
Material: System
Distress: Beyond Expected Life
Category: Capital Renewal
Priority: 4 - Recommended (Years 6-10)
Correction: Renew System
Qty: 1-Ea.
Estimate: \$6,006.78
Assessor Name: Sonny Satterfield
Date Created: 01/25/2013

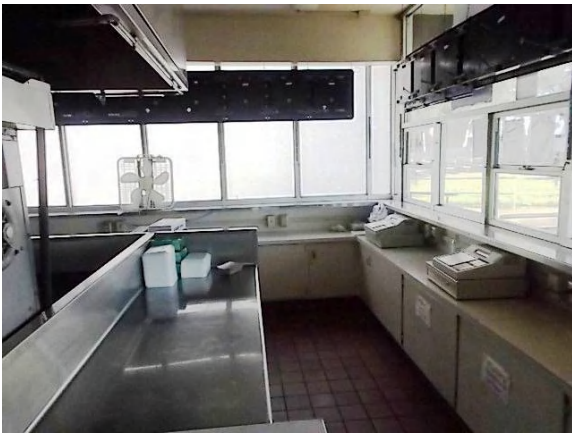
Location: Typical for all locations
Material: System
Distress: Beyond Service Life
Category: Capital Renewal
Priority: 4 - Recommended (Years 6-10)
Correction: Renew System
Qty: 1-Ea.
Estimate: \$16,474.80
Assessor Name: Sonny Satterfield
Date Created: 01/25/2013

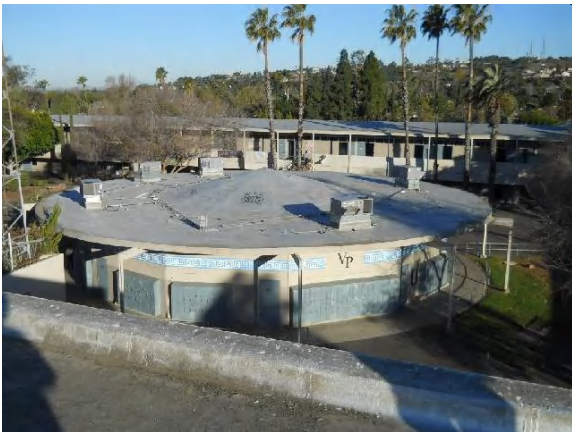
Location: Roof
Material: System
Distress: Beyond Expected Life
Category: Capital Renewal
Priority: 3 - Necessary/Not Yet Critical (Years 2-5)
Correction: Renew System
Qty: 1-Ea.
Estimate: \$141,693.24
Assessor Name: Dave Cunningham
Date Created: 01/29/2013
