## Orange Unified School District

Facilities Condition Assessment for:

**El Modena High School**  
**3920 Spring Street**  
**Orange, CA 92869**

# Campus Report

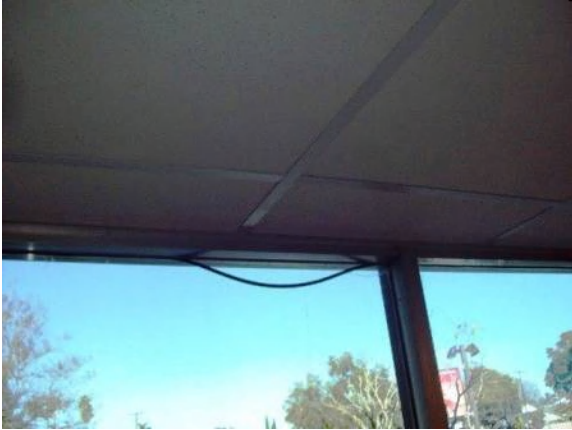
### System: B2020 - Exterior Windows

**Location:** Exterior windows all sides of building.  
Includes operable windows at attendance.

**Notes:** Quantity/area includes transom panels at doors, ceramic tile assembly above and below windows and transaction windows at attendance office. Existing windows are typically single pane in aluminum frames. Glazing systems are failing. Tile panels are ACM per 2012 AHERA report.

**Correction:** Replace windows OUSD EIMo

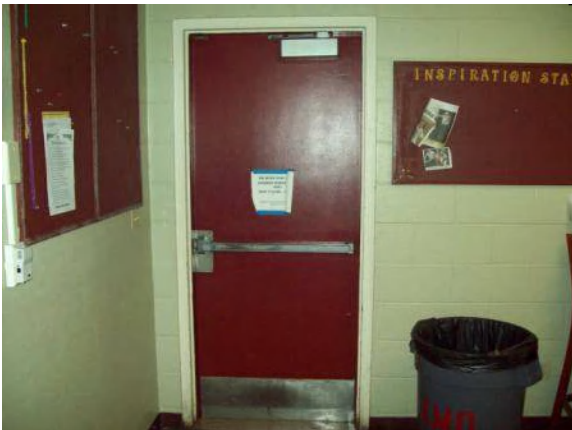
### System: B2030 - Exterior Doors

**Location:** Exterior doors at principal's office,  
conference room, staff lounge and pair at  
electrical closet

**Notes:** Exterior doors at the building are beyond their expected service life. Replacement, including new frames and hardware, is recommended to reduce maintenance costs and improve security.

**Correction:** Replace 3'-0" x 7'-0" solid core, painted,  
door

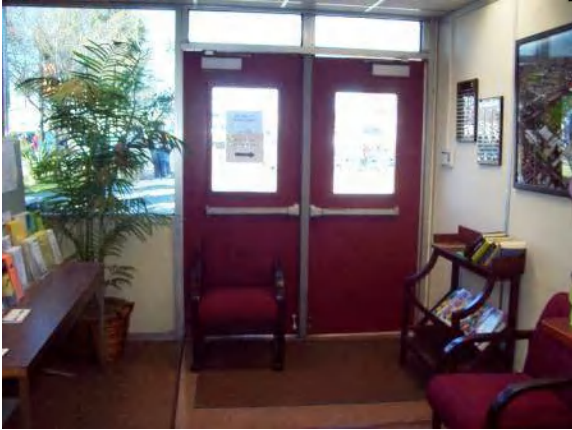
### System: B2030 - Exterior Doors

**Location:** Exterior doors at main entrance, storage, and attendance corridor.

**Notes:** Exterior doors are beyond their expected life. An ADA operator is recommended for the main entrance.

**Correction:** Replace 3'-0" x 7'-0" aluminum door, incl. vision

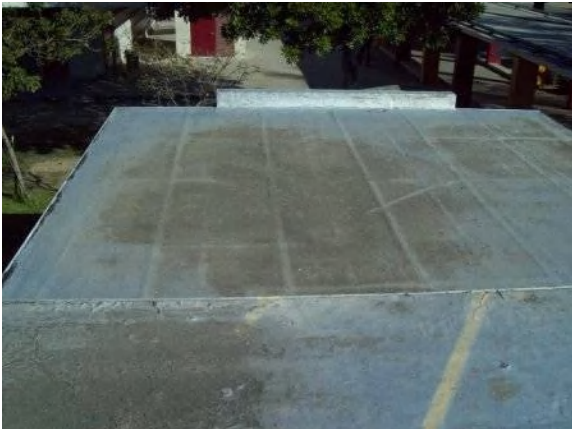
### System: B3010105 - Built-Up

**Location:** Roof, including roof over attendance queuing area at the east side of the building.

**Notes:** The roof system is built-up with a reflective fiber reinforced coating. This roof is visibly deteriorated. Areas of obvious ponding, which contributes to deteriorations, are evident.

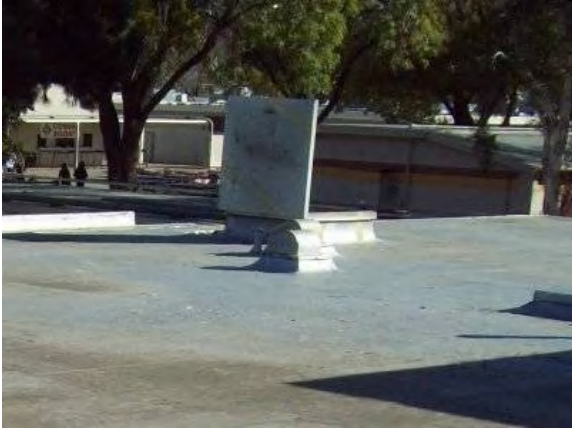
### System: B3020 - Roof Openings

**Location:** Access from electrical equipment room.  
**Material:** System  
**Distress:** Beyond Expected Life  
**Category:** Capital Renewal  
**Priority:** 3 - Necessary/Not Yet Critical (Years 2-5)  
**Correction:** Renew System  
**Qty:** 1-Ea.  
**Estimate:** \$8,593.36  
**Assessor Name:** Ann Buerger Linden  
**Date Created:** 01/22/2013

**Notes:** Replace roof hatch and access ladder with code compliant assembly.

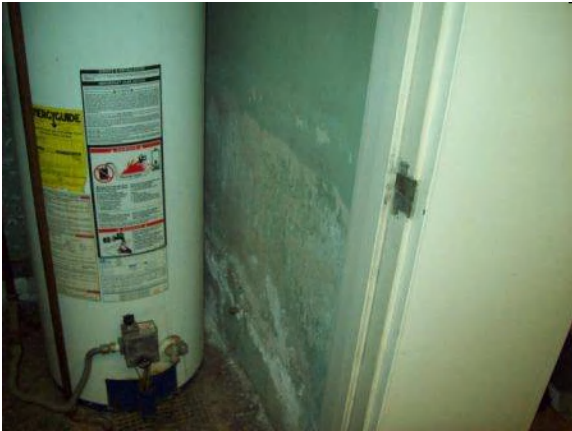
### System: C1010 - Partitions

**Location:** Primarily restrooms and elsewhere as needed.  
**Material:** Interior Partitions  
**Distress:** Inadequate  
**Category:** Capital Renewal  
**Priority:** 3 - Necessary/Not Yet Critical (Years 2-5)  
**Correction:** Allowance repair/remodel interior partitions  
OUSD  
**Qty:** 1-Job  
**Estimate:** \$11,016.00  
**Assessor Name:** Ann Buerger Linden  
**Date Created:** 01/24/2013

**Notes:** Provide an allowance to repair and remodel interior partitions as needed to accommodate renovations to adjacent systems and update configurations for ADA compliance and operational efficiency.

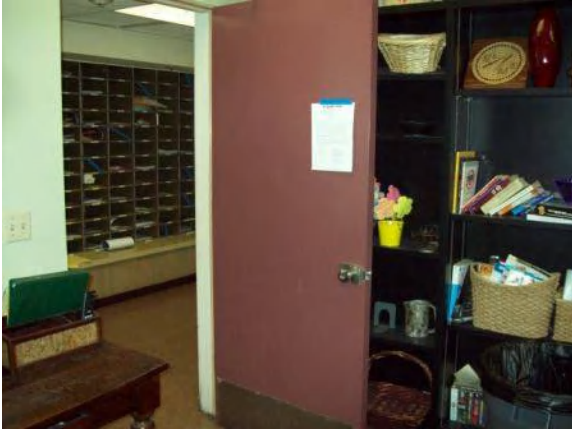
### System: C1020 - Interior Doors

**Location:** All interior doors.  
**Material:** Solid Core Interior Doors  
**Distress:** Beyond Expected Life  
**Category:** Capital Renewal  
**Priority:** 1 - Currently Critical (Immediate)  
**Correction:** Replace 3'-0" x 7'-0" solid core wood door interior  
**Qty:** 27-Ea.  
**Estimate:** \$54,823.52  
**Assessor Name:** Ann Buerger Linden  
**Date Created:** 01/22/2013

**Notes:** Doors are well maintained in good working order. However, all doors are beyond their expected life. Several doors installed as dutch doors no longer function in that mode. Doors to restrooms are narrow. Doors do not have lever latches. Replacement of interior doors and hardware is recommended.

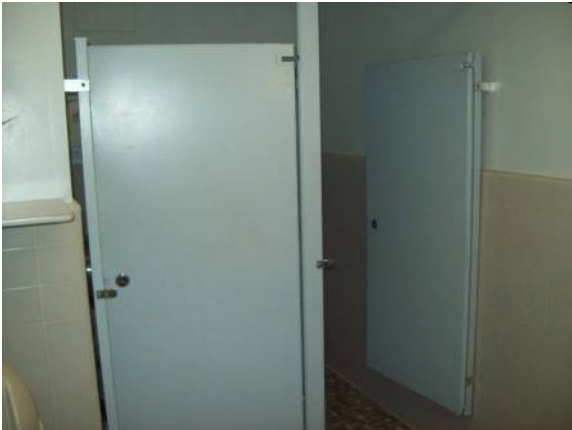
### System: C1030 - Fittings

**Location:** Men's and women's staff restrooms.  
Restrooms at nurse's office.  
**Material:** Toilet Partitions  
**Distress:** Beyond Expected Life  
**Category:** Capital Renewal  
**Priority:** 3 - Necessary/Not Yet Critical (Years 2-5)  
**Correction:** Toilet partitions  
**Qty:** 3-Ea.  
**Estimate:** \$10,742.49  
**Assessor Name:** Ann Buerger Linden  
**Date Created:** 01/22/2013

**Notes:** Toilet partitions have been repainted, likely multiple times. Hardware is worn. Toilet accessories are beyond expected life. ADA compliant partitions and accessories are absent.

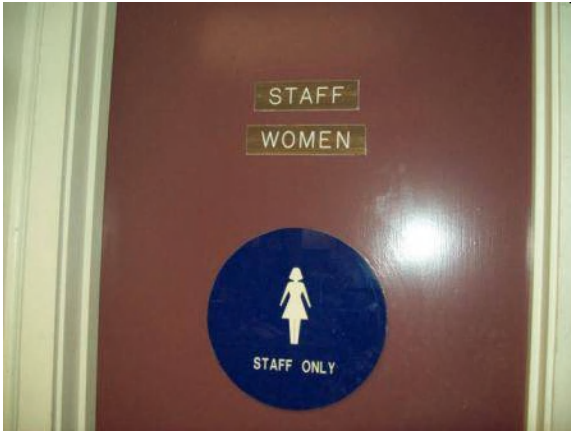
### System: C1030 - Fittings

**Location:** Building wide, typical at doors.  
**Material:** Signage  
**Distress:** Inadequate  
**Category:** Code Compliance  
**Priority:** 3 - Necessary/Not Yet Critical (Years 2-5)  
**Correction:** Replace/Install code compliant signage  
**Qty:** 6,006-S.F.  
**Estimate:** \$1,297.30  
**Assessor Name:** Ann Buerger Linden  
**Date Created:** 01/24/2013

**Notes:** Provide code compliant signage throughout the building.

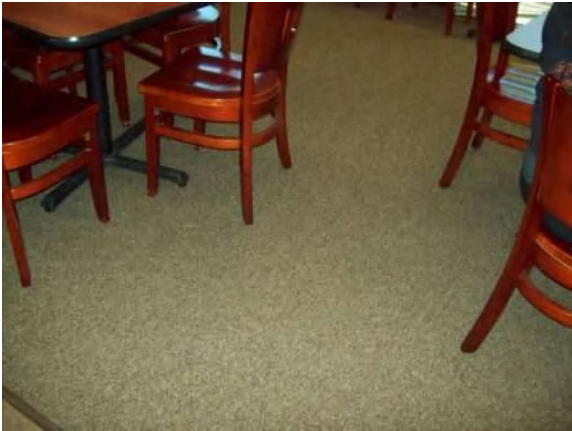
**System:** C3020210 - Carpet

**Location:** Offices and portion of staff lounge.  
**Material:** Carpet  
**Distress:** Beyond Expected Life  
**Category:** Capital Renewal  
**Priority:** 3 - Necessary/Not Yet Critical (Years 2-5)  
**Correction:** Replace carpet  
**Qty:** 355-S.Y.  
**Estimate:** \$35,140.90  
**Assessor Name:** Ann Buerger Linden  
**Date Created:** 01/24/2013

**Notes:** Existing carpeting has reached the end of it's expected service life. Although well maintained in good condition, replacement is recommended in the near future

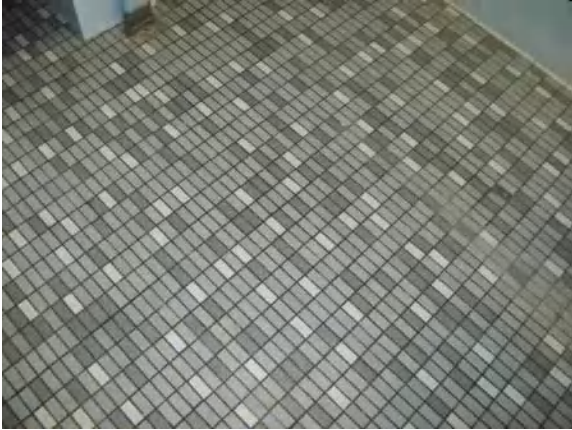
**System: C3020210 - Ceramic Tile**

**Location:** Staff and nurse station restrooms  
**Material:** Ceramic Tile  
**Distress:** Beyond Expected Life  
**Category:** Capital Renewal  
**Priority:** 3 - Necessary/Not Yet Critical (Years 2-5)  
**Correction:** Replace 2" x 2" thin set ceramic tile floor  
**Qty:** 3-C.S.F.  
**Estimate:** \$7,534.08  
**Assessor Name:** Ann Buerger Linden  
**Date Created:** 01/24/2013

**Notes:** Restroom renovation and upgrade to ADA standards will necessitate ceramic floor tile replacement.

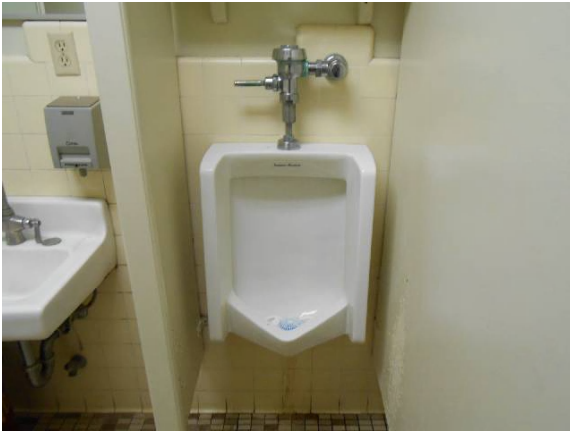
### System: D2010 - Plumbing Fixtures

**Location:** Men Staff restroom  
**Material:** Urinal  
**Distress:** Beyond Expected Life  
**Category:** Capital Renewal  
**Priority:** 4 - Recommended (Years 6-10)  
**Correction:** Replace wall-hung urinal  
**Qty:** 1-Ea.  
**Estimate:** \$1,551.31  
**Assessor Name:** Eduardo Lopez  
**Date Created:** 01/22/2013

**Notes:** Replace during next remodel or renovation.

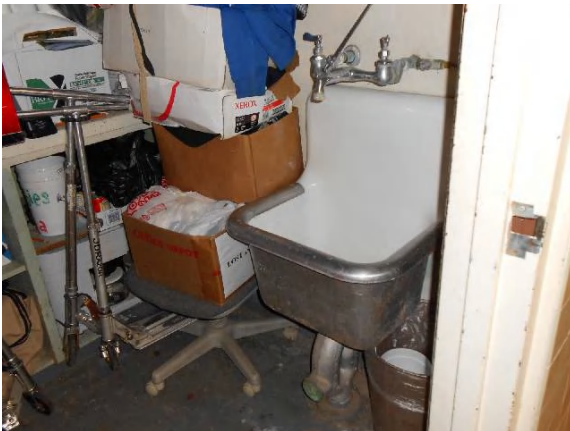
### System: D2010 - Plumbing Fixtures

**Location:** Custodial Closet  
**Material:** Service/Utility Sink  
**Distress:** Beyond Expected Life  
**Category:** Capital Renewal  
**Priority:** 4 - Recommended (Years 6-10)  
**Correction:** Replace sink and fixtures  
**Qty:** 1-Ea.  
**Estimate:** \$3,297.64  
**Assessor Name:** Eduardo Lopez  
**Date Created:** 01/22/2013

**Notes:** Replace during next remodel or renovation.

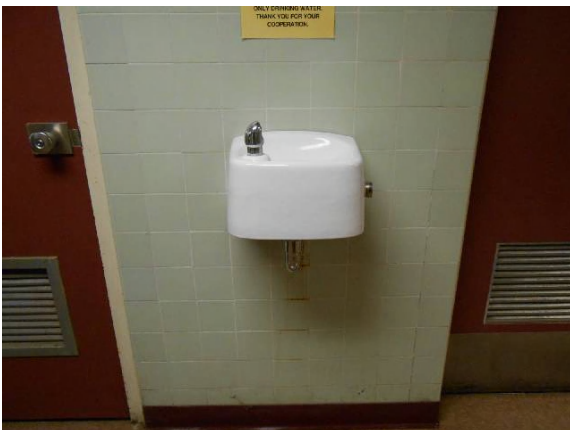
### System: D2010 - Plumbing Fixtures

**Location:** Typical for entire building  
**Material:** Drinking Fountain  
**Distress:** Missing  
**Category:** Code Compliance  
**Priority:** 4 - Recommended (Years 6-10)  
**Correction:** Replace fountain drinking fountain  
**Qty:** 2-Ea.  
**Estimate:** \$4,813.01  
**Assessor Name:** Eduardo Lopez  
**Date Created:** 01/22/2013

**Notes:** The Drinking fountain is beyond its expected life and non-ADA. It is recommended to be replaced during next remodel or renovation.

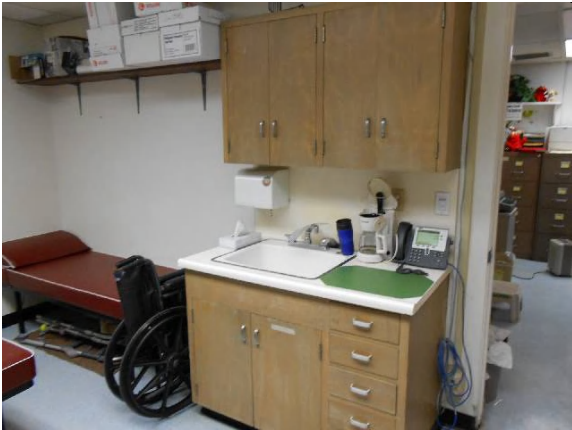
### **System: D2010 - Plumbing Fixtures**

**Location:** Staff Lounge & Nurse Cot. Room  
**Material:** Sink, Stainless Steel  
**Distress:** Beyond Expected Life  
**Category:** Capital Renewal  
**Priority:** 4 - Recommended (Years 6-10)  
**Correction:** Replace sink, stainless steel  
**Qty:** 2-Ea.  
**Estimate:** \$3,458.15  
**Assessor Name:** Eduardo Lopez  
**Date Created:** 01/24/2013

**Notes:** Sinks are mostly original and beyond expected life and it is recommended to be replaced during next remodel or renovation.

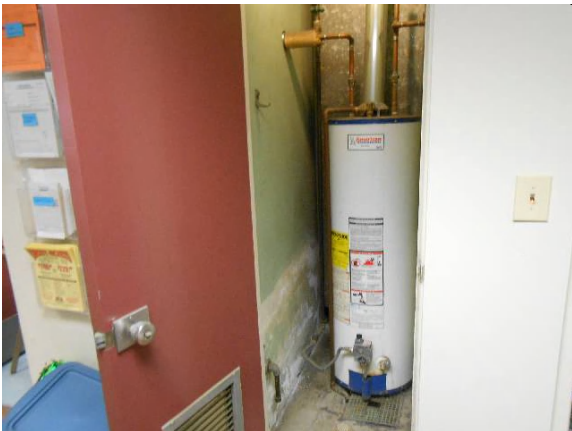
### **System: D2020 - Domestic Water Distribution**

**Location:** Typical for entire building  
**Material:** System  
**Distress:** Beyond Service Life  
**Category:** Capital Renewal  
**Priority:** 3 - Necessary/Not Yet Critical (Years 2-5)  
**Correction:** Renew System  
**Qty:** 1-Ea.  
**Estimate:** \$12,272.42  
**Assessor Name:** Eduardo Lopez  
**Date Created:** 01/24/2013

**Notes:** Domestic hot water was replaced in 1992; however it is recommended to replace the domestic water distribution system during next remodel or renovation.

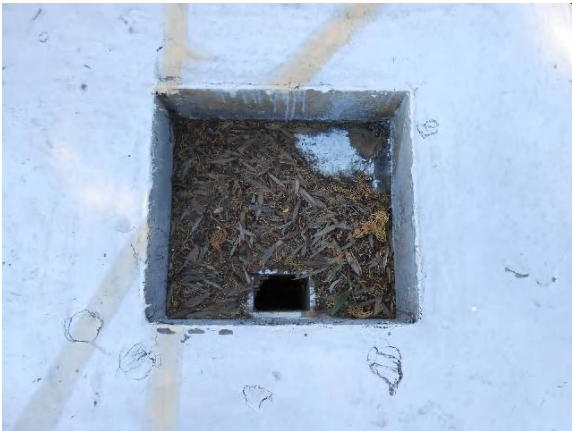
### System: D2040 - Rain Water Drainage

**Location:** Typical for entire building  
**Material:** System  
**Distress:** Beyond Service Life  
**Category:** Capital Renewal  
**Priority:** 4 - Recommended (Years 6-10)  
**Correction:** Renew System  
**Qty:** 1-Ea.  
**Estimate:** \$6,754.59  
**Assessor Name:** Eduardo Lopez  
**Date Created:** 01/24/2013

**Notes:** Replace system during next remodel or renovation.

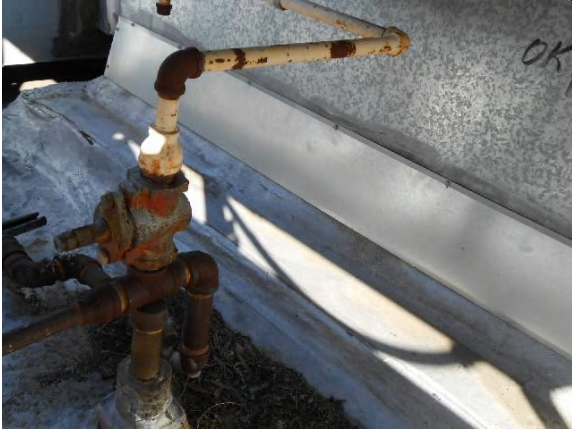
### System: D2090 - Other Plumbing Systems-Nat Gas

**Location:** Typical for entire building  
**Material:** System  
**Distress:** Beyond Service Life  
**Category:** Capital Renewal  
**Priority:** 4 - Recommended (Years 6-10)  
**Correction:** Renew System  
**Qty:** 1-Ea.  
**Estimate:** \$11,321.07  
**Assessor Name:** Eduardo Lopez  
**Date Created:** 01/24/2013

**Notes:** The Natural Gas distribution is original to the building age. It is recommended to be replaced during the next major renovation.

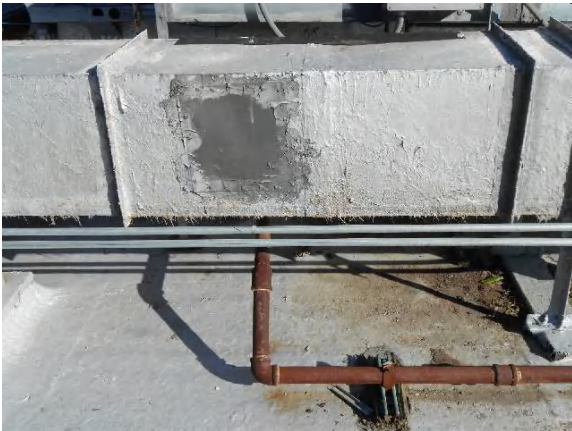
### System: D3040 - Distribution Systems

**Location:** Typical for entire building  
**Material:** System  
**Distress:** Beyond Service Life  
**Category:** Capital Renewal  
**Priority:** 3 - Necessary/Not Yet Critical (Years 2-5)  
**Correction:** Renew System  
**Qty:** 1-Ea.  
**Estimate:** \$166,010.64  
**Assessor Name:** Eduardo Lopez  
**Date Created:** 01/24/2013

**Notes:** HVAC system was replaced in 2008, however the ductwork, ventilation diffusers/grilles and fresh air supply is recommended to be upgraded during the next major renovation.

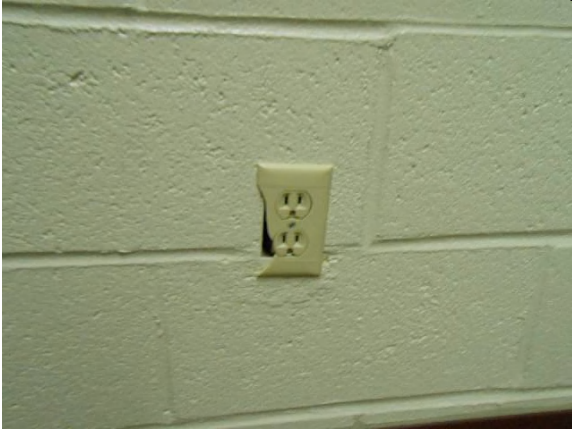
**System: D5020 - Branch Wiring**

**Location:** Typical for entire building  
**Material:** System  
**Distress:** Beyond Service Life  
**Category:** Capital Renewal  
**Priority:** 4 - Recommended (Years 6-10)  
**Correction:** Renew System  
**Qty:** 1-Ea.  
**Estimate:** \$214,719.79  
**Assessor Name:** Eduardo Lopez  
**Date Created:** 01/24/2013

**Notes:** The branch wiring, electrical panels and devices are mostly original to the building age. It is recommended to be replaced during the next major renovation.

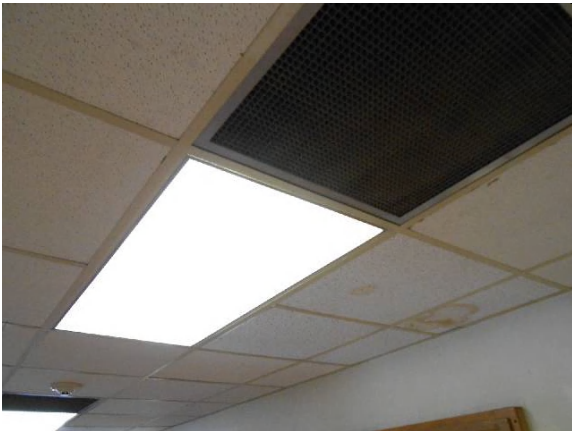
**System: D5020 - Lighting**

**Location:** Typical for entire building  
**Material:** System  
**Distress:** Beyond Expected Life  
**Category:** Capital Renewal  
**Priority:** 4 - Recommended (Years 6-10)  
**Correction:** Renew System  
**Qty:** 1-Ea.  
**Estimate:** \$168,864.70  
**Assessor Name:** Eduardo Lopez  
**Date Created:** 01/27/2013

**Notes:** Light switches with motion sensor, T8 fluorescent lamps and ballasts were updated in 2006; however it is recommended to replace lighting fixtures and related wiring during next remodel or renovation.

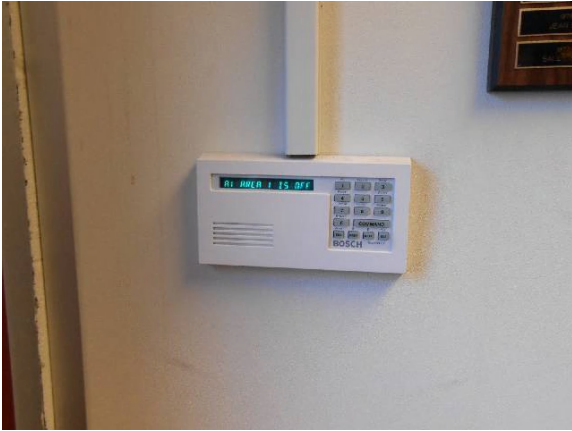
**System: D5030910 - Security System, Camers, Access Control**

**Location:** Typical for entire building  
**Material:** System  
**Distress:** Beyond Expected Life  
**Category:** Capital Renewal  
**Priority:** 4 - Recommended (Years 6-10)  
**Correction:** Renew System  
**Qty:** 1-Ea.  
**Estimate:** \$9,772.96  
**Assessor Name:** Eduardo Lopez  
**Date Created:** 01/27/2013

**Notes:** Security is needing upgrades. Recommend replacing and enhancing during the next building renovation.

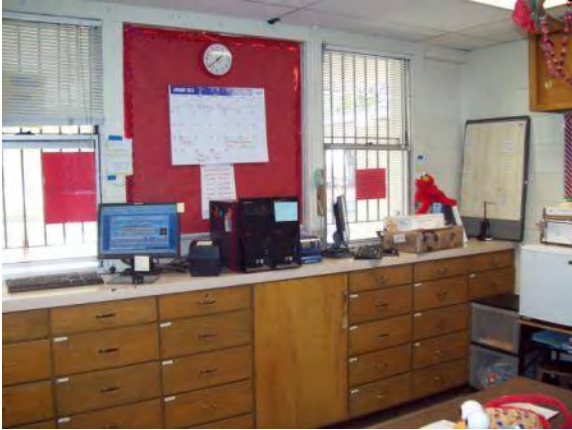
### System: E1090610 - School Equipment, EACH

**Location:** Reception, Conference, Staff Lounge, Copy Room, Nurse Station, Attendance

**Notes:** Provide new tackboards at listed spaces. Provide whiteboard and Smartboard at conference room.  
Existing products are worn.

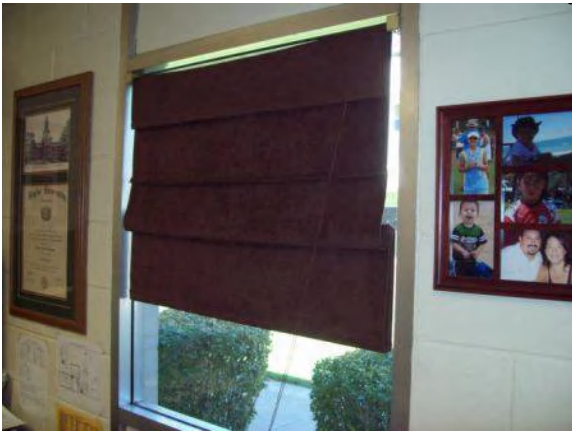
### System: E2010 - Fixed Furnishings

**Location:** Office windows at east,west and north elevations, attendance windows, staff lounge windows.

**Notes:** Existing window treatments to control glare and privacy are in poor condition or are missing.

**Correction:** Replace window blinds

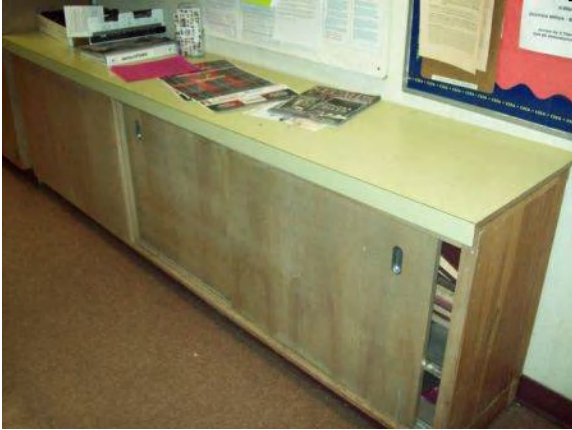
### System: E2010 - Fixed Furnishings

**Location:** Staff lounge, attendance, nurse's station, work areas, corridors.

**Notes:** All millwork and cabinetry in the building is original and in generally poor condition with peeling veneers, discoloration, chipping etc. Base cabinets in the staff lounge were re-faced over existing units approximately 5 years ago.

**Correction:** Replace Casework OUSD

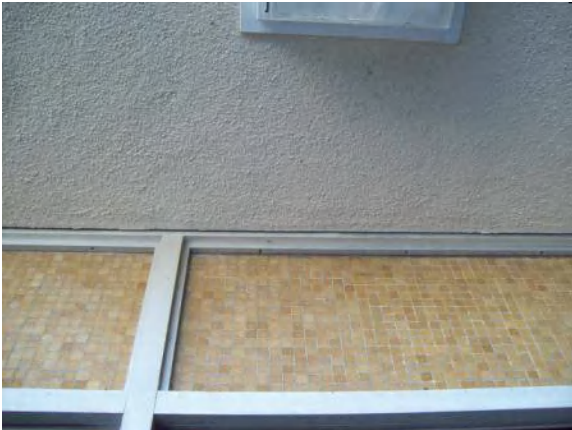
### System: F2020 - Hazardous Components Abatement

**Location:** Friable material above ceilings. Non-friable material in exterior stucco soffits, above and below windows in transite panels, and at interior plaster walls.

**Notes:** The AHERA six-month surveillance of asbestos-containing materials - Summer 2012, identifies ACM at this building. Complete abatement is recommended.

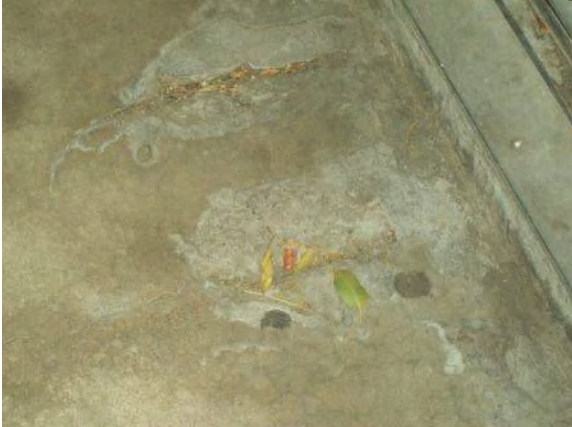
**Location:** Level 2 exterior balcony cantilevered slabs.  
**Material:** Floor Construction Concrete  
**Distress:** Damaged  
**Category:** Safety  
**Priority:** 1 - Currently Critical (Immediate)  
**Correction:** Repair concrete suspended slab  
**Qty:** 200-SF  
**Estimate:** \$3,841.92  
**Assessor Name:** Ann Buerger Linden  
**Date Created:** 01/25/2013

**Notes:** Slab appears to be cracking at some rebar locations. In some cases rebar is exposed. Condition may be a tripping hazard.

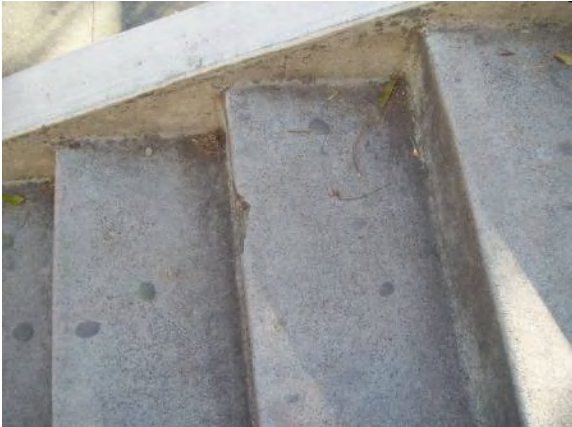
**Location:** Exterior concrete steps, south end of building.  
**Material:** Concrete Stairs  
**Distress:** Damaged  
**Category:** Safety  
**Priority:** 1 - Currently Critical (Immediate)  
**Correction:** Repair concrete steps  
**Qty:** 10-S.F.  
**Estimate:** \$301.10  
**Assessor Name:** Ann Buerger Linden  
**Date Created:** 01/26/2013

**Notes:** Damage to steps is a tripping hazard.

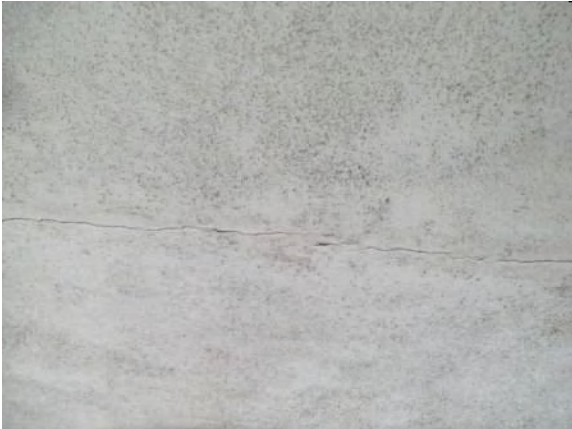
**Location:** Exterior soffits.  
**Material:** Plaster Soffits  
**Distress:** Beyond Expected Life  
**Category:** Capital Renewal  
**Priority:** 3 - Necessary/Not Yet Critical (Years 2-5)  
**Correction:** Replace plaster soffits  
**Qty:** 1,200-S.F.  
**Estimate:** \$66,897.79  
**Assessor Name:** Ann Buerger Linden  
**Date Created:** 01/26/2013

**Notes:** Soffits are stained and cracked. Water damage from roof leaks. Soffits are non-friable ACM.

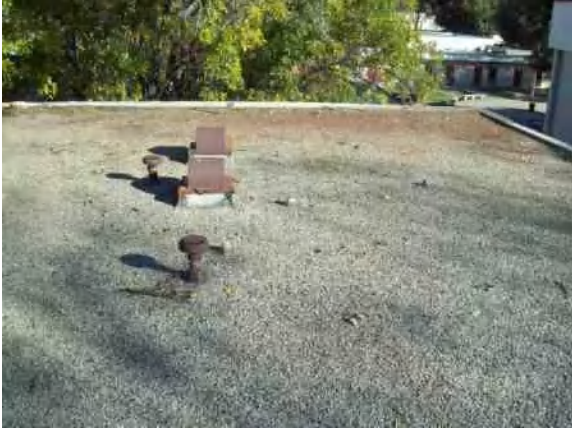
**Location:** Roof  
**Material:** System  
**Distress:** Beyond Expected Life  
**Category:** Capital Renewal  
**Priority:** 2 - Potentially Critical (Year 1)  
**Correction:** Renew System  
**Qty:** 1-Ea.  
**Estimate:** \$271,206.14  
**Assessor Name:** Eduardo Lopez  
**Date Created:** 01/21/2013

**Notes:** The roof system is built-up with granular cap sheet. It is beyond it's expected life and failing. Water damage to soffits is present. Water stains to 2nd floor ceiling tiles are present. Roof slopes/sags to outside corners where gutters and downspouts have been retrofitted.

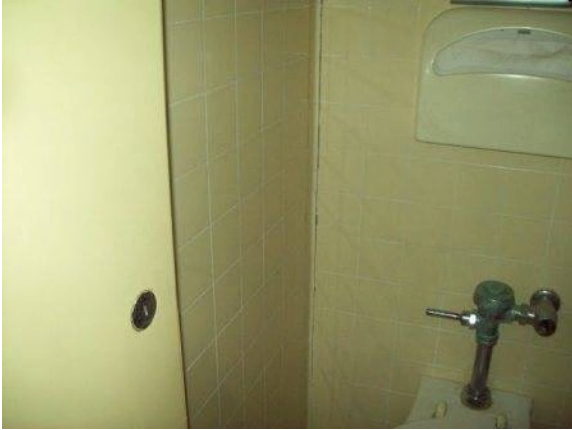
**Location:** Building wide as needed.  
**Material:** Interior Partitions  
**Distress:** Damaged  
**Category:** Capital Renewal  
**Priority:** 3 - Necessary/Not Yet Critical (Years 2-5)  
**Correction:** Allowance repair/remodel interior partitions  
OUSD  
**Qty:** 1-Job  
**Estimate:** \$29,376.00  
**Assessor Name:** Ann Buerger Linden  
**Date Created:** 01/26/2013

**Notes:** Provide an allowance to repair and remodel interior partitions as required to accommodate renovations to adjacent systems (door replacement, ACM abatement) etc. Repair existing minor damage. Photo shows minor settlement cracking at restroom walls.

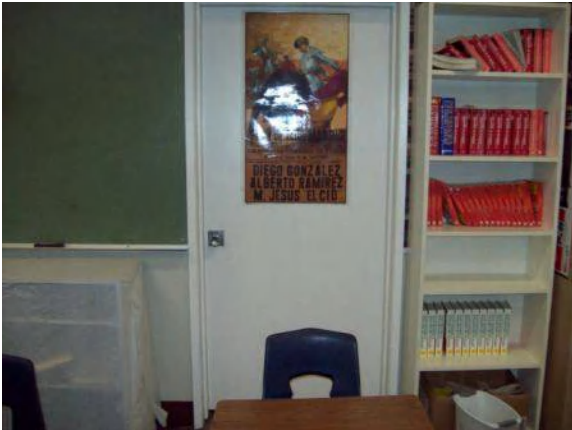
**Location:** Interior doors between classrooms.  
Faculty/staff restrooms.  
**Material:** Solid Core Interior Doors  
**Distress:** Beyond Expected Life  
**Category:** Capital Renewal  
**Priority:** 3 - Necessary/Not Yet Critical (Years 2-5)  
**Correction:** Replace 3070 SC Int Dr Fr & Hdwe OUSD  
**Qty:** 13-Ea.  
**Estimate:** \$24,159.10  
**Assessor Name:** Ann Buerger Linden  
**Date Created:** 01/25/2013

**Notes:** Doors are well maintained in good working order. However, all doors are beyond their expected life and do not have lever hardware.

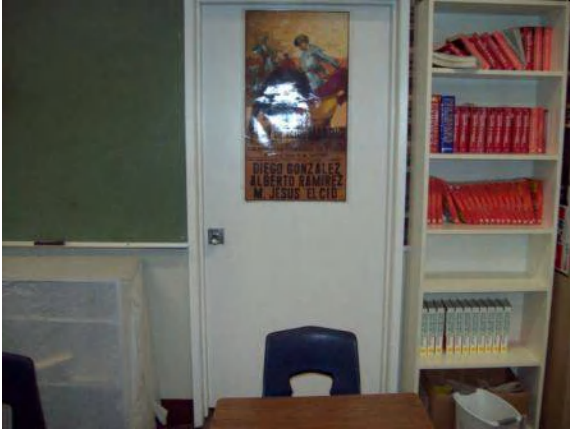
**Location:** Doors between classrooms. Faculty/staff restroom doors.

**Material:** System

**Notes:** Interior doors are in fair to poor condition. System renewal is recommended.

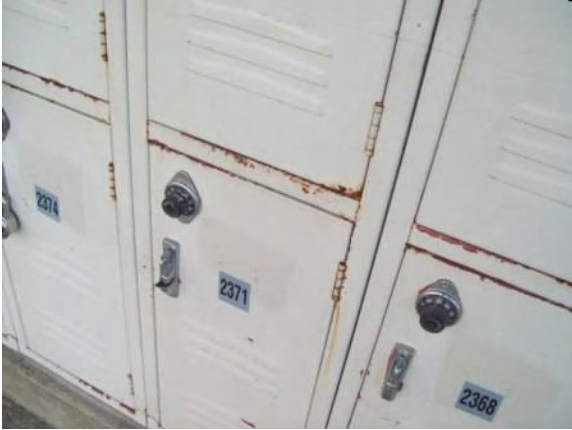
**Location:** Exterior first floor.  
**Material:** Fixed Furnishings - Lockers  
**Distress:** Beyond Expected Life  
**Category:** Capital Renewal  
**Priority:** 3 - Necessary/Not Yet Critical (Years 2-5)  
**Correction:** Student lockers stacked 2-high  
**Qty:** 500-Ea.  
**Estimate:** \$202,507.20  
**Assessor Name:** Ann Buerger Linden  
**Date Created:** 01/25/2013

**Notes:** Exterior lockers appear to be mostly original. Missing hardware, rust, and general damage is widespread. Existing Units are typically 2 or 3 tier.

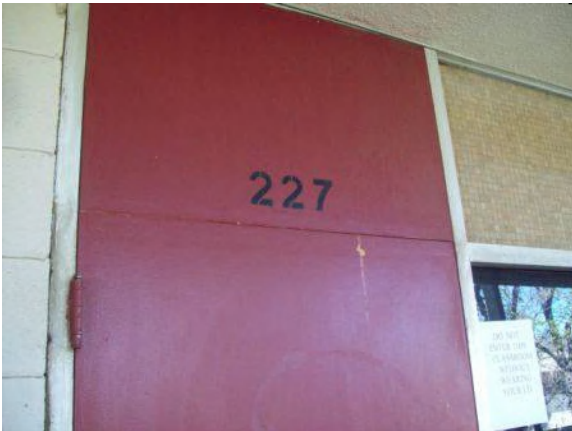
**Location:** Throughout the building.  
**Material:** Signage  
**Distress:** Beyond Expected Life  
**Category:** Capital Renewal  
**Priority:** 3 - Necessary/Not Yet Critical (Years 2-5)  
**Correction:** Replace/Install code compliant signage  
**Qty:** 16,402-S.F.  
**Estimate:** \$3,542.83  
**Assessor Name:** Ann Buerger Linden  
**Date Created:** 01/25/2013

**Notes:** Provide code compliant signage throughout the building.

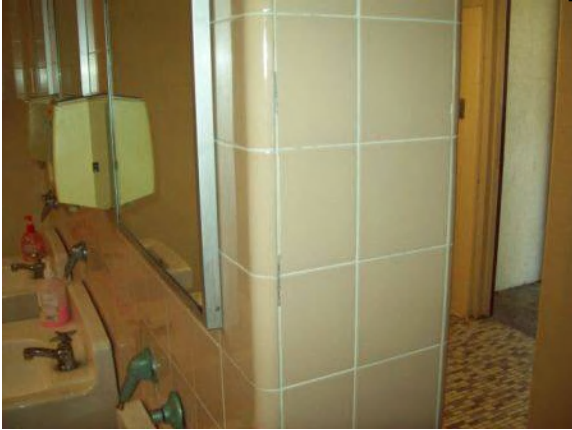
**Location:** Faculty and student restrooms.

**Material:** Tile

**Notes:** Replace expired ceramic tile.

**Correction:** Replace 4" x 4" thin set ceramic tile

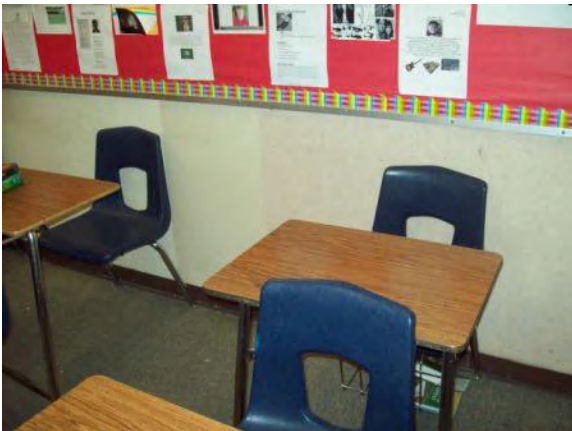
**Location:** All interior walls.

**Material:** Wall Finishes

**Notes:** Interior wall paint has some wear and tear. Some old vinyl wall covering has been painted over. Other recommended renovations will necessitate repainting.

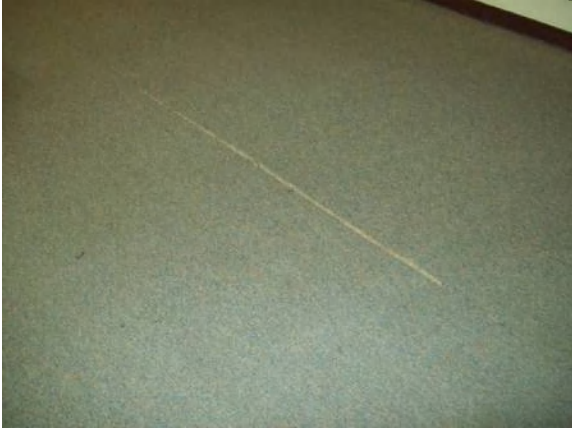
**Location:** All classrooms except 206, 222, 227.  
**Material:** System  
**Distress:** Beyond Service Life  
**Category:** Capital Renewal  
**Priority:** 2 - Potentially Critical (Year 1)  
**Correction:** Renew System  
**Qty:** 1-Ea.  
**Estimate:** \$156,017.66  
**Assessor Name:** Ann Buerger Linden  
**Date Created:** 01/25/2013

**Notes:** Carpeting in classrooms is extremely worn and stained. Some rips/tears have been repaired. Some classrooms have been provided with a stopgap VCT area in front of entrance doors.

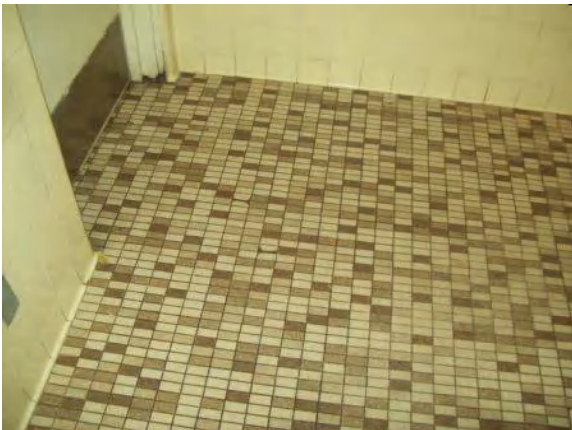
**Location:** All restrooms  
**Material:** System  
**Distress:** Beyond Service Life  
**Category:** Capital Renewal  
**Priority:** 3 - Necessary/Not Yet Critical (Years 2-5)  
**Correction:** Renew System  
**Qty:** 1-Ea.  
**Estimate:** \$32,741.28  
**Assessor Name:** Ann Buerger Linden  
**Date Created:** 01/25/2013

**Notes:** Ceramic tile is expired and in worn conditions. Replacement is recommended.

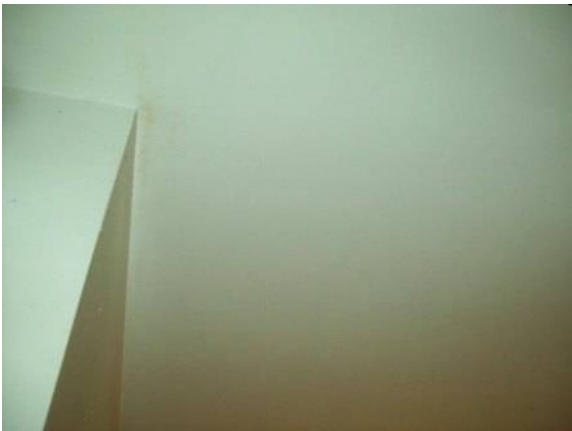
**Location:** Restrooms, janitor closets  
**Material:** Sheetrock  
**Distress:** Beyond Expected Life  
**Category:** Capital Renewal  
**Priority:** 3 - Necessary/Not Yet Critical (Years 2-5)  
**Correction:** Replace sheetrock ceiling  
**Qty:** 10-C.S.F.  
**Estimate:** \$7,488.00  
**Assessor Name:** Ann Buerger Linden  
**Date Created:** 01/26/2013

**Notes:** Replace hard lid ceilings at restrooms and janitor closets.

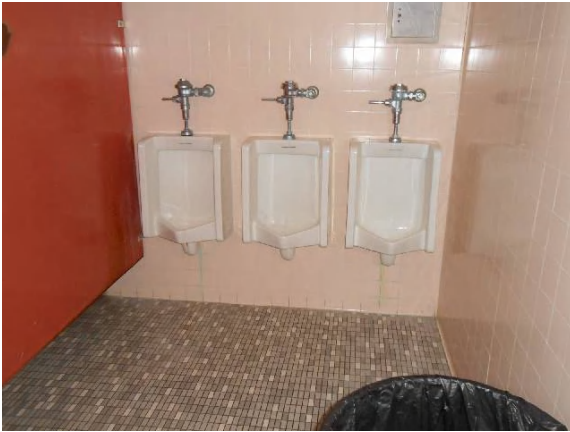
**Location:** Men restrooms, South end at both levels  
**Material:** Urinal  
**Distress:** Beyond Expected Life  
**Category:** Capital Renewal  
**Priority:** 4 - Recommended (Years 6-10)  
**Correction:** Replace wall-hung urinal  
**Qty:** 6-Ea.  
**Estimate:** \$9,307.87  
**Assessor Name:** Eduardo Lopez  
**Date Created:** 01/22/2013

**Notes:** Replace during next remodel or renovation.

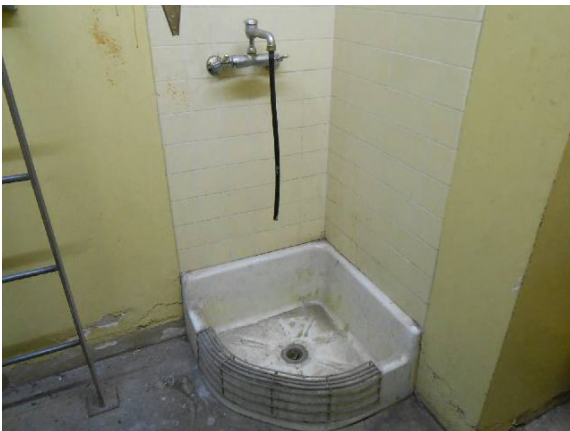
**Location:** Custodial Rooms, South end at both levels  
**Material:** Service/Utility Sink  
**Distress:** Beyond Expected Life  
**Category:** Capital Renewal  
**Priority:** 4 - Recommended (Years 6-10)  
**Correction:** Replace sink and fixtures  
**Qty:** 2-Ea.  
**Estimate:** \$6,595.29  
**Assessor Name:** Eduardo Lopez  
**Date Created:** 01/22/2013

**Notes:** Replace during next remodel or renovation.

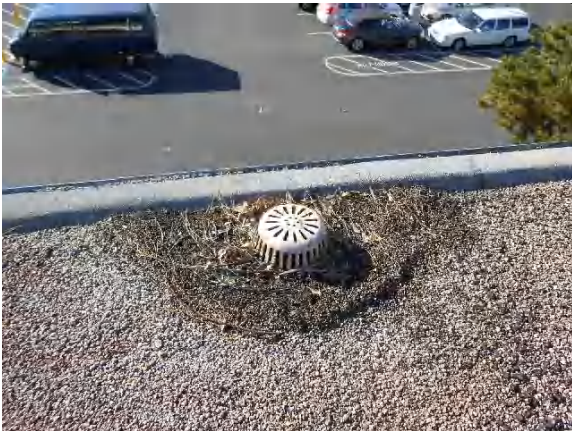
**Location:** Typical for entire building  
**Material:** System  
**Distress:** Beyond Expected Life  
**Category:** Capital Renewal  
**Priority:** 4 - Recommended (Years 6-10)  
**Correction:** Renew System  
**Qty:** 1-Ea.  
**Estimate:** \$15,588.46  
**Assessor Name:** Eduardo Lopez  
**Date Created:** 01/22/2013

**Notes:** Replace system during next remodel or renovation.

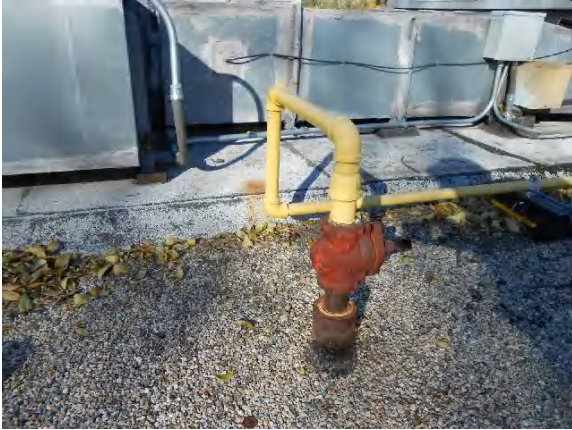
**Location:** Typical for entire building  
**Material:** System  
**Distress:** Beyond Expected Life  
**Category:** Capital Renewal  
**Priority:** 4 - Recommended (Years 6-10)  
**Correction:** Renew System  
**Qty:** 1-Ea.  
**Estimate:** \$26,500.38  
**Assessor Name:** Eduardo Lopez  
**Date Created:** 01/22/2013

**Notes:** The Natural Gas distribution is original to the building age. It is recommended to be replaced during the next major renovation.

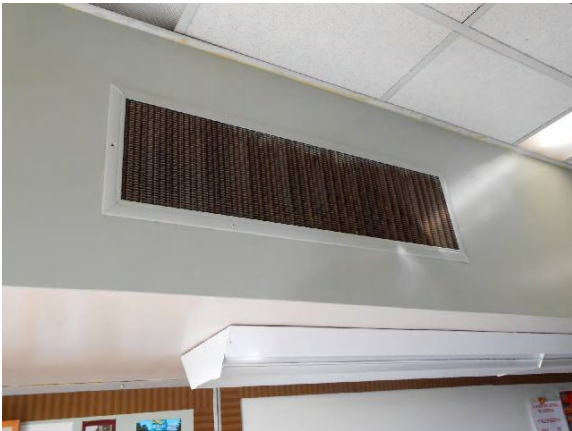
**Location:** Typical for entire building  
**Material:** System  
**Distress:** Beyond Expected Life  
**Category:** Capital Renewal  
**Priority:** 4 - Recommended (Years 6-10)  
**Correction:** Renew System  
**Qty:** 1-Ea.  
**Estimate:** \$387,633.06  
**Assessor Name:** Eduardo Lopez  
**Date Created:** 01/22/2013

**Notes:** The roof centrifugal exhaust fan (1) was replaced in 2004, however the ductwork, air vents and fresh air supply is recommended to be upgraded during the next major renovation.

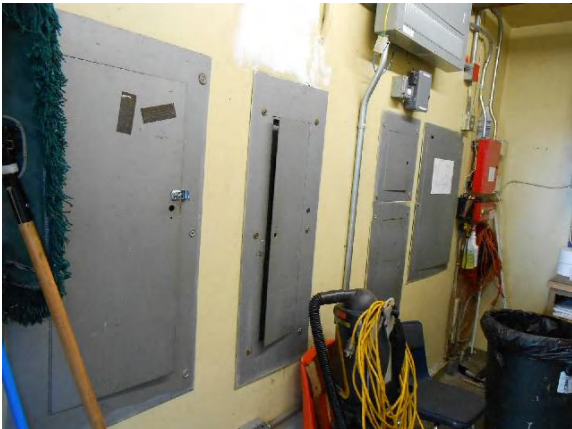
**Location:** Typical for entire building  
**Material:** System  
**Distress:** Beyond Expected Life  
**Category:** Capital Renewal  
**Priority:** 4 - Recommended (Years 6-10)  
**Correction:** Renew System  
**Qty:** 1-Ea.  
**Estimate:** \$145,492.30  
**Assessor Name:** Eduardo Lopez  
**Date Created:** 01/22/2013

**Notes:** The main electrical panels, distribution panel boards and feeders are mostly original to the building age. It is recommended to be replaced during the next major renovation.

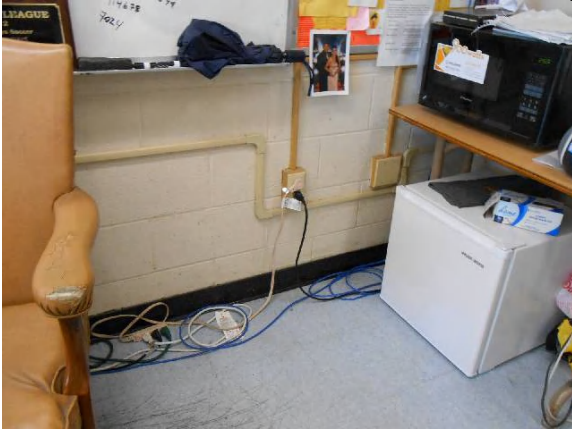
**Location:** Typical for entire building  
**Material:** System  
**Distress:** Beyond Expected Life  
**Category:** Capital Renewal  
**Priority:** 4 - Recommended (Years 6-10)  
**Correction:** Renew System  
**Qty:** 1-Ea.  
**Estimate:** \$501,688.63  
**Assessor Name:** Eduardo Lopez  
**Date Created:** 01/22/2013

**Notes:** The branch wiring, electrical panels and devices are mostly original to the building age. It is recommended to be replaced during the next major renovation.

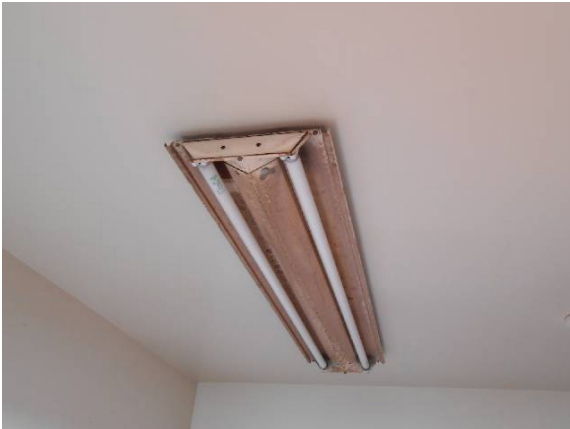
**Location:** Women/Men restrooms & Staff restrooms,  
South end at both levels

**Material:** Fluorescent Lighting Fixture, 80 W

**Priority:** 4 - Recommended (Years 6-10)

**Notes:** T8 fluorescent lamps and ballasts were updated in 2006; however light fixtures, switches and wiring are original to building age and it is recommended to be replaced during next remodel or renovation.

**Correction:** Replace fixture fluorescent lighting fixture,  
80 W

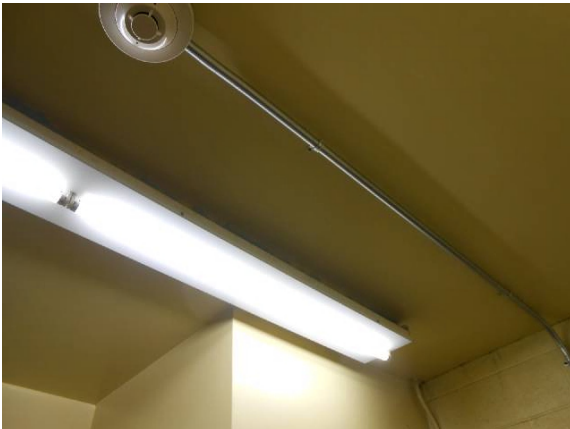
**Location:** Custodial rooms at both levels

**Material:** Fluorescent Lighting Fixture, 80 W

**Priority:** 4 - Recommended (Years 6-10)

**Notes:** T8 fluorescent lamps and ballasts were updated in 2006; however light fixtures, switches and wiring are original to building age and it is recommended to be replaced during next remodel or renovation.

**Correction:** Replace fixture fluorescent lighting fixture,  
80 W

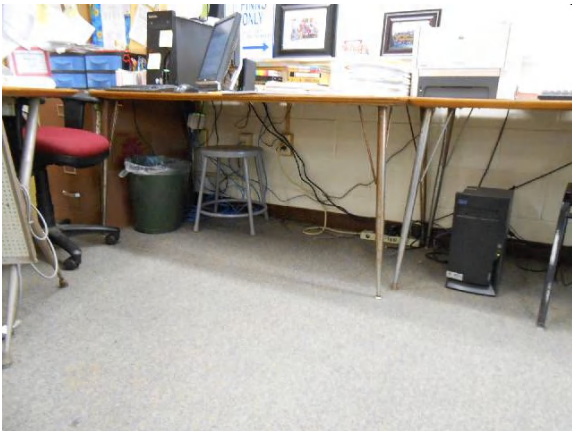
**Location:** Typical for entire building  
**Material:** Lan System  
**Distress:** Inadequate  
**Category:** Capital Renewal  
**Priority:** 4 - Recommended (Years 6-10)  
**Correction:** Replace LAN System Drop CAT6  
**Qty:** 32-Ea.  
**Estimate:** \$12,555.19  
**Assessor Name:** Eduardo Lopez  
**Date Created:** 01/24/2013

**Notes:** Most of the existing LAN outlets will require new drops and it is recommended to be enhanced during the next major building renovation.

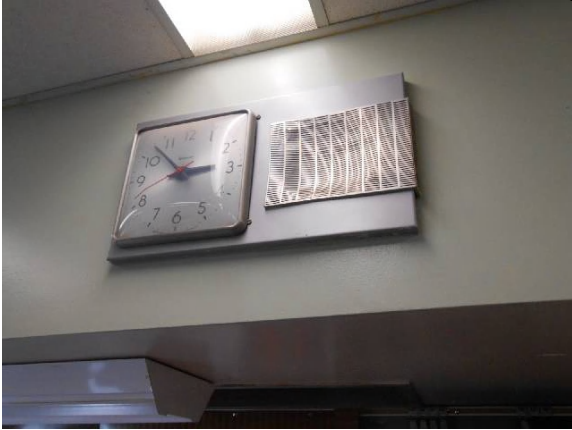
**Location:** Typical for entire building  
**Material:** System  
**Distress:** Beyond Expected Life  
**Category:** Capital Renewal  
**Priority:** 4 - Recommended (Years 6-10)  
**Correction:** Renew System  
**Qty:** 1-Ea.  
**Estimate:** \$22,910.31  
**Assessor Name:** Eduardo Lopez  
**Date Created:** 01/27/2013

**Notes:** Clock System is needing upgrades. Recommend replacing and enhancing during the next building renovation.

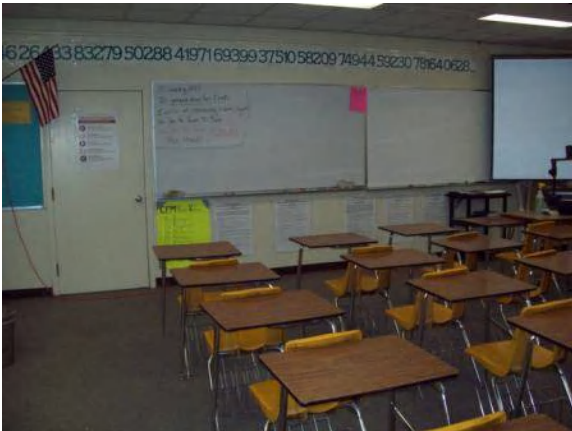
**Location:** All classrooms.  
**Material:** Boards  
**Distress:** Beyond Expected Life  
**Category:** Capital Renewal  
**Priority:** 3 - Necessary/Not Yet Critical (Years 2-5)  
**Correction:** Install Smartboards Tackboards  
Markerboards OUSD  
**Qty:** 16-Ea.  
**Estimate:** \$128,067.84  
**Assessor Name:** Ann Buerger Linden  
**Date Created:** 01/25/2013

**Notes:** Tackboards are dilapidated. Some greenboards still exist. Some whiteboards are stained and cannot be cleaned. A Smartboard is present in only one classroom.

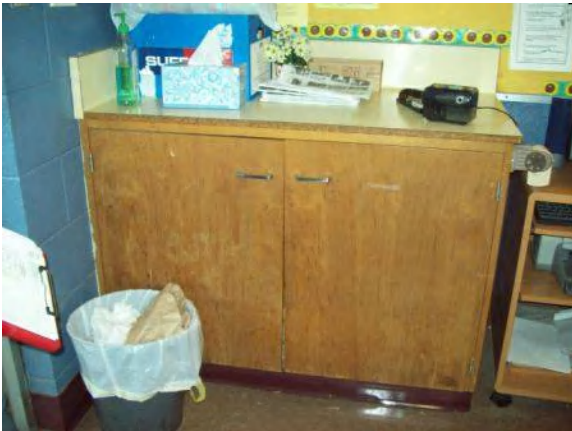
**Location:** All classrooms  
**Material:** Fixed Casework  
**Distress:** Beyond Expected Life  
**Category:** Capital Renewal  
**Priority:** 3 - Necessary/Not Yet Critical (Years 2-5)  
**Correction:** Replace Casework OUSD  
**Qty:** 128-L.F.  
**Estimate:** \$71,744.95  
**Assessor Name:** Ann Buerger Linden  
**Date Created:** 01/25/2013

**Notes:** Each classroom has a tall cabinet and a small base unit with counter. They are in poor condition with delaminating veneers and counters, missing or malfunctioning hardware etc.

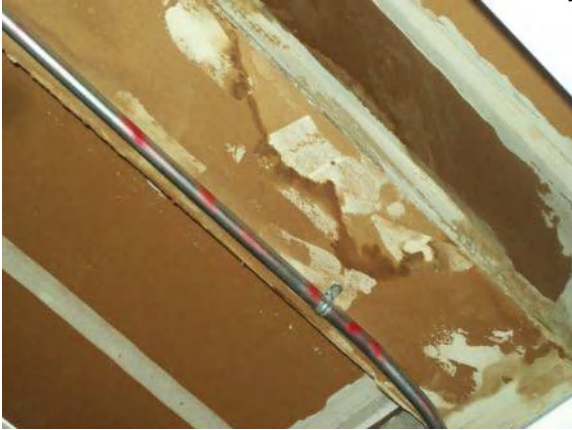
**Location:** Building wide. Friable asbestos is present in first and second floor attics, and in fire door insulation. Non-friable ACM is present in stucco soffits, window transite panels, and interior plaster.

**Notes:** The AHERA six-month surveillance of asbestos-containing materials - Summer 2012, identifies ACM at this building. Complete abatement is recommended.

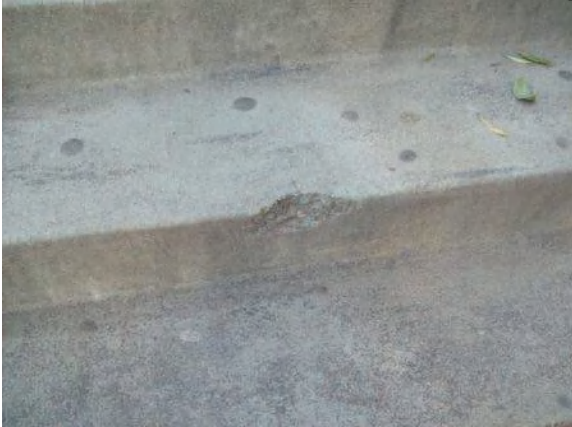
**Location:** Exterior concrete ste  
**Material:** Concrete Stairs  
**Distress:** Damaged  
**Category:** Safety  
**Priority:** 1 - Currently Critical (Immediate)  
**Correction:** Repair concrete steps  
**Qty:** 10-S.F.  
**Estimate:** \$301.10  
**Assessor Name:** Ann Buerger Linden  
**Date Created:** 01/26/2013

**Notes:** Repair damaged concrete treads.

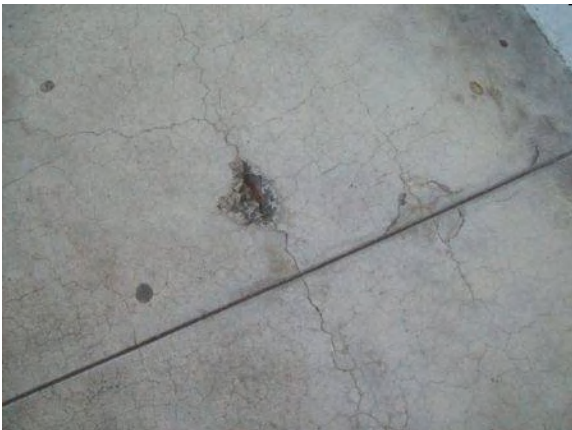
**Location:** Level 2 balcony.  
**Material:** Floor Construction Concrete  
**Distress:** Damaged  
**Category:** Safety  
**Priority:** 1 - Currently Critical (Immediate)  
**Correction:** Repair concrete suspended slab  
**Qty:** 400-S.F.  
**Estimate:** \$8,075.52  
**Assessor Name:** Ann Buerger Linden  
**Date Created:** 01/26/2013

**Notes:** There is considerable surface spalling of concrete at the second floor balcony slabs. In some cases rebar is exposed. A safety hazard exists.

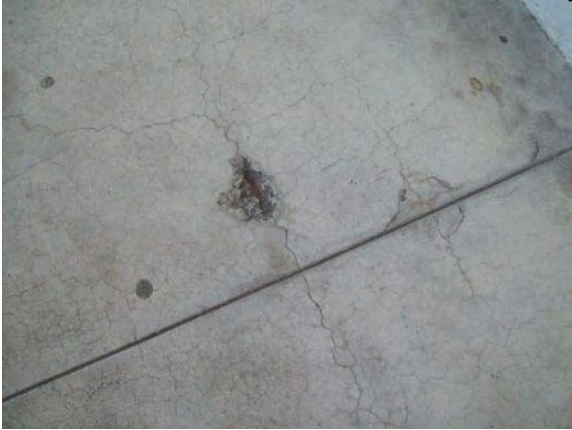
**Location:** Level 2 balcony.  
**Material:** Floor Construction Concrete  
**Distress:** Damaged  
**Category:** Safety  
**Priority:** 1 - Currently Critical (Immediate)  
**Correction:** Repair concrete suspended slab  
**Qty:** 400-S.F.  
**Estimate:** \$8,075.52  
**Assessor Name:** Ann Buerger Linden  
**Date Created:** 01/26/2013

**Notes:** There is considerable surface spalling of concrete at the second floor balcony slabs. In some cases rebar is exposed. A safety hazard exists.

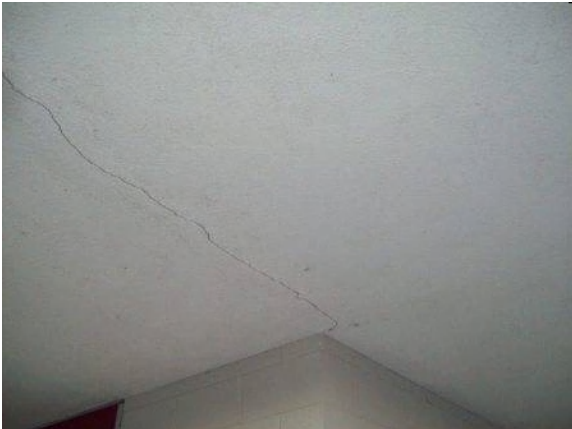
**Location:** Exterior soffits  
**Material:** Plaster Soffits  
**Distress:** Beyond Expected Life  
**Category:** Capital Renewal  
**Priority:** 3 - Necessary/Not Yet Critical (Years 2-5)  
**Correction:** Replace plaster soffits  
**Qty:** 1,200-S.F.  
**Estimate:** \$74,545.92  
**Assessor Name:** Ann Buerger Linden  
**Date Created:** 01/26/2013

**Notes:** Soffits are stained and cracked. Water damage from roof and area drain leads Soffits are non-riable ACM.

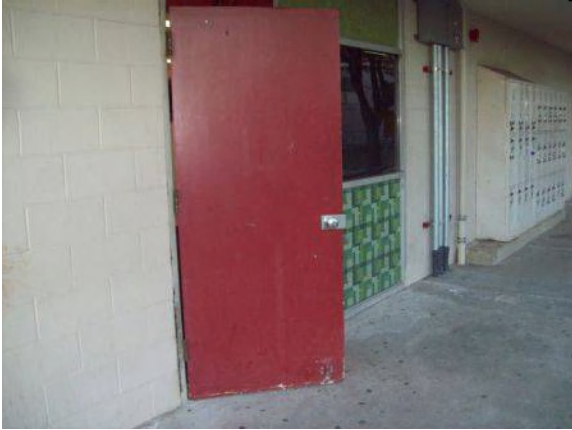
**Location:** All exterior doors at classrooms and utility rooms.  
**Material:** System  
**Distress:** Beyond Expected Life  
**Category:** Capital Renewal  
**Priority:** 3 - Necessary/Not Yet Critical (Years 2-5)  
**Correction:** Renew System  
**Qty:** 1-Ea.  
**Estimate:** \$120,384.00  
**Assessor Name:** Eduardo Lopez  
**Date Created:** 01/21/2013

**Notes:** Existing wood exterior doors are deteriorated. Aluminum frames are failing. Many have attached reinforcing hardware to stabilize them. Caulking is failed. Provide interior locking lever hardware at classrooms.

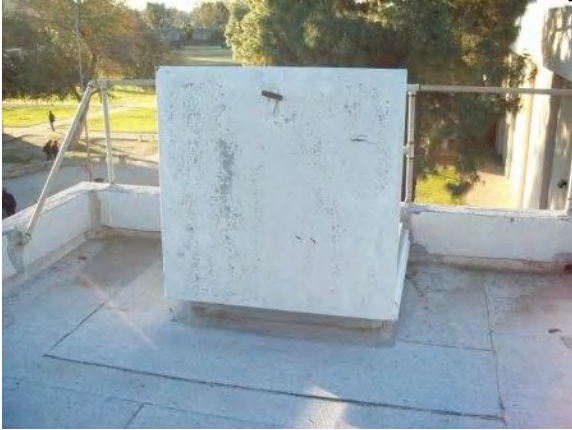
**Location:** Access from 2nd floor custodial closet.  
**Material:** System  
**Distress:** Beyond Expected Life  
**Category:** Capital Renewal  
**Priority:** 3 - Necessary/Not Yet Critical (Years 2-5)  
**Correction:** Renew System  
**Qty:** 1-Ea.  
**Estimate:** \$5,544.00  
**Assessor Name:** Eduardo Lopez  
**Date Created:** 01/21/2013

**Notes:** Roof hatch is beyond it's expected life. Ladder does not have code required extension.
