## Orange Unified School District

Facilities Condition Assessment for:

**El Modena High School**  
**3920 Spring Street**  
**Orange, CA 92869**

# Campus Report

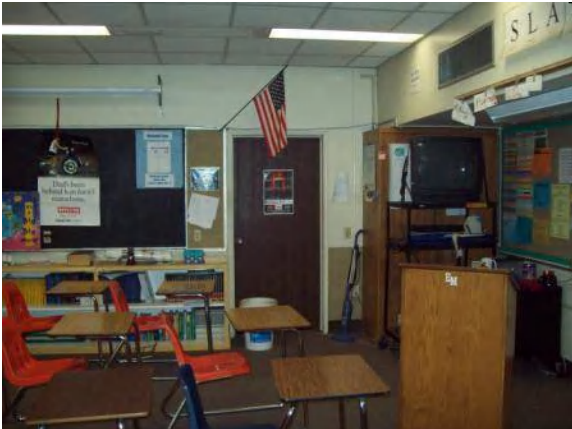
**Location:** Between 301 and 308  
**Material:** System  
**Distress:** Beyond Expected Life  
**Category:** Capital Renewal  
**Priority:** 3 - Necessary/Not Yet Critical (Years 2-5)  
**Correction:** Renew System  
**Qty:** 1-Ea.  
**Estimate:** \$2,513.81  
**Assessor Name:** Eduardo Lopez  
**Date Created:** 01/21/2013

**Notes:** Door is beyond their expected life. Door does not have lever latch.

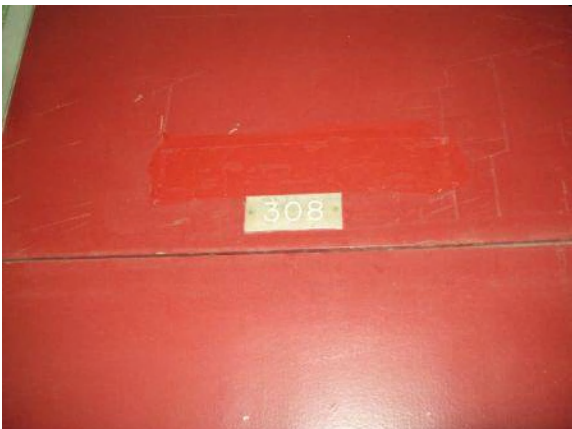
**Location:** Throughout the building.  
**Material:** Signage  
**Distress:** Inadequate  
**Category:** Capital Renewal  
**Priority:** 3 - Necessary/Not Yet Critical (Years 2-5)  
**Correction:** Replace/Install code compliant signage  
**Qty:** 15,230-S.F.  
**Estimate:** \$3,289.68  
**Assessor Name:** Ann Buerger Linden  
**Date Created:** 01/27/2013

Notes: Provide code compliant signage throughout the building.

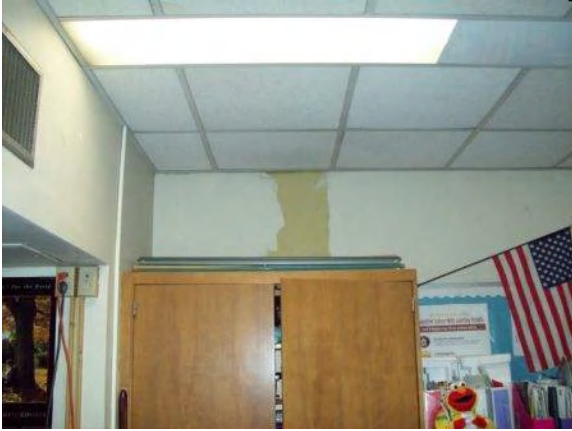
**Location:** All interior walls.  
**Material:** Wall Finishes  
**Distress:** Beyond Expected Life  
**Category:** Capital Renewal  
**Priority:** 3 - Necessary/Not Yet Critical (Years 2-5)  
**Correction:** Refinish/Repaint  
**Qty:** 19,200-S.F.  
**Estimate:** \$11,612.16  
**Assessor Name:** Ann Buerger Linden  
**Date Created:** 01/26/2013

Notes: Interior wall paint has some wear and tear. Other recommended renovations will necessitate repainting.

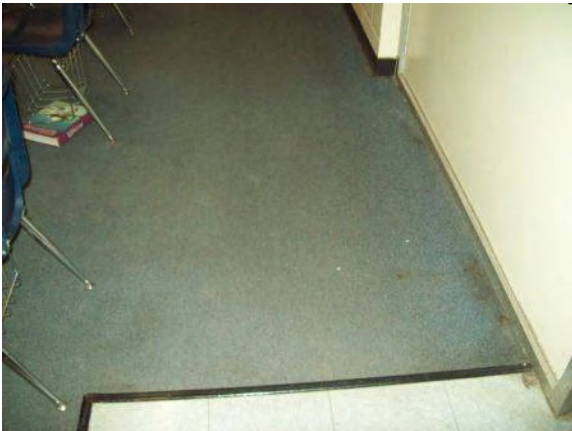
**Location:** All classrooms.  
**Material:** System  
**Distress:** Beyond Expected Life  
**Category:** Capital Renewal  
**Priority:** 3 - Necessary/Not Yet Critical (Years 2-5)  
**Correction:** Renew System  
**Qty:** 1-Ea.  
**Estimate:** \$145,160.29  
**Assessor Name:** Eduardo Lopez  
**Date Created:** 01/21/2013

Notes: Carpet is worn and stained.

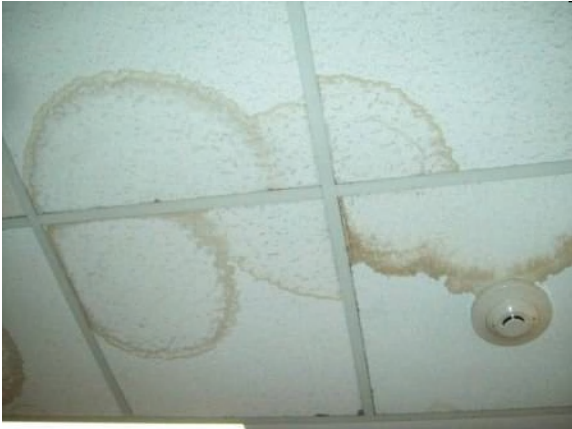
**Location:** Classroom ceilings. Utility room plaster ceilings.  
**Material:** System  
**Distress:** Beyond Expected Life  
**Category:** Capital Renewal  
**Priority:** 3 - Necessary/Not Yet Critical (Years 2-5)  
**Correction:** Renew System  
**Qty:** 1-Ea.  
**Estimate:** \$248,480.50  
**Assessor Name:** Eduardo Lopez  
**Date Created:** 01/21/2013

**Notes:** Ceilings on the second floor are stained in many locations by roof leaks. Recommended renewal of related systems such as lighting replacement and ACM abatement suggest complete system renewal. Plaster ceilings in utility closets are water damaged

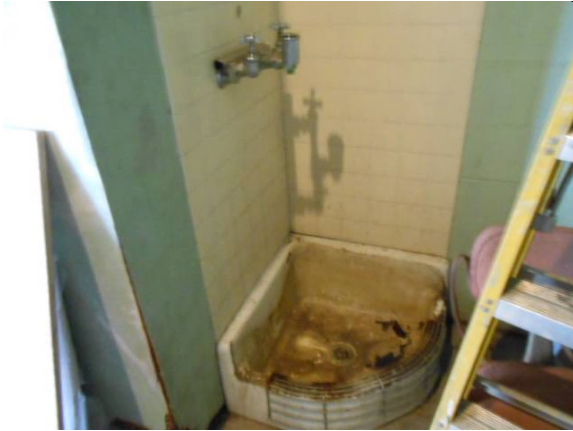
**Location:** Custodial Rooms, South end at both levels  
**Material:** Service/Utility Sink  
**Distress:** Beyond Expected Life  
**Category:** Capital Renewal  
**Priority:** 4 - Recommended (Years 6-10)  
**Correction:** Replace sink and fixtures  
**Qty:** 2-Ea.  
**Estimate:** \$6,595.29  
**Assessor Name:** Eduardo Lopez  
**Date Created:** 01/22/2013

**Notes:** Replace during next remodel or renovation.

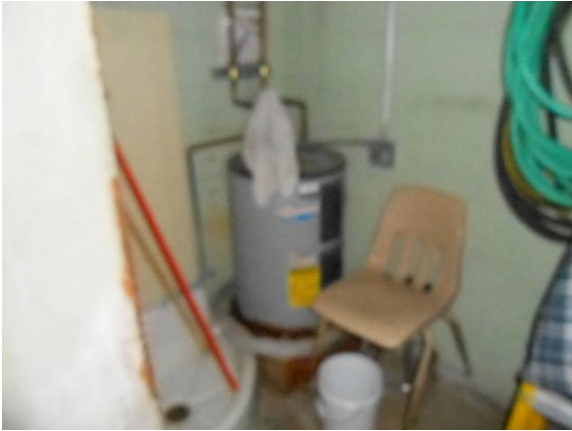
**Location:** Typical for entire building  
**Material:** System  
**Distress:** Beyond Expected Life  
**Category:** Capital Renewal  
**Priority:** 4 - Recommended (Years 6-10)  
**Correction:** Renew System  
**Qty:** 1-Ea.  
**Estimate:** \$20,023.19  
**Assessor Name:** Eduardo Lopez  
**Date Created:** 01/22/2013

**Notes:** Domestic hot water was replaced in 1992 and is currently furnished for custodial rooms only; however it is recommended to replace the domestic water distribution system during next remodel or renovation.

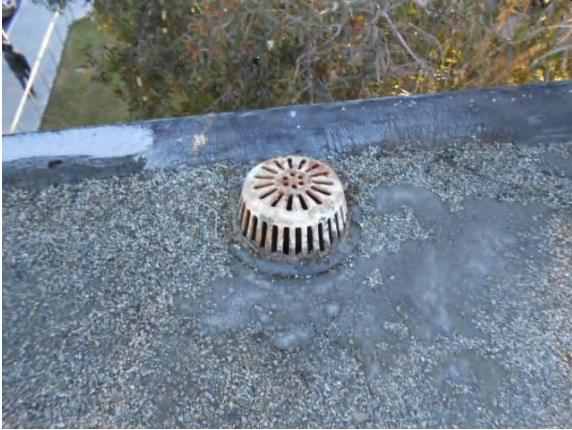
**Location:** Typical for entire building  
**Material:** System  
**Distress:** Beyond Expected Life  
**Category:** Capital Renewal  
**Priority:** 4 - Recommended (Years 6-10)  
**Correction:** Renew System  
**Qty:** 1-Ea.  
**Estimate:** \$11,097.19  
**Assessor Name:** Eduardo Lopez  
**Date Created:** 01/22/2013

**Notes:** Replace system during next remodel or renovation.

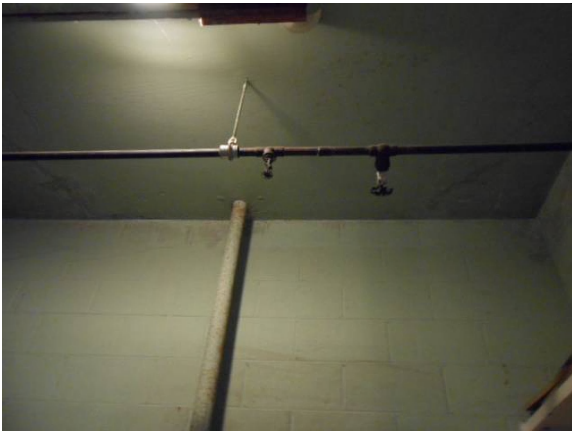
**Location:** Typical for entire building  
**Material:** System  
**Distress:** Beyond Expected Life  
**Category:** Capital Renewal  
**Priority:** 5 - Codes or Standards Compliance  
**Correction:** Renew System  
**Qty:** 1-Ea.  
**Estimate:** \$92,396.15  
**Assessor Name:** Eduardo Lopez  
**Date Created:** 01/22/2013

**Notes:** Building is partially sprinklered, wet type fire sprinklers are currently located in the storage/electrical room and it's recommended to be added throughout building wide during next major renovation.

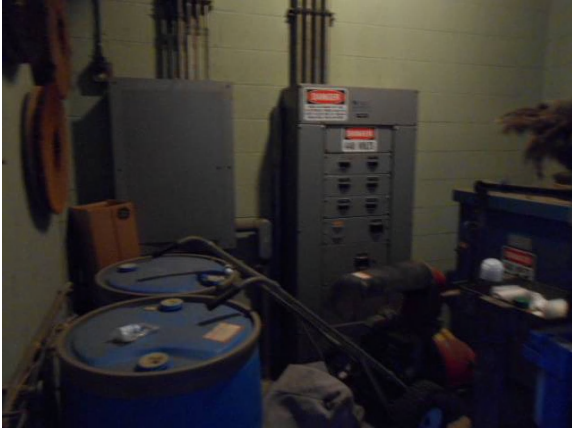
**Location:** Typical for entire building  
**Material:** System  
**Distress:** Beyond Expected Life  
**Category:** Capital Renewal  
**Priority:** 4 - Recommended (Years 6-10)  
**Correction:** Renew System  
**Qty:** 1-Ea.  
**Estimate:** \$101,804.63  
**Assessor Name:** Eduardo Lopez  
**Date Created:** 01/22/2013

**Notes:** The main electrical panels, distribution panel boards and feeders are mostly original to the building age. It is recommended to be replaced during the next major renovation.

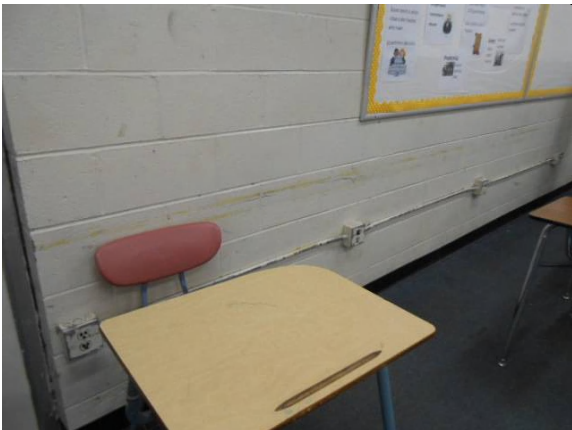
**Location:** Typical for entire building  
**Material:** System  
**Distress:** Beyond Expected Life  
**Category:** Capital Renewal  
**Priority:** 4 - Recommended (Years 6-10)  
**Correction:** Renew System  
**Qty:** 1-Ea.  
**Estimate:** \$351,250.10  
**Assessor Name:** Eduardo Lopez  
**Date Created:** 01/22/2013

**Notes:** The branch wiring, electrical panels and devices are mostly original to the building age. It is recommended to be replaced during the next major renovation.

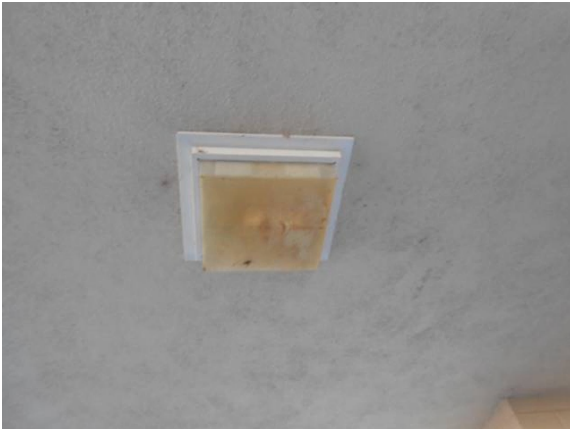
**Location:** Corridor, North end at second level  
**Material:** HP Sodium Fixture, 250 W  
**Distress:** Inadequate  
**Category:** Deferred Maintenance  
**Priority:** 1 - Currently Critical (Immediate)  
**Correction:** Replace fixture H.P. sodium fixture, 250 W  
**Qty:** 1-Ea.  
**Estimate:** \$2,138.57  
**Assessor Name:** Eduardo Lopez  
**Date Created:** 01/24/2013

**Notes:** There is water inside the refractor lens that has been filtering from the roof every time it rains. The Light fixture is not suitable to operate under these conditions. An engineering study by a PE is recommended prior replacement.

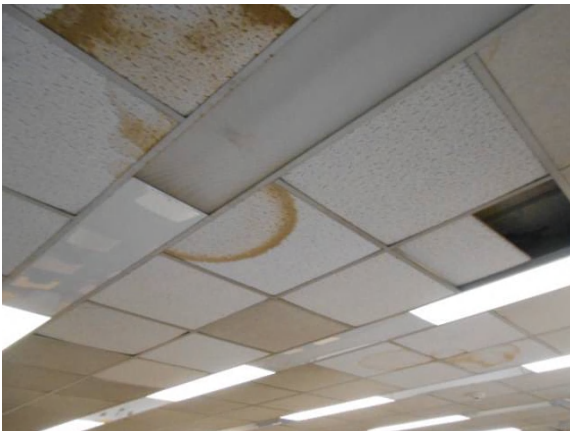
**Location:** Typical for all classrooms  
**Material:** Fluorescent Lighting Fixture, 80 W  
**Distress:** Beyond Expected Life  
**Category:** Capital Renewal  
**Priority:** 4 - Recommended (Years 6-10)  
**Correction:** Replace fixture fluorescent lighting fixture, 80 W  
**Qty:** 320-Ea.  
**Estimate:** \$112,193.28  
**Assessor Name:** Eduardo Lopez  
**Date Created:** 01/23/2013

**Notes:** Light switches with motion sensor, T8 fluorescent lamps and ballasts were updated in 2006; however it is recommended to replace lighting fixtures and related wiring during next remodel or renovation.

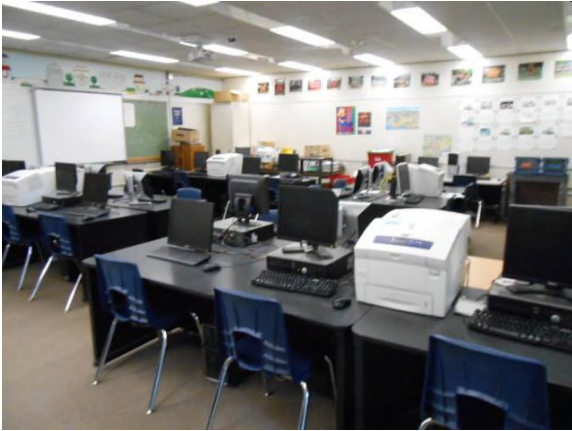
**Location:** Typical for entire building  
**Material:** System  
**Distress:** Beyond Expected Life  
**Category:** Capital Renewal  
**Priority:** 4 - Recommended (Years 6-10)  
**Correction:** Renew System  
**Qty:** 1-Ea.  
**Estimate:** \$16,009.78  
**Assessor Name:** Eduardo Lopez  
**Date Created:** 01/27/2013

**Notes:** Security is needing upgrades. Recommend replacing and enhancing during the next building renovation.

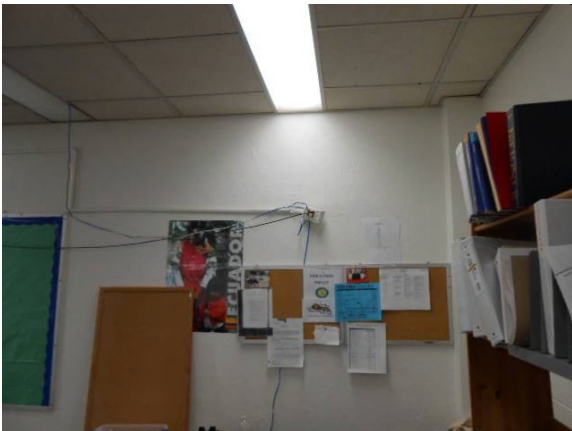
**Location:** Typical for entire building  
**Material:** Lan System  
**Distress:** Inadequate  
**Category:** Capital Renewal  
**Priority:** 4 - Recommended (Years 6-10)  
**Correction:** Replace LAN System Drop CAT6  
**Qty:** 32-Ea.  
**Estimate:** \$12,555.19  
**Assessor Name:** Eduardo Lopez  
**Date Created:** 01/24/2013

**Notes:** Most of the existing LAN outlets will require new drops and it is recommended to be enhanced during the next major building renovation.

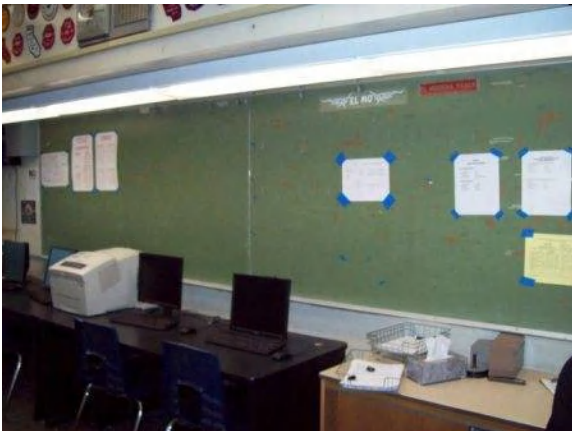
**Location:** All classrooms. Two rooms, 301 and 303 have Smartboards.  
**Material:** Boards  
**Distress:** Beyond Expected Life  
**Category:** Capital Renewal  
**Priority:** 3 - Necessary/Not Yet Critical (Years 2-5)  
**Correction:** Install Smartboards Tackboards  
Markerboards OUSD  
**Qty:** 16-Ea.  
**Estimate:** \$119,448.69  
**Assessor Name:** Ann Buerger Linden  
**Date Created:** 01/26/2013

**Notes:** Some marker boards are stained and cannot be cleaned. Tackboards are beyond expected life. Some chalkboards are present. Provide 1 Smartboard for each classroom.

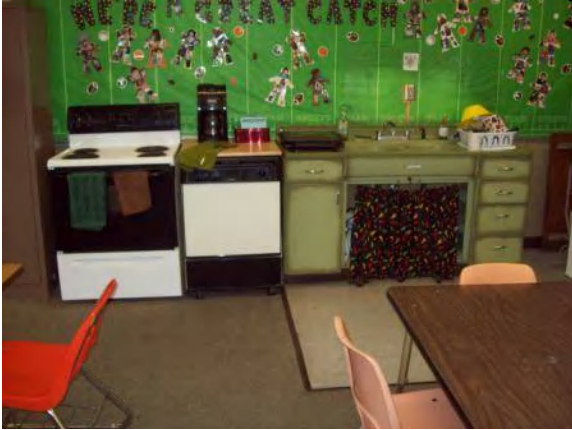
**Location:** Special Ed Room 307  
**Material:** Kitchen Equipment  
**Distress:** Beyond Expected Life  
**Category:** Capital Renewal  
**Priority:** 4 - Recommended (Years 6-10)  
**Correction:** Home Economics Kitchen Class Set-up  
**Qty:** 1-Ea.  
**Estimate:** \$11,978.91  
**Assessor Name:** Ann Buerger Linden  
**Date Created:** 01/26/2013

**Notes:** Provide new residential kitchen appliances.

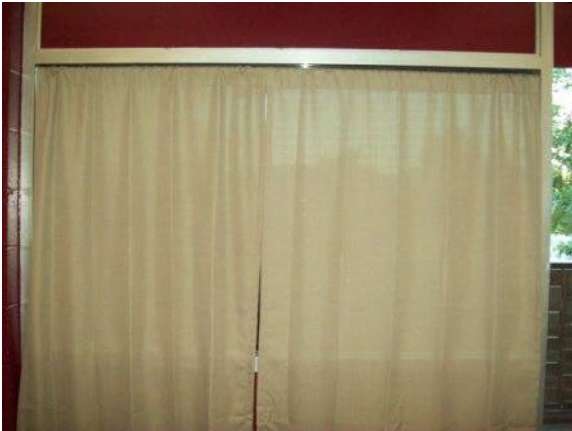
**Location:** Exterior windows.  
**Material:** Blinds and Other Window Treatment  
**Distress:** Beyond Expected Life  
**Category:** Capital Renewal  
**Priority:** 1 - Currently Critical (Immediate)  
**Correction:** Replace window blinds  
**Qty:** 288-S.F.  
**Estimate:** \$3,122.84  
**Assessor Name:** Ann Buerger Linden  
**Date Created:** 01/26/2013

**Notes:** Provide window treatments to allow control of glare and to facilitate A/V presentations. Blinds are either not present or in fair condition.

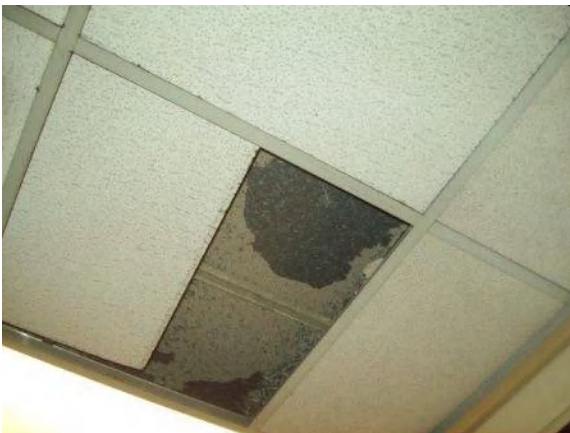
**Location:** Friable material above ceilings in fireproofing and drywall mud, and on pipe insulation in sprinkler valve room. Non-friable material in exterior stucco soffits, above and below windows in transite panels, and at interior plaster walls.  
**Material:** Removal of Hazardous Components  
**Distress:** Beyond Expected Life  
**Category:** Capital Renewal  
**Priority:** 3 - Necessary/Not Yet Critical (Years 2-5)  
**Correction:** Abate all ACM in building  
**Qty:** 15,230-S.F.  
**Estimate:** \$134,218.94  
**Assessor Name:** Ann Buerger Linden  
**Date Created:** 01/26/2013

**Notes:** The AHERA six-month surveillance of asbestos-containing materials - Summer 2012, identifies ACM at this building. Complete abatement is recommended.

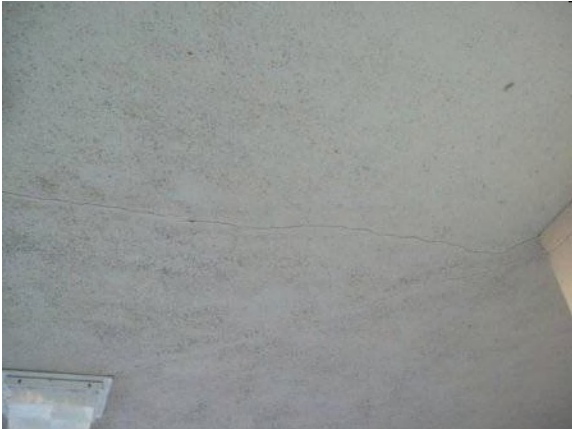
**Location:** Exterior soffits  
**Material:** Plaster Soffits  
**Distress:** Beyond Expected Life  
**Category:** Capital Renewal  
**Priority:** 3 - Necessary/Not Yet Critical (Years 2-5)  
**Correction:** Replace plaster soffits  
**Qty:** 6,600-S.F.  
**Estimate:** \$46,422.58  
**Assessor Name:** Ann Buerger Linden  
**Date Created:** 01/27/2013

**Notes:** Soffits are cracking and water damaged

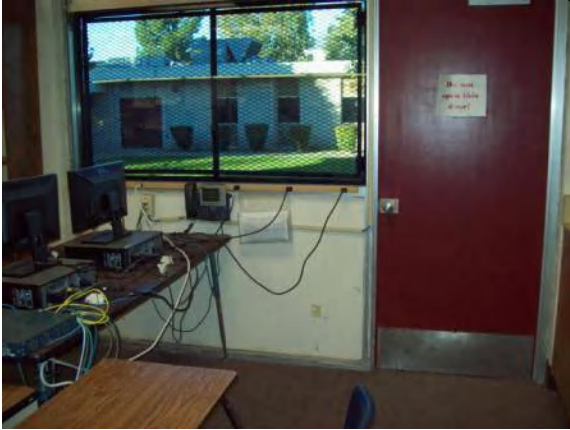
**Location:** All exterior windows.  
**Material:** System  
**Distress:** Beyond Expected Life  
**Category:** Capital Renewal  
**Priority:** 3 - Necessary/Not Yet Critical (Years 2-5)  
**Correction:** Renew System  
**Qty:** 1-Ea.  
**Estimate:** \$78,890.80  
**Assessor Name:** Eduardo Lopez  
**Date Created:** 01/21/2013

**Notes:** Quantity/area includes transom panels at doors, ceramic tile assembly above and below windows. Existing windows are typically single pane in aluminum frames. Glazing systems are failing. Tile panels are ACM per 2012 AHERA report.

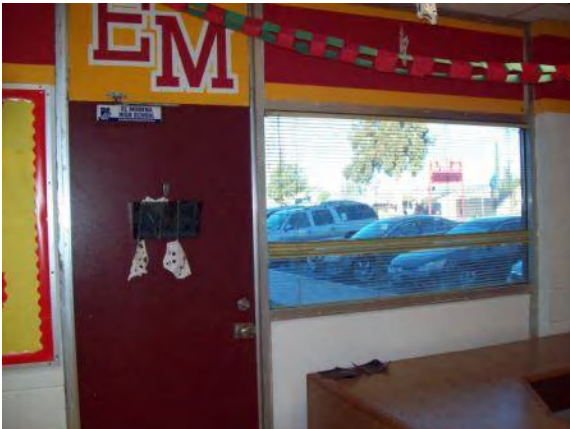
**Location:** Building wide.  
**Material:** System  
**Distress:** Beyond Expected Life  
**Category:** Capital Renewal  
**Priority:** 3 - Necessary/Not Yet Critical (Years 2-5)  
**Correction:** Renew System  
**Qty:** 1-Ea.  
**Estimate:** \$167,998.88  
**Assessor Name:** Eduardo Lopez  
**Date Created:** 01/21/2013

**Notes:** Existing wood exterior doors are deteriorated. Aluminum frames are failing. Caulking is failed. Full system replacement is recommended. Provide interior locking lever locksets at classrooms.

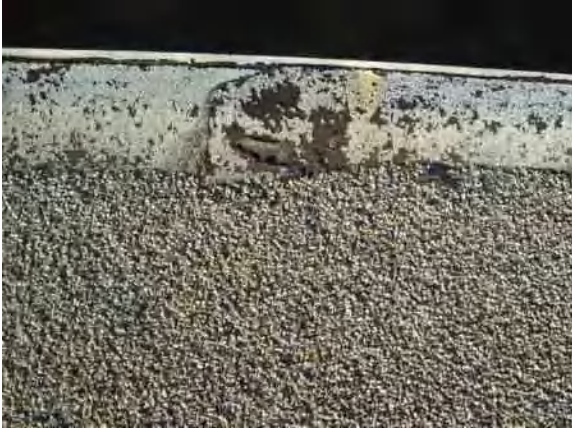
**Location:** Roof  
**Material:** System  
**Distress:** Beyond Expected Life  
**Category:** Capital Renewal  
**Priority:** 1 - Currently Critical (Immediate)  
**Correction:** Renew System  
**Qty:** 1-Ea.  
**Estimate:** \$196,589.76  
**Assessor Name:** Eduardo Lopez  
**Date Created:** 01/21/2013

**Notes:** The roof is in visibly poor condition. Holes observed in membrane at perimeter. Sloope to corenrs - external gutters and downspouts have been retrofitted.

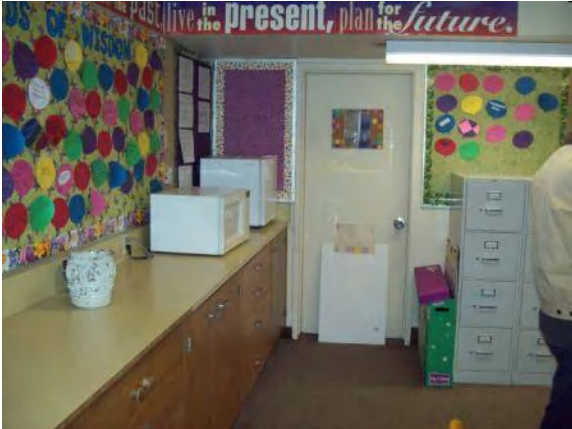
**Location:** Interior doors to storage rooms and between classrooms.  
**Material:** System  
**Distress:** Beyond Expected Life  
**Category:** Capital Renewal  
**Priority:** 3 - Necessary/Not Yet Critical (Years 2-5)  
**Correction:** Renew System  
**Qty:** 1-Ea.  
**Estimate:** \$25,291.42  
**Assessor Name:** Eduardo Lopez  
**Date Created:** 01/21/2013

**Notes:** Doors are beyond their expected life. Doors do not have lever latches. Replacement of interior doors and hardware is recommended.

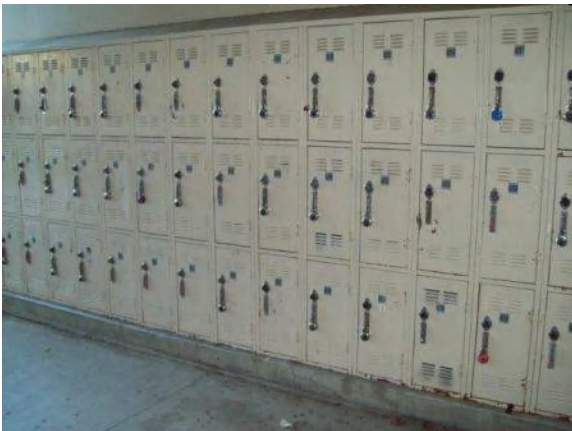
**Location:** First floor exterior.  
**Material:** Fixed Furnishings - Lockers  
**Distress:** Beyond Expected Life  
**Category:** Capital Renewal  
**Priority:** 3 - Necessary/Not Yet Critical (Years 2-5)  
**Correction:** Student lockers stacked 2-high  
**Qty:** 250-Ea.  
**Estimate:** \$101,253.60  
**Assessor Name:** Ann Buerger Linden  
**Date Created:** 01/27/2013

**Notes:** Lockers are typically in very poor conditions with rust, missing or malfunctioning hardware, etc. Approximately half of the lockers at this building are newer.

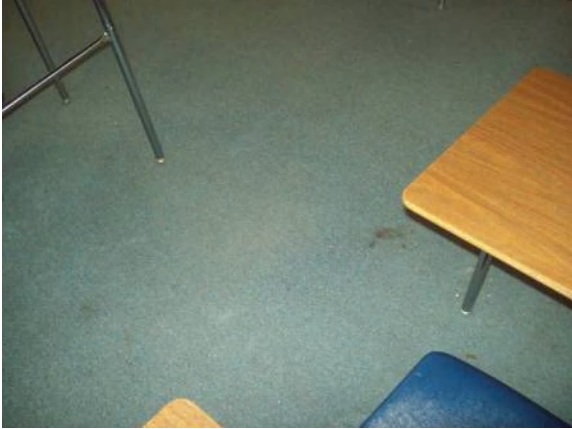
**Location:** Classrooms 403, 404, 406, 422, 424, portions of 421 and 426.

**Notes:** Carpet is stained and worn. Removal and replacement is required to facilitate ACM abatement.

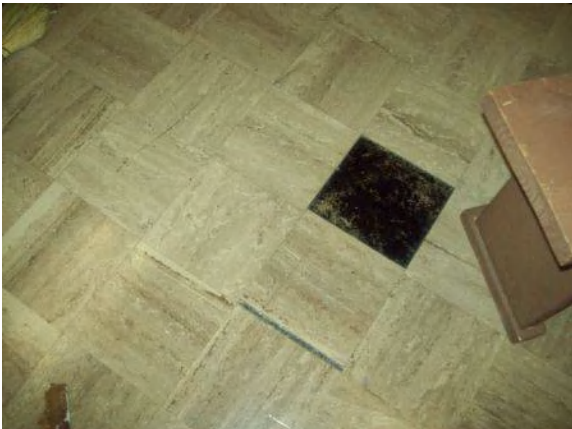
**Location:** Rooms 421, 426 and storage rooms.

**Material:** Vinyl

**Correction:** Replace VCT Flooring and Resilient Base

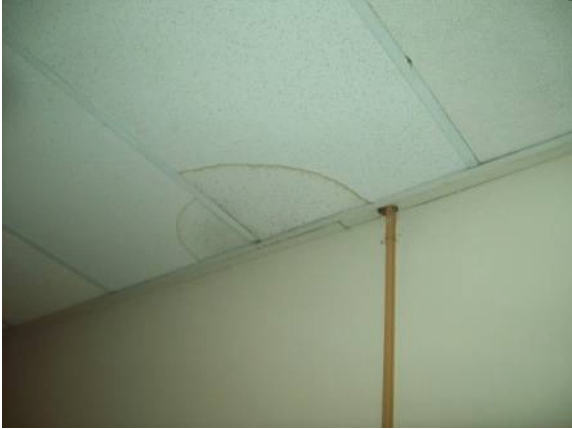
**Location:** All rooms.  
**Material:** System  
**Distress:** Beyond Expected Life  
**Category:** Capital Renewal  
**Priority:** 3 - Necessary/Not Yet Critical (Years 2-5)  
**Correction:** Renew System  
**Qty:** 1-Ea.  
**Estimate:** \$258,991.03  
**Assessor Name:** Eduardo Lopez  
**Date Created:** 01/21/2013

**Notes:** Suspended acoustical tile ceilings have water damage and are typically beyond their expected life. Storage rooms have 12" glued on tile that is failed. Utility closet plaster ceilings are water damaged and deteriorated.

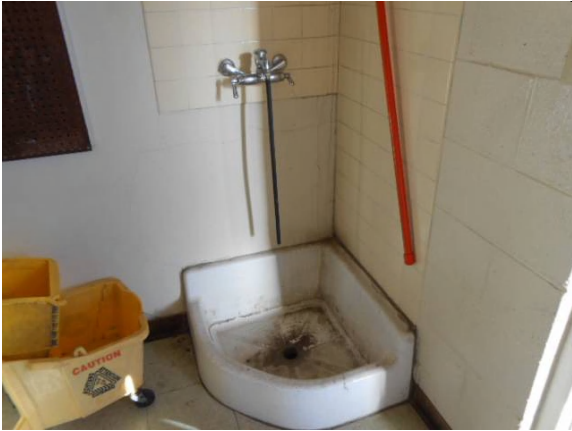
**Location:** Custodial Rooms, at both levels  
**Material:** Service/Utility Sink  
**Distress:** Beyond Expected Life  
**Category:** Capital Renewal  
**Priority:** 4 - Recommended (Years 6-10)  
**Correction:** Replace sink and fixtures  
**Qty:** 2-Ea.  
**Estimate:** \$6,595.29  
**Assessor Name:** Eduardo Lopez  
**Date Created:** 01/22/2013

**Notes:** Replace during next remodel or renovation.

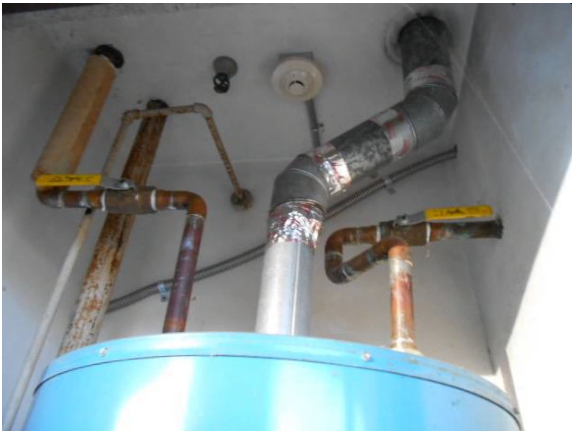
**Location:** Typical for entire building  
**Material:** System  
**Distress:** Beyond Service Life  
**Category:** Capital Renewal  
**Priority:** 4 - Recommended (Years 6-10)  
**Correction:** Renew System  
**Qty:** 1-Ea.  
**Estimate:** \$20,928.57  
**Assessor Name:** Eduardo Lopez  
**Date Created:** 01/24/2013

**Notes:** Domestic hot water was replaced in 1998 and is currently furnished for foods classroom and custodial rooms only; however it is recommended to replace the domestic water distribution system during next remodel or renovation.

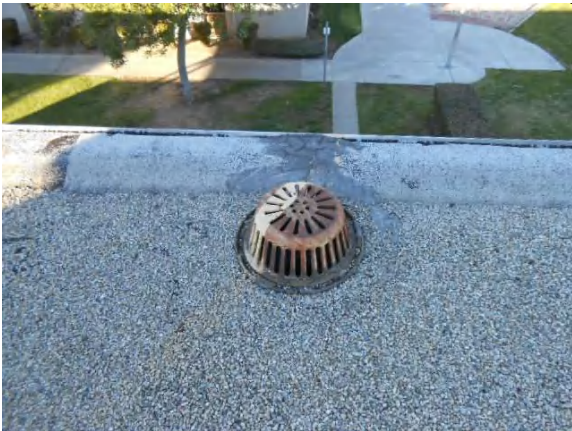
**Location:** Typical for entire building  
**Material:** System  
**Distress:** Beyond Service Life  
**Category:** Capital Renewal  
**Priority:** 4 - Recommended (Years 6-10)  
**Correction:** Renew System  
**Qty:** 1-Ea.  
**Estimate:** \$11,554.31  
**Assessor Name:** Eduardo Lopez  
**Date Created:** 01/24/2013

**Notes:** Replace system during next remodel or renovation.

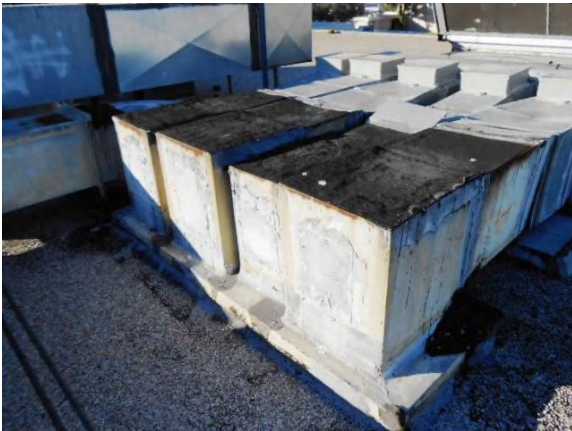
**Location:** Typical for entire building  
**Material:** System  
**Distress:** Beyond Service Life  
**Category:** Capital Renewal  
**Priority:** 4 - Recommended (Years 6-10)  
**Correction:** Renew System  
**Qty:** 1-Ea.  
**Estimate:** \$282,971.68  
**Assessor Name:** Eduardo Lopez  
**Date Created:** 01/24/2013

**Notes:** The HVAC System was replaced in 2008, however the ductwork, exhaust fns, air vents and fresh air supply is recommended to be upgraded during the next major renovation.

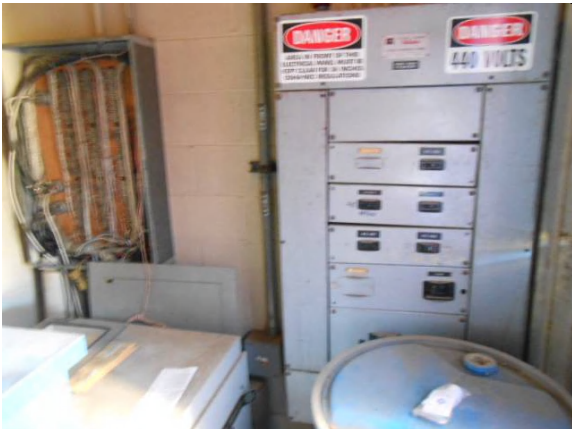
**Location:** Typical for entire building  
**Material:** System  
**Distress:** Beyond Service Life  
**Category:** Capital Renewal  
**Priority:** 4 - Recommended (Years 6-10)  
**Correction:** Renew System  
**Qty:** 1-Ea.  
**Estimate:** \$106,168.88  
**Assessor Name:** Eduardo Lopez  
**Date Created:** 01/24/2013

**Notes:** The main electrical panels, distribution panel boards and feeders are mostly original to the building age. It is recommended to be replaced during the next major renovation.

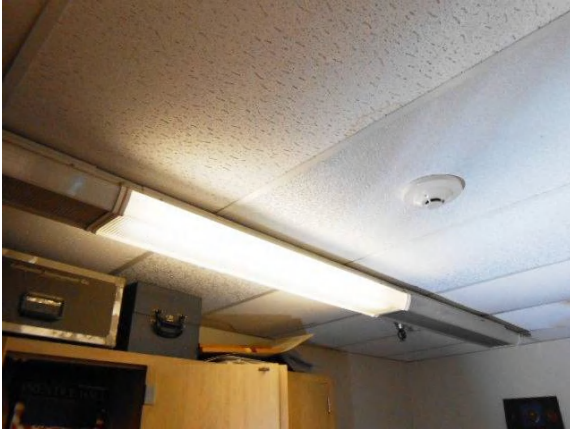
**Location:** Custodial rooms at both levels and storage rooms at second level.

**Material:** Fluorescent Lighting Fixture, 80 W

**Notes:** T8 fluorescent lamps and ballasts were updated in 2006; however light fixtures, switches and wiring are original to building age and it is recommended to be replaced during next remodel or renovation.

**Correction:** Replace fixture fluorescent lighting fixture, 80 W

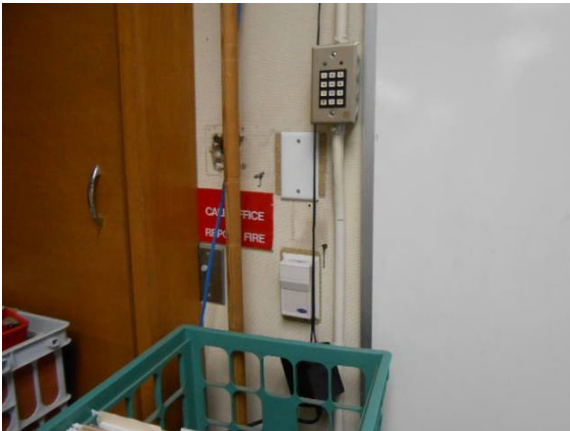
**Location:** Typical for entire building

**Notes:** Security is needing upgrades. Recommend replacing and enhancing during the next building renovation.

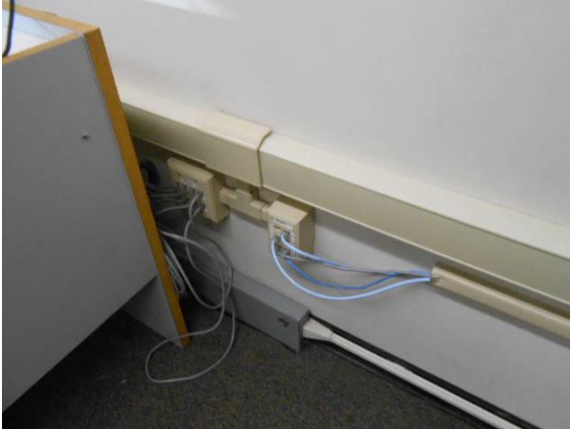
**Location:** Typical for entire building  
**Material:** Lan System  
**Distress:** Inadequate  
**Category:** Capital Renewal  
**Priority:** 4 - Recommended (Years 6-10)  
**Correction:** Replace LAN System Drop CAT6  
**Qty:** 100-Ea.  
**Estimate:** \$39,234.96  
**Assessor Name:** Eduardo Lopez  
**Date Created:** 01/24/2013

**Notes:** Most of the existing LAN outlets will require new drops and it is recommended to be enhanced during the next major building renovation.

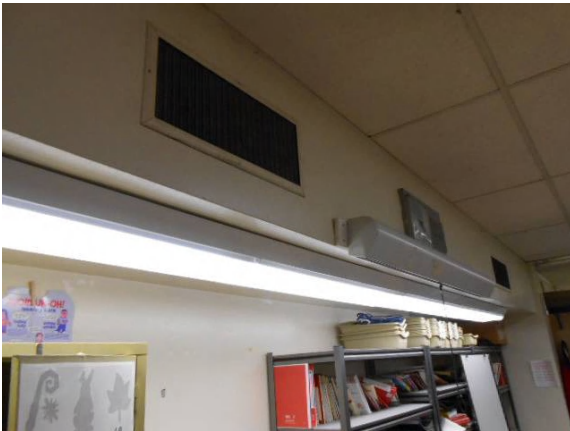
**Location:** Typical for entire building  
**Material:** System  
**Distress:** Beyond Expected Life  
**Category:** Capital Renewal  
**Priority:** 4 - Recommended (Years 6-10)  
**Correction:** Renew System  
**Qty:** 1-Ea.  
**Estimate:** \$16,647.72  
**Assessor Name:** Eduardo Lopez  
**Date Created:** 01/27/2013

**Notes:** Clock System is needing upgrades. Recommend replacing and enhancing during the next building renovation.

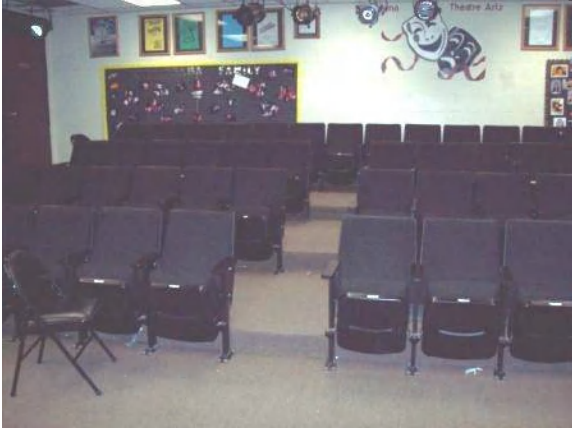
**Location:** Drama classroom 426  
**Material:** System  
**Distress:** Beyond Expected Life  
**Category:** Capital Renewal  
**Priority:** 3 - Necessary/Not Yet Critical (Years 2-5)  
**Correction:** Renew System  
**Qty:** 1-Ea.  
**Estimate:** \$73,054.08  
**Assessor Name:** Ann Buerger Linden  
**Date Created:** 01/28/2013

**Notes:** Existing black box theater equipment including stage, seating, sound and lighting controls, stage and curtains is beyond its expected life and in fair condition.

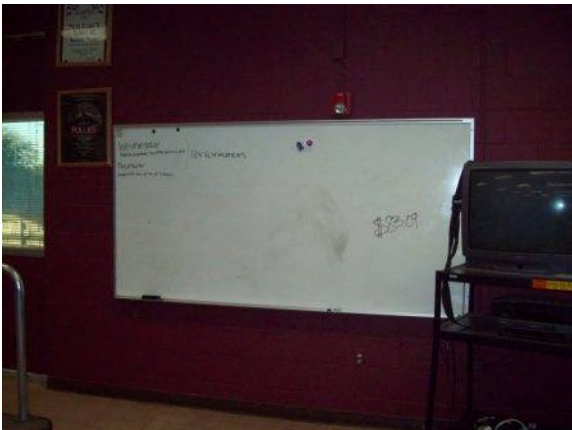
**Location:** Classrooms, Student Center  
**Material:** Boards  
**Distress:** Beyond Expected Life  
**Category:** Capital Renewal  
**Priority:** 3 - Necessary/Not Yet Critical (Years 2-5)  
**Correction:** Install Smartboards Tackboards  
Markerboards OUSD  
**Qty:** 8-Ea.  
**Estimate:** \$36,529.06  
**Assessor Name:** Ann Buerger Linden  
**Date Created:** 01/27/2013

**Notes:** Tack and marker boards are typically in poor condition. Provide Smartboards at three additional classrooms, 401, 403, and 422.

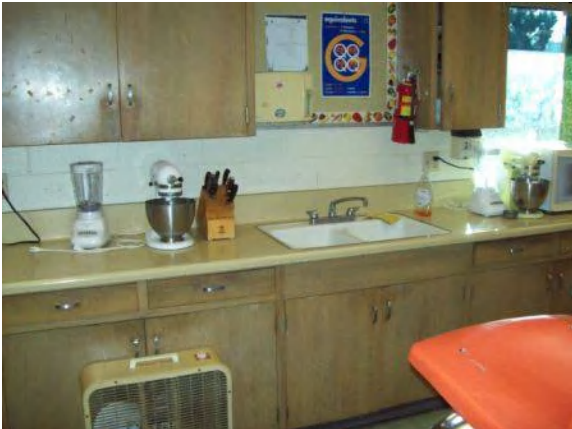
**Location:** Classroom 421  
**Material:** Kitchen Equipment  
**Distress:** Beyond Expected Life  
**Category:** Capital Renewal  
**Priority:** 4 - Recommended (Years 6-10)  
**Correction:** Home Economics Kitchen Class Set-up  
**Qty:** 6-Ea.  
**Estimate:** \$78,936.08  
**Assessor Name:** Ann Buerger Linden  
**Date Created:** 01/27/2013

**Notes:** Home Ec kitchen appliances are expired.

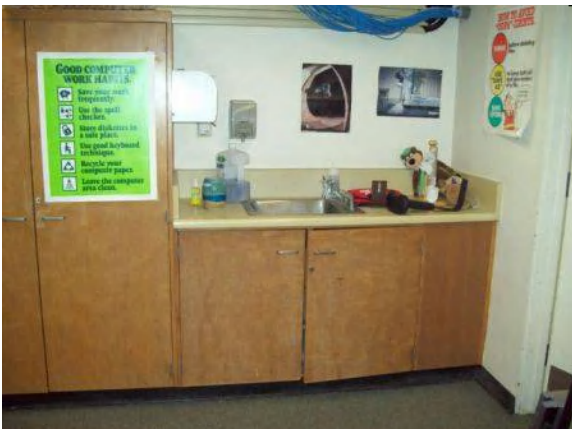
**Location:** Classrooms, student center, storage rooms  
**Material:** Fixed Casework  
**Distress:** Beyond Expected Life  
**Category:** Capital Renewal  
**Priority:** 3 - Necessary/Not Yet Critical (Years 2-5)  
**Correction:** Replace Casework OUSD  
**Qty:** 450-L.F.  
**Estimate:** \$221,555.09  
**Assessor Name:** Ann Buerger Linden  
**Date Created:** 01/27/2013

**Notes:** Casework throughout the building is original and in poor condition.

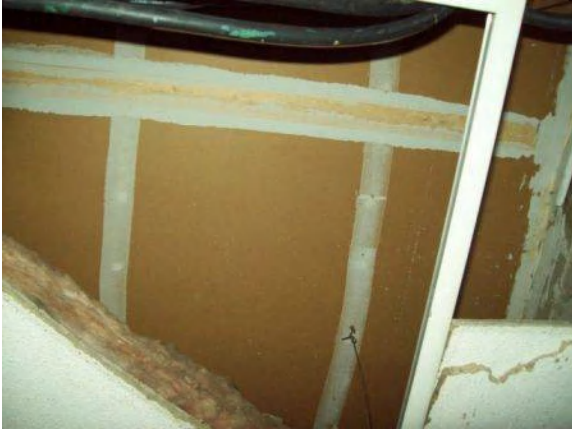
**Location:** Building wide in attic spaces, 9" VAT flooring, fire door insulation, some 12" floor tile, pipe fitting insulation, interior plaster, transite panels at windows, exterior stucco soffits.

**Notes:** The AHERA six-month surveillance of asbestos-containing materials - Summer 2012, identifies ACM at this building. Complete abatement is recommended.

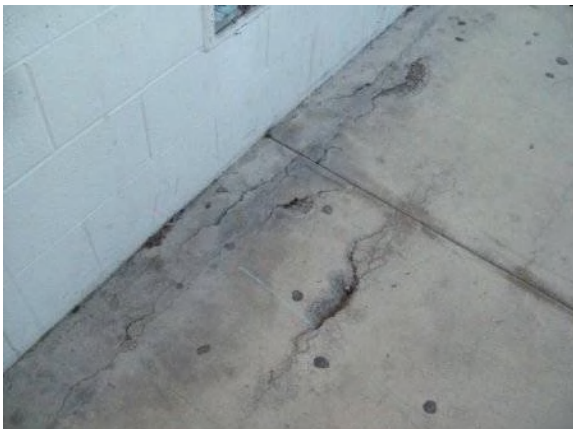
**Location:** Level 2 exterior balconies.  
**Material:** Floor Construction Concrete  
**Distress:** Failing  
**Category:** Deferred Maintenance  
**Priority:** 2 - Potentially Critical (Year 1)  
**Correction:** Repair concrete suspended slab  
**Qty:** 500-S.F.  
**Estimate:** \$10,094.40  
**Assessor Name:** Ann Buerger Linden  
**Date Created:** 01/28/2013

**Notes:** Slabs have cracking, spalling, exposed rebar. Tripping hazards are present.

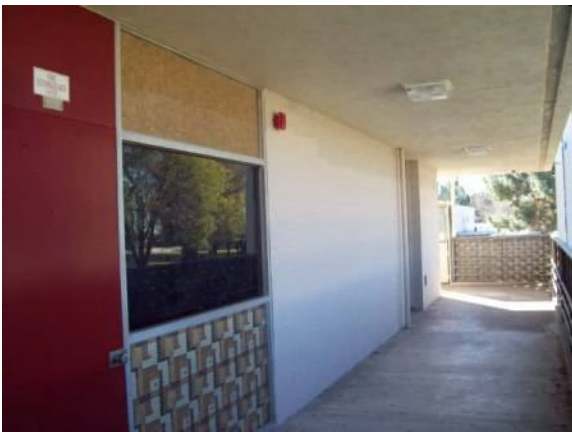
**Location:** Building exterior walls adjacent to classroom entry doors.  
**Material:** System  
**Distress:** Beyond Expected Life  
**Category:** Capital Renewal  
**Priority:** 3 - Necessary/Not Yet Critical (Years 2-5)  
**Correction:** Renew System  
**Qty:** 1-Ea.  
**Estimate:** \$75,416.14  
**Assessor Name:** Ann Buerger Linden  
**Date Created:** 01/28/2013

**Notes:** Quantity/area includes transom panels at doors, ceramic tile assembly above and below windows. Existing windows are typically single pane in aluminum frames. Glazing systems are failing. Tile panels are ACM per 2012 AHERA report.

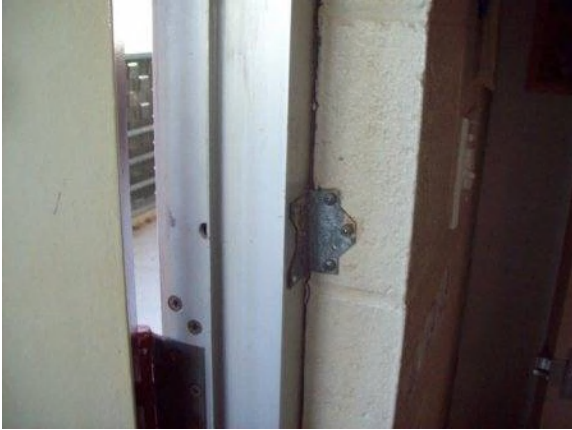
**Location:** Building wide  
**Material:** System  
**Distress:** Beyond Expected Life  
**Category:** Capital Renewal  
**Priority:** 3 - Necessary/Not Yet Critical (Years 2-5)  
**Correction:** Renew System  
**Qty:** 1-Ea.  
**Estimate:** \$183,554.25  
**Assessor Name:** Ann Buerger Linden  
**Date Created:** 01/27/2013

**Notes:** Existing wood exterior doors are deteriorated. Aluminum frames are failing. Many have attached reinforcing hardware to stabilize them. Caulking is failed. Provide interior locking lever hardware at classrooms.

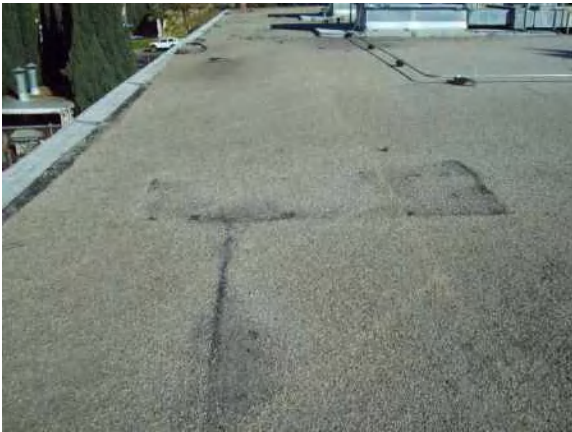
**Location:** Roof  
**Material:** System  
**Distress:** Beyond Expected Life  
**Category:** Capital Renewal  
**Priority:** 1 - Currently Critical (Immediate)  
**Correction:** Renew System  
**Qty:** 1-Ea.  
**Estimate:** \$238,721.47  
**Assessor Name:** Ann Buerger Linden  
**Date Created:** 01/27/2013

**Notes:** The existing built-up roof is beyond it's expected life and is failing.

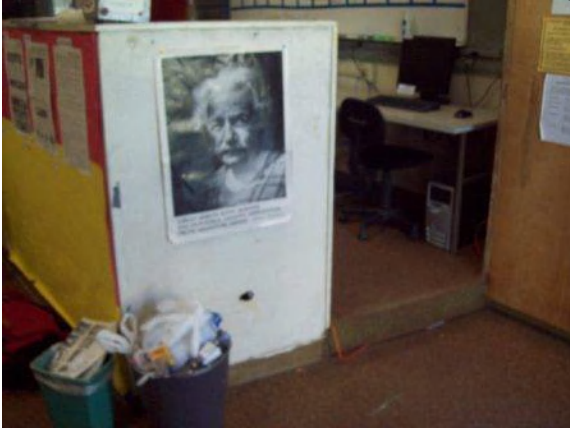
**Location:** Building interior partitions  
**Material:** Interior Partitions  
**Distress:** Beyond Expected Life  
**Category:** Capital Renewal  
**Priority:** 3 - Necessary/Not Yet Critical (Years 2-5)  
**Correction:** Allowance repair/remodel interior partitions  
OUSD  
**Qty:** 1-Job  
**Estimate:** \$44,064.00  
**Assessor Name:** Ann Buerger Linden  
**Date Created:** 01/28/2013

**Notes:** Provide an allowance to repair and remodel interior partitions as needed to accommodate renovations to adjacent systems and update configurations for ADA compliance and operational efficiency. Folding partition between 525 and 526 is non-functional.

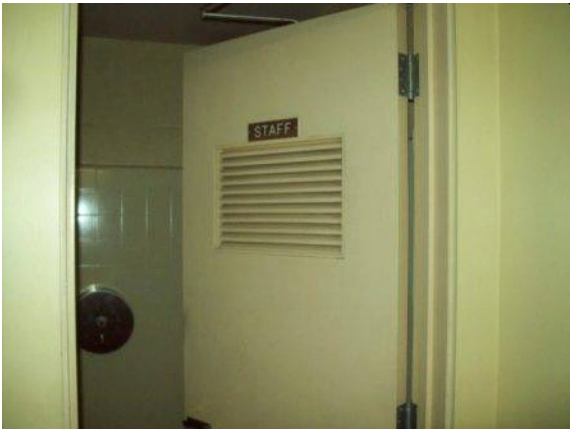
**Location:** Building wide.  
**Material:** System  
**Distress:** Beyond Expected Life  
**Category:** Capital Renewal  
**Priority:** 3 - Necessary/Not Yet Critical (Years 2-5)  
**Correction:** Renew System  
**Qty:** 1-Ea.  
**Estimate:** \$55,266.42  
**Assessor Name:** Ann Buerger Linden  
**Date Created:** 01/27/2013

**Notes:** Doors, frames and hardware are beyond their expected life. Doors do not have lever latches. Replacement of interior doors and hardware is recommended.

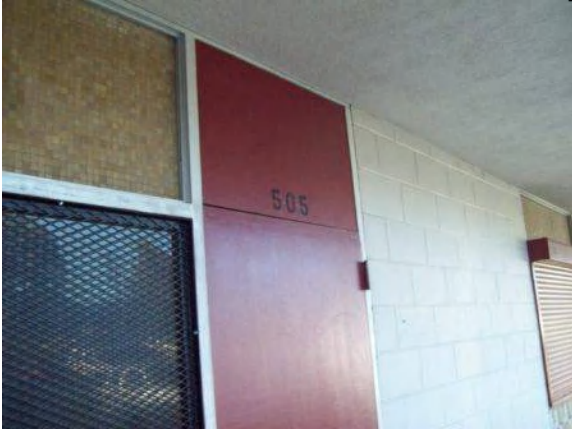
**Location:** Building wide  
**Material:** Signage  
**Distress:** Beyond Expected Life  
**Category:** Capital Renewal  
**Priority:** 3 - Necessary/Not Yet Critical (Years 2-5)  
**Correction:** Replace/Install code compliant signage  
**Qty:** 15,481-S.F.  
**Estimate:** \$3,343.90  
**Assessor Name:** Ann Buerger Linden  
**Date Created:** 01/28/2013

**Notes:** Provide code compliant signage throughout the building.

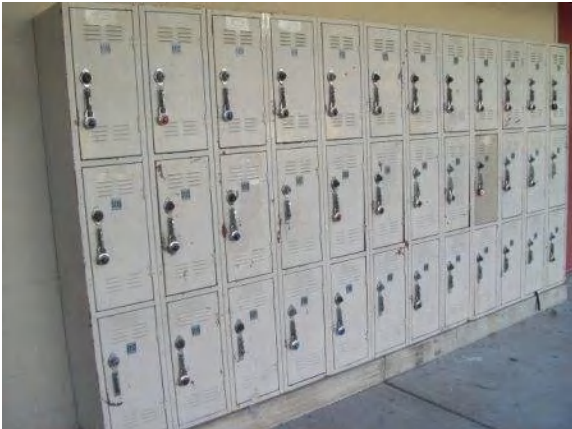
**Location:** First floor exterior.  
**Material:** Fixed Furnishings - Lockers  
**Distress:** Beyond Expected Life  
**Category:** Capital Renewal  
**Priority:** 3 - Necessary/Not Yet Critical (Years 2-5)  
**Correction:** Student lockers stacked 2-high  
**Qty:** 500-Ea.  
**Estimate:** \$202,507.20  
**Assessor Name:** Ann Buerger Linden  
**Date Created:** 01/28/2013

**Notes:** Lockers are typically in very poor conditions with rust, missing or malfunctioning hardware, etc.

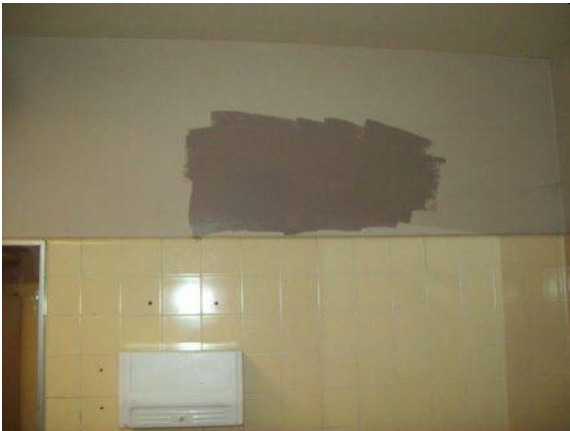
**Location:** Building wide.  
**Material:** System  
**Distress:** Beyond Expected Life  
**Category:** Capital Renewal  
**Priority:** 3 - Necessary/Not Yet Critical (Years 2-5)  
**Correction:** Renew System  
**Qty:** 1-Ea.  
**Estimate:** \$179,255.12  
**Assessor Name:** Ann Buerger Linden  
**Date Created:** 01/28/2013

**Notes:** Interior wall finishes are primarily paint. There is ceramic wall tile at student and staff restrooms. Expected renovations throughout the building, including ACM removal, millwork and science equipment replacement, etc, will necessitate interior repainting.

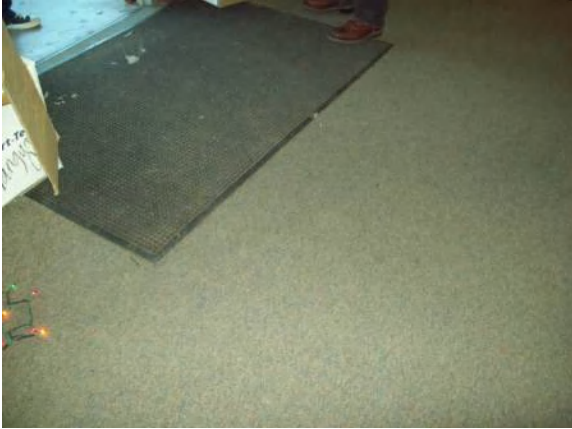
**Location:** Classroom 504  
**Material:** System  
**Distress:** Beyond Expected Life  
**Category:** Capital Renewal  
**Priority:** 3 - Necessary/Not Yet Critical (Years 2-5)  
**Correction:** Renew System  
**Qty:** 1-Ea.  
**Estimate:** \$16,990.81  
**Assessor Name:** Ann Buerger Linden  
**Date Created:** 01/28/2013

**Notes:** Carpet is worn and stained.

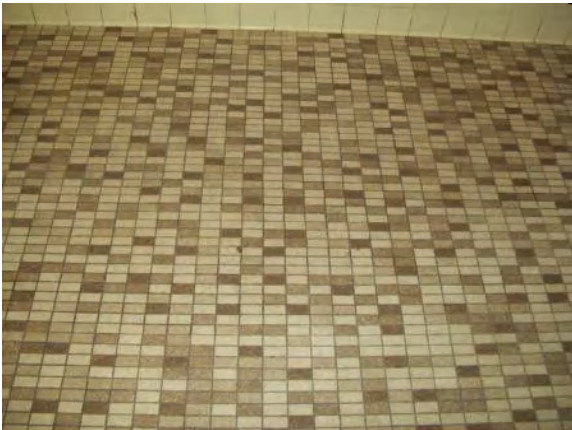
**Location:** First floor student restrooms. Faculty/staff restrooms on first and second floors.  
**Material:** System  
**Distress:** Beyond Expected Life  
**Category:** Capital Renewal  
**Priority:** 3 - Necessary/Not Yet Critical (Years 2-5)  
**Correction:** Renew System  
**Qty:** 1-Ea.  
**Estimate:** \$17,119.08  
**Assessor Name:** Ann Buerger Linden  
**Date Created:** 01/28/2013

**Notes:** Restroom renovation and upgrade to ADA standards will necessitate ceramic floor tile replacement.

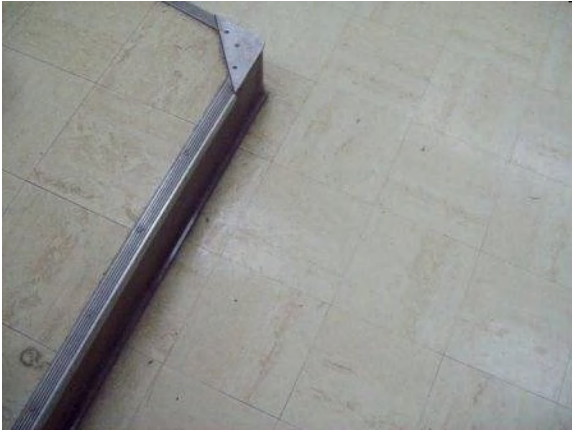
**Location:** Building classrooms and prep rooms, except room 504.  
**Material:** System  
**Distress:** Beyond Expected Life  
**Category:** Capital Renewal  
**Priority:** 3 - Necessary/Not Yet Critical (Years 2-5)  
**Correction:** Renew System  
**Qty:** 1-Ea.  
**Estimate:** \$93,436.20  
**Assessor Name:** Ann Buerger Linden  
**Date Created:** 01/28/2013

**Notes:** Most flooring is 9" VAT. Tiles are worn, some are loose.

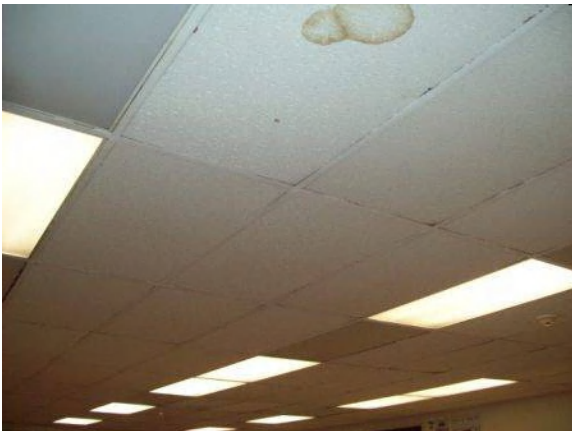
**Location:** Throughout the building.  
**Material:** System  
**Distress:** Beyond Expected Life  
**Category:** Capital Renewal  
**Priority:** 3 - Necessary/Not Yet Critical (Years 2-5)  
**Correction:** Renew System  
**Qty:** 1-Ea.  
**Estimate:** \$318,049.09  
**Assessor Name:** Ann Buerger Linden  
**Date Created:** 01/27/2013

**Notes:** Ceiling systems, though not typically original, are beyond their expected life with stained and mismatched tiles a frequent occurrence. Anticipated ACM abatement will require ceiling removal. System includes some original 12" glue on tile and hard lids in restrooms.

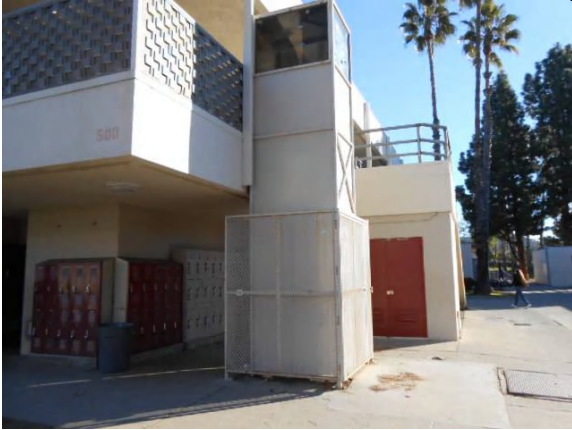
**Location:** South end of building  
**Material:** System  
**Distress:** Beyond Expected Life  
**Category:** Capital Renewal  
**Priority:** 2 - Potentially Critical (Year 1)  
**Correction:** Renew System  
**Qty:** 1-Ea.  
**Estimate:** \$448,750.84  
**Assessor Name:** Eduardo Lopez  
**Date Created:** 01/25/2013

**Notes:** Elevator was mostly used for ADA but it is out-of-service, with an expired permit and it is recommended to be replaced during next major renovation.

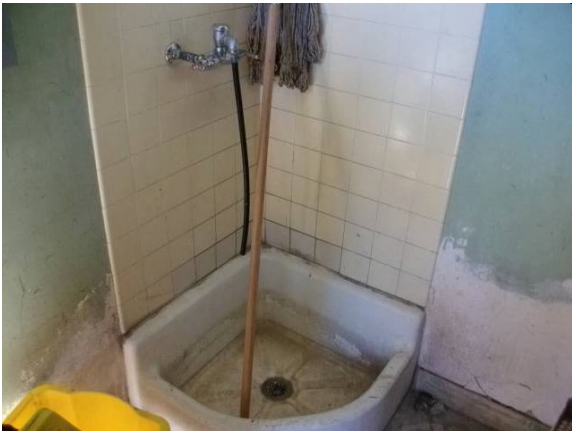
**Location:** Custodial Rooms, South end at both levels  
**Material:** Service/Utility Sink  
**Distress:** Beyond Expected Life  
**Category:** Capital Renewal  
**Priority:** 4 - Recommended (Years 6-10)  
**Correction:** Replace sink and fixtures  
**Qty:** 2-Ea.  
**Estimate:** \$6,595.29  
**Assessor Name:** Eduardo Lopez  
**Date Created:** 01/22/2013

**Notes:** Replace during next remodel or renovation.

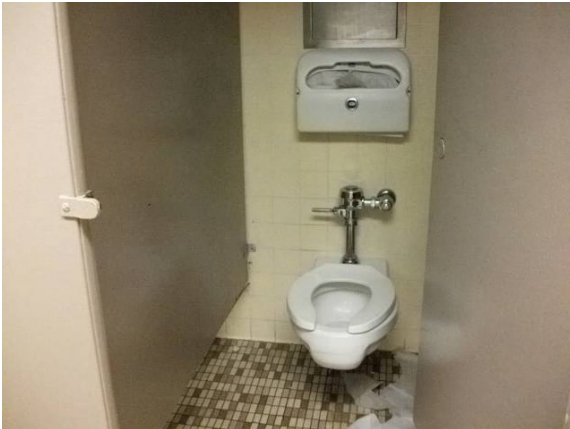
**Location:** Women and Men restrooms at ground level and Staff restrooms at both levels  
**Material:** Tankless Water Closet  
**Distress:** Beyond Expected Life  
**Category:** Capital Renewal  
**Priority:** 4 - Recommended (Years 6-10)  
**Correction:** Replace tankless water closet  
**Qty:** 10-Ea.  
**Estimate:** \$12,354.62  
**Assessor Name:** Eduardo Lopez  
**Date Created:** 01/22/2013

**Notes:** Replace during next remodel or renovation.

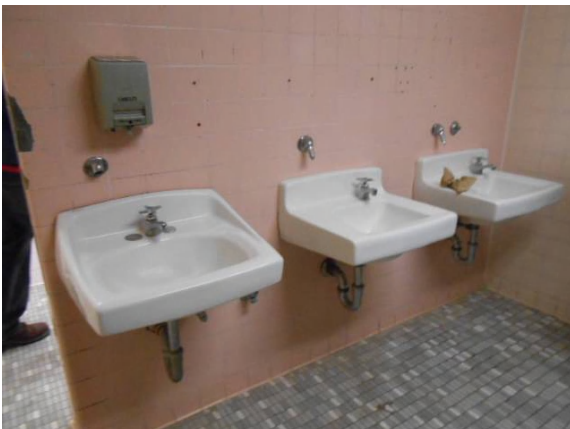
**Location:** Women and Men restrooms at ground level and Staff restrooms at both levels  
**Material:** Lavatory, Vitreous China  
**Distress:** Beyond Expected Life  
**Category:** Capital Renewal  
**Priority:** 4 - Recommended (Years 6-10)  
**Correction:** Replace lavatory, vitreous china  
**Qty:** 10-Ea.  
**Estimate:** \$10,749.89  
**Assessor Name:** Eduardo Lopez  
**Date Created:** 01/22/2013

Notes: Replace during next remodel or renovation.
