## Orange Unified School District

Facilities Condition Assessment for:

**El Modena High School**  
**3920 Spring Street**  
**Orange, CA 92869**

# Campus Report

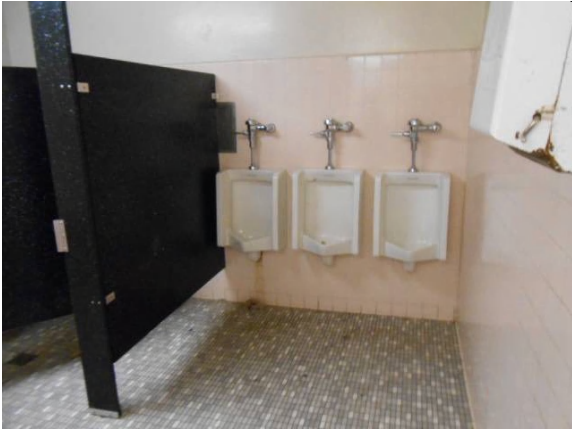
**Location:** Men restrooms, South end at ground level

**Material:** Urinal

Notes: Replace during next remodel or renovation.

**Correction:** Replace wall-hung urinal

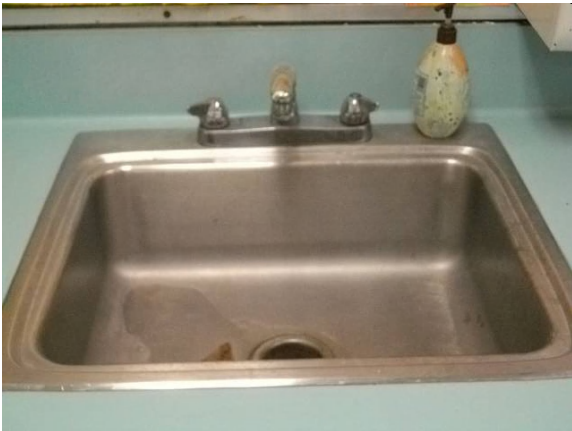
**Location:** Classrooms 501 & 506

**Material:** Sink, Stainless Steel

Notes: Sinks are mostly original and beyond expected life and it is recommended to be replaced during next remodel or renovation.

**Correction:** Replace sink, stainless steel

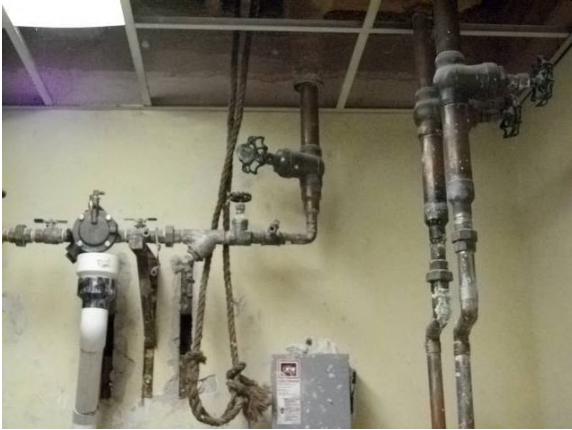
**Location:** Typical for entire building  
**Material:** System  
**Distress:** Beyond Service Life  
**Category:** Capital Renewal  
**Priority:** 4 - Recommended (Years 6-10)  
**Correction:** Renew System  
**Qty:** 1-Ea.  
**Estimate:** \$25,748.00  
**Assessor Name:** Eduardo Lopez  
**Date Created:** 01/24/2013

**Notes:** (2) Domestic hot water were replaced in 1992 & 2011; however it is recommended to replace the domestic water distribution system during next remodel or renovation.

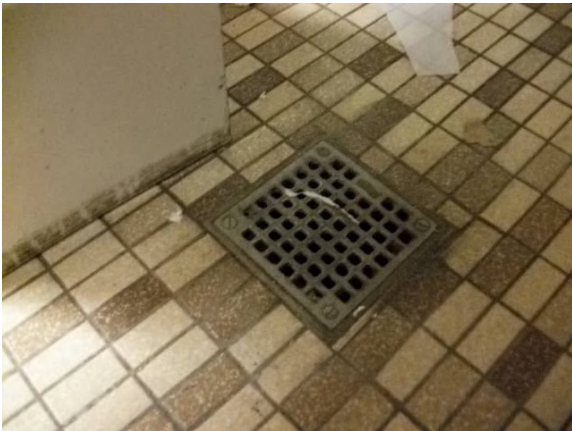
### System: D2030 - Sanitary Waste

**Location:** Typical for entire building  
**Material:** System  
**Distress:** Beyond Service Life  
**Category:** Capital Renewal  
**Priority:** 4 - Recommended (Years 6-10)  
**Correction:** Renew System  
**Qty:** 1-Ea.  
**Estimate:** \$87,543.20  
**Assessor Name:** Eduardo Lopez  
**Date Created:** 01/24/2013

**Notes:** The Sanitary Sewer is original and it is reported to be constantly clogged. Replace all above grade sanitary waste and vent piping during next remodel or renovation; below grade as needed.

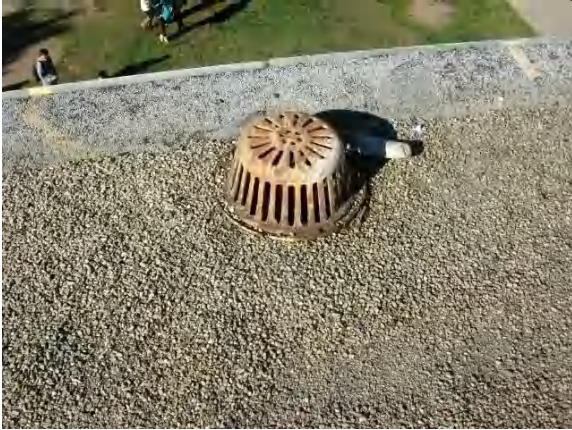
### System: D2040 - Rain Water Drainage

**Location:** Typical for entire building  
**Material:** System  
**Distress:** Beyond Service Life  
**Category:** Capital Renewal  
**Priority:** 4 - Recommended (Years 6-10)  
**Correction:** Renew System  
**Qty:** 1-Ea.  
**Estimate:** \$14,222.70  
**Assessor Name:** Eduardo Lopez  
**Date Created:** 01/24/2013

**Notes:** Replace system during next remodel or renovation.

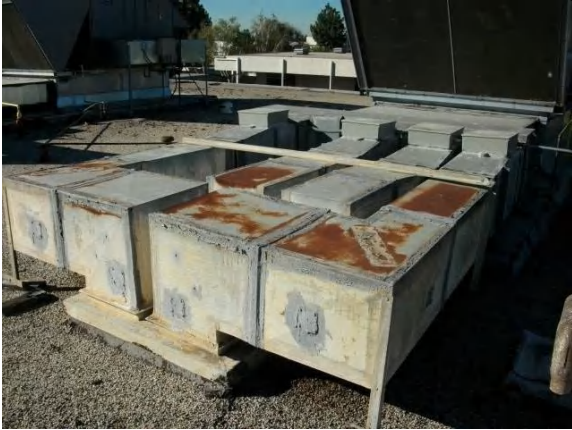
### System: D3040 - Distribution Systems

**Location:** Typical for entire building  
**Material:** System  
**Distress:** Beyond Service Life  
**Category:** Capital Renewal  
**Priority:** 4 - Recommended (Years 6-10)  
**Correction:** Renew System  
**Qty:** 1-Ea.  
**Estimate:** \$347,720.60  
**Assessor Name:** Eduardo Lopez  
**Date Created:** 01/24/2013

**Notes:** HVAC system was replaced in 2008, however the ductwork, ventilation diffusers/grilles and fresh air supply is recommended to be upgraded during the next major renovation.

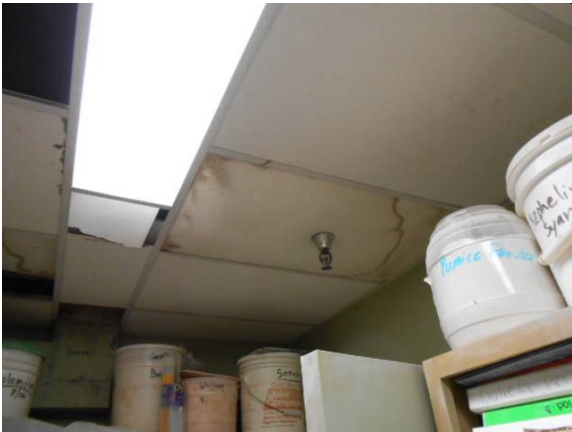
### System: D4010 - Sprinklers

**Location:** Typical for entire building  
**Material:** System  
**Distress:** Beyond Expected Life  
**Category:** Capital Renewal  
**Priority:** 5 - Codes or Standards Compliance  
**Correction:** Renew System  
**Qty:** 1-Ea.  
**Estimate:** \$118,440.80  
**Assessor Name:** Eduardo Lopez  
**Date Created:** 01/24/2013

**Notes:** Building is partially sprinklered, wet type fire sprinklers are currently located in the storage/electrical room and it's recommended to be added throughout building wide during next major renovation.

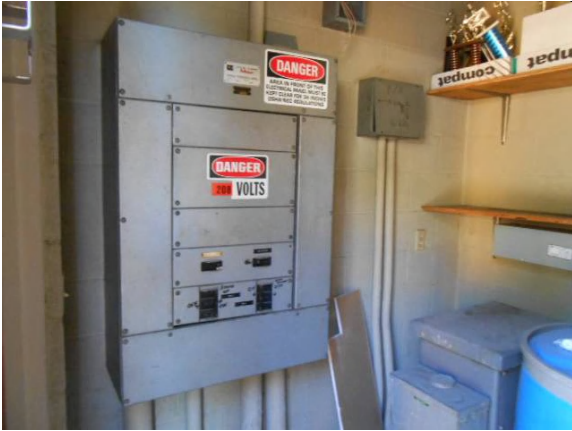
**System: D5010 - Electrical Service/Distribution**

**Location:** Typical for entire building  
**Material:** System  
**Distress:** Beyond Service Life  
**Category:** Capital Renewal  
**Priority:** 4 - Recommended (Years 6-10)  
**Correction:** Renew System  
**Qty:** 1-Ea.  
**Estimate:** \$130,456.53  
**Assessor Name:** Eduardo Lopez  
**Date Created:** 01/24/2013

**Notes:** The main electrical panels, distribution panel boards and feeders are mostly original to the building age. It is recommended to be replaced during the next major renovation.

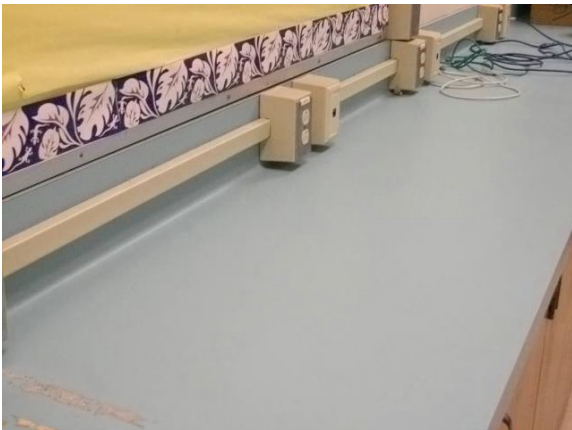
**System: D5020 - Branch Wiring**

**Location:** Typical for entire building  
**Material:** System  
**Distress:** Beyond Service Life  
**Category:** Capital Renewal  
**Priority:** 4 - Recommended (Years 6-10)  
**Correction:** Renew System  
**Qty:** 1-Ea.  
**Estimate:** \$449,731.72  
**Assessor Name:** Eduardo Lopez  
**Date Created:** 01/24/2013

**Notes:** The branch wiring, electrical panels and devices are mostly original to the building age. It is recommended to be replaced during the next major renovation.

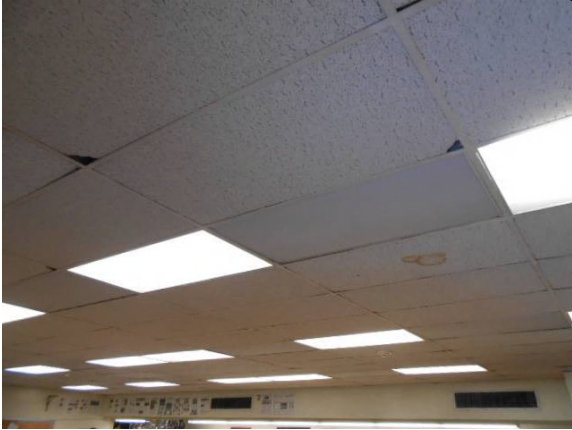
### System: D5020 - Lighting

**Location:** Classrooms at both levels and Prep-rooms from classroom 521, 522, 523 & 524 only

**Notes:** Light switches with motion sensor, T8 fluorescent lamps and ballasts were updated in 2006; however it is recommended to replace lighting fixtures and related wiring during next remodel or renovation.

**Correction:** Replace fixture fluorescent lighting fixture, 80 W

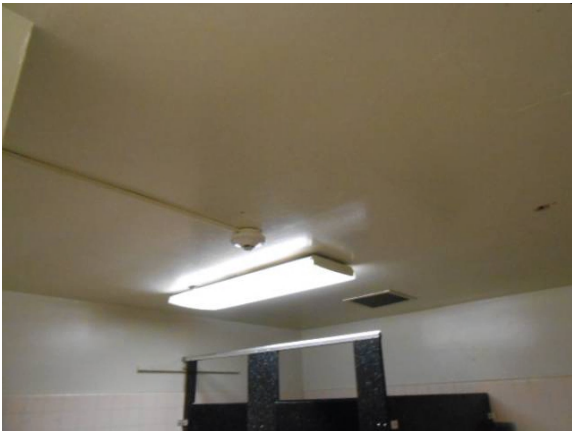
### System: D5020 - Lighting

**Location:** Men and Women restrooms at ground level, Prep-room from classroom 525 & 526 at second level and Custodial rooms from both levels

**Notes:** T8 fluorescent lamps and ballasts were updated in 2006; however light fixtures, switches and wiring are original to building age and it is recommended to be replaced during next remodel or renovation.

**Correction:** Replace fixture fluorescent lighting fixture, 80 W

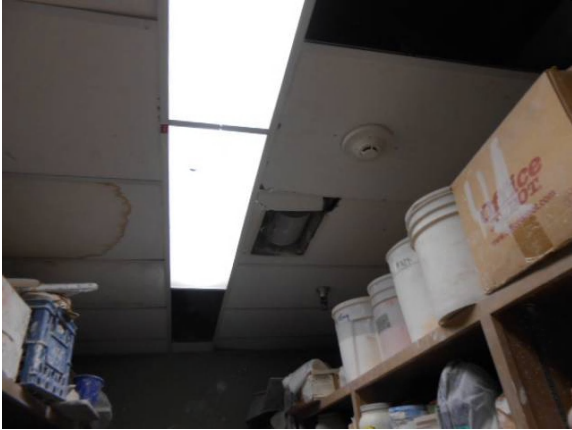
**System: D5020 - Lighting**

**Location:** Storage from classrooms 501, 502 & 503  
**Material:** Fluorescent Lighting Fixture, 80 W  
**Distress:** Beyond Expected Life  
**Category:** Capital Renewal  
**Priority:** 4 - Recommended (Years 6-10)  
**Correction:** Replace fixture fluorescent lighting fixture, 80 W  
**Qty:** 6-Ea.  
**Estimate:** \$2,757.02  
**Assessor Name:** Eduardo Lopez  
**Date Created:** 01/23/2013

**Notes:** T8 fluorescent lamps and ballasts were updated in 2006; however light fixtures, switches and wiring are original to building age and it is recommended to be replaced during next remodel or renovation.

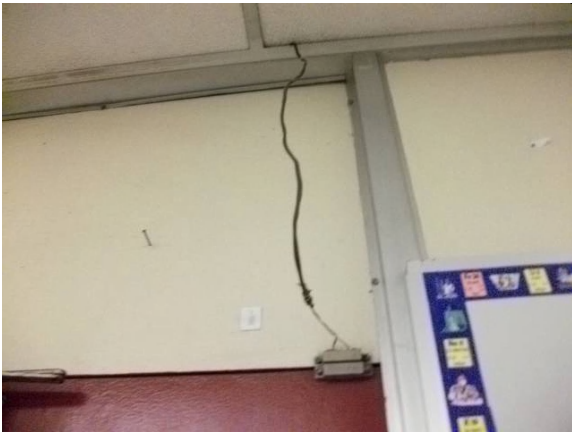
**System: D5030910 - Security System, Camers, Access Control**

**Location:** Typical for entire building  
**Material:** System  
**Distress:** Beyond Expected Life  
**Category:** Capital Renewal  
**Priority:** 4 - Recommended (Years 6-10)  
**Correction:** Renew System  
**Qty:** 1-Ea.  
**Estimate:** \$20,509.23  
**Assessor Name:** Eduardo Lopez  
**Date Created:** 01/27/2013

**Notes:** Security is needing upgrades. Recommend replacing and enhancing during the next building renovation.

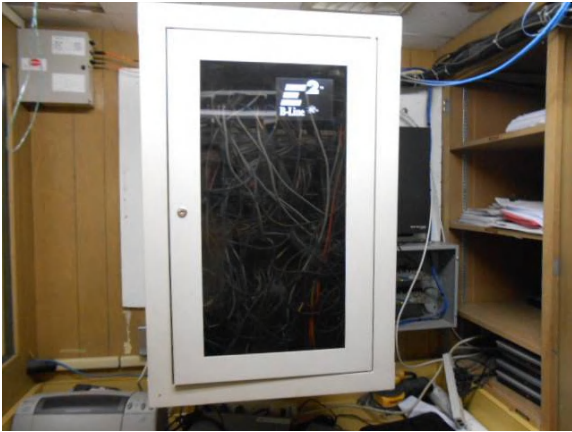
**System: D5030920 - LAN System**

**Location:** Typical for entire building  
**Material:** Lan System  
**Distress:** Inadequate  
**Category:** Capital Renewal  
**Priority:** 4 - Recommended (Years 6-10)  
**Correction:** Replace LAN System Drop CAT6  
**Qty:** 50-Ea.  
**Estimate:** \$19,617.48  
**Assessor Name:** Eduardo Lopez  
**Date Created:** 01/24/2013

**Notes:** Most of the existing LAN outlets will require new drops and it is recommended to be enhanced during the next major building renovation.

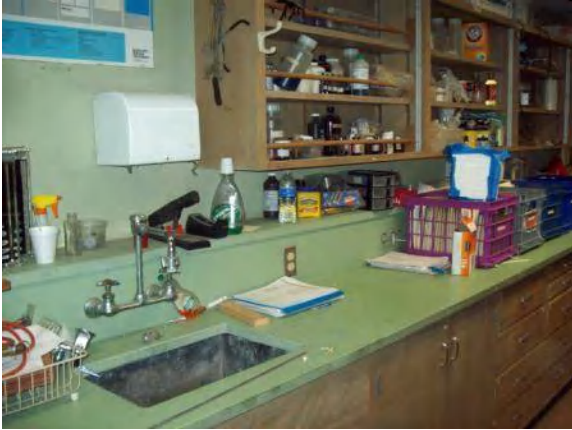
### System: E1020 - Institutional Equipment

**Location:** Second floor science classrooms and prep labs rms. 521, 522, 523, 524 and 526.

**Notes:** Science classroom/laboratory equipment is original and in poor condition.

**Correction:** Replace science laboratory fixed casework

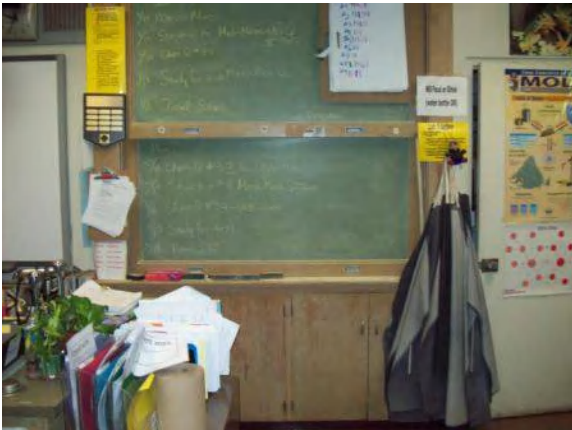
### System: E1020 - Institutional Equipment

**Location:** Classrooms

**Notes:** Existing marker and tackboards are typically worn and used. Three smartboards are installed in the building. Smartboards are recommended for all classrooms.

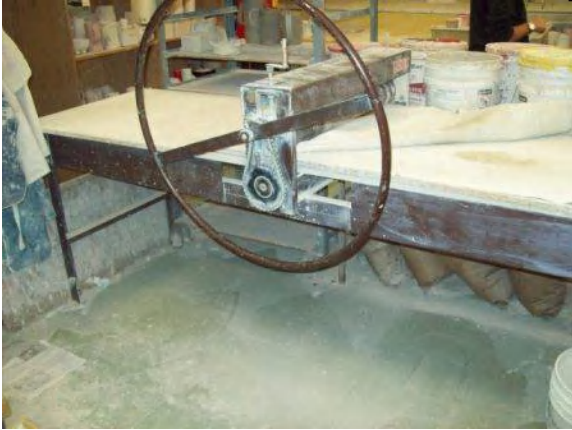
### System: E1090 - Other Equipment - Art

**Location:** Ceramics and art classrooms.  
**Material:** System  
**Distress:** Beyond Expected Life  
**Category:** Capital Renewal  
**Priority:** 3 - Necessary/Not Yet Critical (Years 2-5)  
**Correction:** Renew System  
**Qty:** 1-Ea.  
**Estimate:** \$29,426.28  
**Assessor Name:** Ann Buerger Linden  
**Date Created:** 01/28/2013

**Notes:** Kilns, potter wheels and other art department equipment is expired.

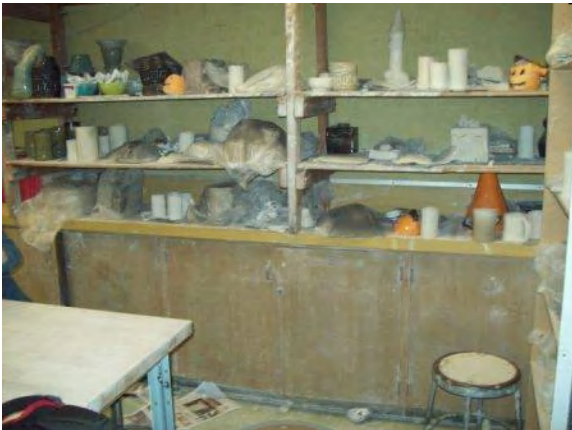
### System: E2010 - Fixed Furnishings

**Location:** Level 1 classrooms. Classroom 525.  
**Material:** Fixed Casework  
**Distress:** Beyond Expected Life  
**Category:** Capital Renewal  
**Priority:** 3 - Necessary/Not Yet Critical (Years 2-5)  
**Correction:** Replace Casework OUSD  
**Qty:** 250-L.F.  
**Estimate:** \$148,941.00  
**Assessor Name:** Ann Buerger Linden  
**Date Created:** 01/28/2013

**Notes:** All millwork and cabinetry in the building is original and in generally poor condition with peeling veneers, discoloration, chipping etc.

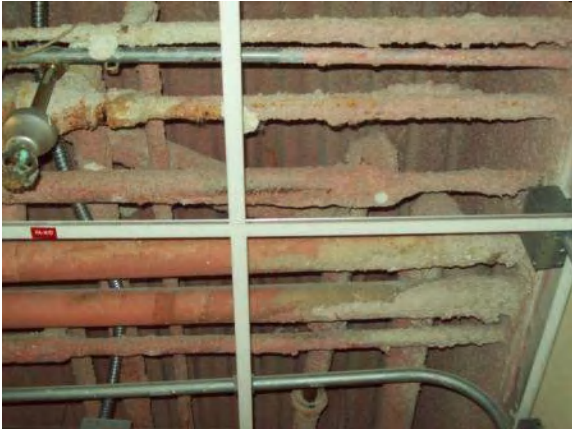
### **System: F2020 - Hazardous Components Abatement**

**Location:** Building wide in stucco soffit, window panels, fireproofing, pipe and duct insulation, floor tile, firedoor insulation, science classroom: tables counters; sinks;, and racks, plaster and drywall mud.

**Notes:** The AHERA six-month surveillance of asbestos-containing materials - Summer 2012, identifies significant quantities of ACM at this building. Complete abatement is recommended.

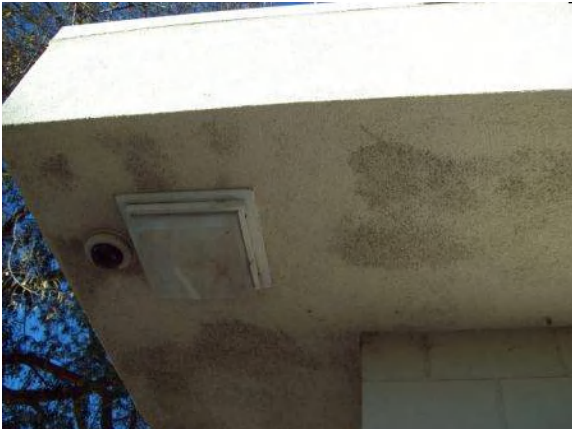
### System: B2010 - Exterior Walls

**Location:** Exterior soffits  
**Material:** Plaster Soffits  
**Distress:** Beyond Expected Life  
**Category:** Capital Renewal  
**Priority:** 3 - Necessary/Not Yet Critical (Years 2-5)  
**Correction:** Replace plaster soffits  
**Qty:** 1,350-S.F.  
**Estimate:** \$10,326.24  
**Assessor Name:** Ann Buerger Linden  
**Date Created:** 01/28/2013

**Notes:** Exterior soffit are cracked and water stained from roof leaks. Soffits are ACM.

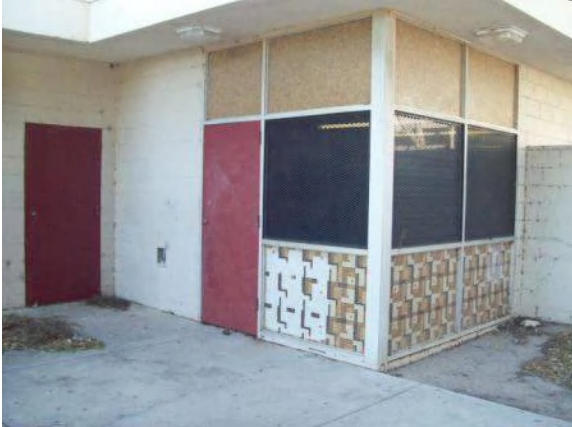
### System: B2020 - Exterior Windows

**Location:** Exterior windows.  
**Material:** System  
**Distress:** Beyond Expected Life  
**Category:** Capital Renewal  
**Priority:** 3 - Necessary/Not Yet Critical (Years 2-5)  
**Correction:** Renew System  
**Qty:** 1-Ea.  
**Estimate:** \$37,926.66  
**Assessor Name:** Eduardo Lopez  
**Date Created:** 01/21/2013

**Notes:** Quantity/area includes transom panels at doors, ceramic tile assembly above and below windows. Existing windows are typically single pane in aluminum frames. Glazing systems are failing. Tile panels are ACM per 2012 AHERA report.

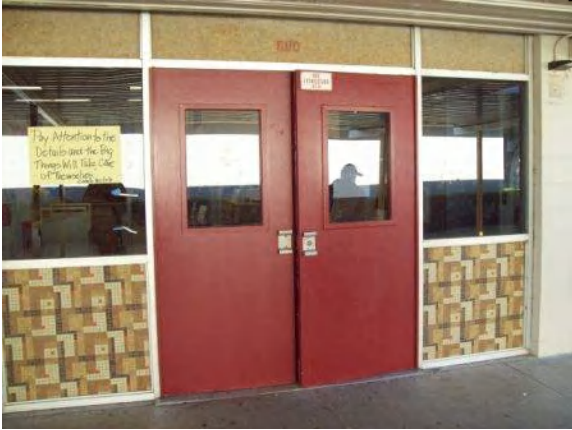
### System: B2030 - Exterior Doors

**Location:** Exterior doors.  
**Material:** System  
**Distress:** Beyond Expected Life  
**Category:** Capital Renewal  
**Priority:** 3 - Necessary/Not Yet Critical (Years 2-5)  
**Correction:** Renew System  
**Qty:** 1-Ea.  
**Estimate:** \$103,004.59  
**Assessor Name:** Eduardo Lopez  
**Date Created:** 01/21/2013

**Notes:** Doors, frames, and hardware are typically original and beyond their expected life. Maintenance costs are high. Addition of a handi-cap operator at the main entrance is recommended. Provide interior latching lever locksets at classrooms and student areas.

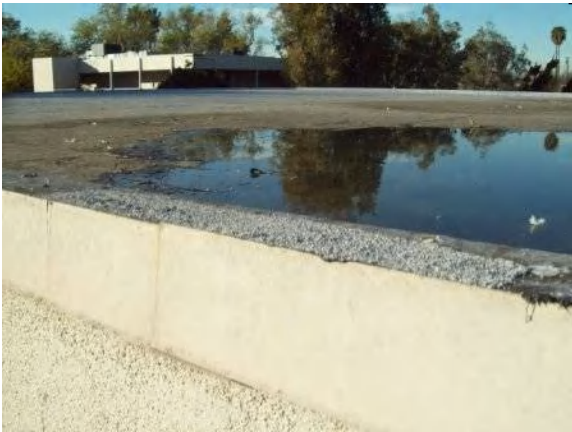
### System: B3010105 - Built-Up

**Location:** Roof  
**Material:** System  
**Distress:** Beyond Expected Life  
**Category:** Capital Renewal  
**Priority:** 3 - Necessary/Not Yet Critical (Years 2-5)  
**Correction:** Renew System  
**Qty:** 1-Ea.  
**Estimate:** \$212,403.00  
**Assessor Name:** Eduardo Lopez  
**Date Created:** 01/21/2013

**Notes:** Roof is expired. It crunches when you walk on it. There are areas of poinding and deteriorated membrane.

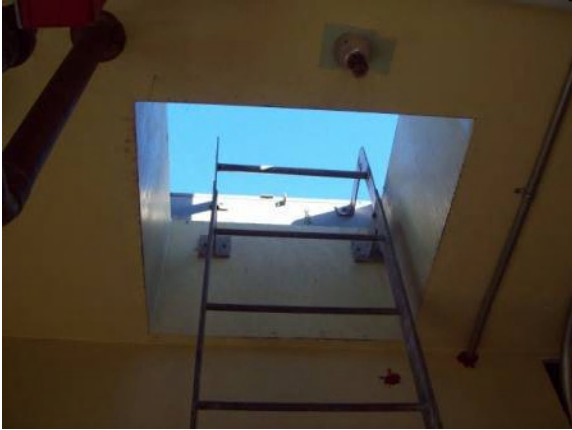
### System: B3020 - Roof Openings

**Location:** Access from janitor's closet.  
**Material:** System  
**Distress:** Beyond Expected Life  
**Category:** Capital Renewal  
**Priority:** 3 - Necessary/Not Yet Critical (Years 2-5)  
**Correction:** Renew System  
**Qty:** 1-Ea.  
**Estimate:** \$7,881.60  
**Assessor Name:** Eduardo Lopez  
**Date Created:** 01/21/2013

**Notes:** Roof hatch is beyond it's expected life. Ladder does not have code required extension.

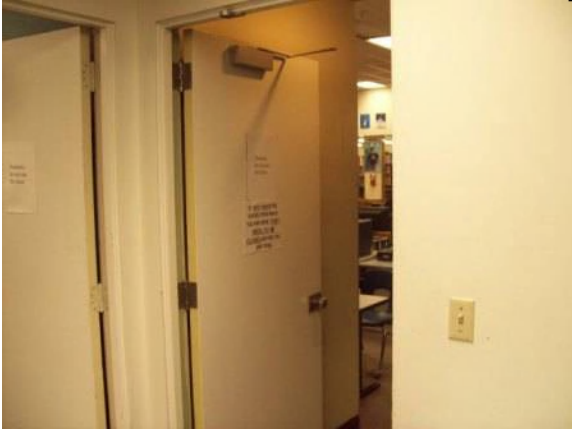
### System: C1020 - Interior Doors

**Location:** Building Systems  
**Material:** System  
**Distress:** Beyond Expected Life  
**Category:** Capital Renewal  
**Priority:** 3 - Necessary/Not Yet Critical (Years 2-5)  
**Correction:** Renew System  
**Qty:** 1-Ea.  
**Estimate:** \$35,125.31  
**Assessor Name:** Eduardo Lopez  
**Date Created:** 01/21/2013

**Notes:** Doors are beyond their expected life. Doors do not have lever latches. Replacement of interior doors and hardware is recommended.

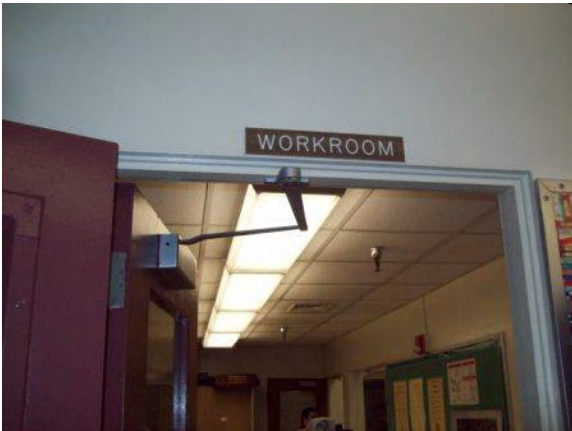
### System: C1030 - Fittings

**Location:** Entire building, typically at doors.  
**Material:** Signage  
**Distress:** Beyond Service Life  
**Category:** Capital Renewal  
**Priority:** 3 - Necessary/Not Yet Critical (Years 2-5)  
**Correction:** Replace/Install code compliant signage  
**Qty:** 7,299-S.F.  
**Estimate:** \$1,576.58  
**Assessor Name:** Ann Buerger Linden  
**Date Created:** 01/28/2013

**Notes:** Provide code compliant signage throughout the building.

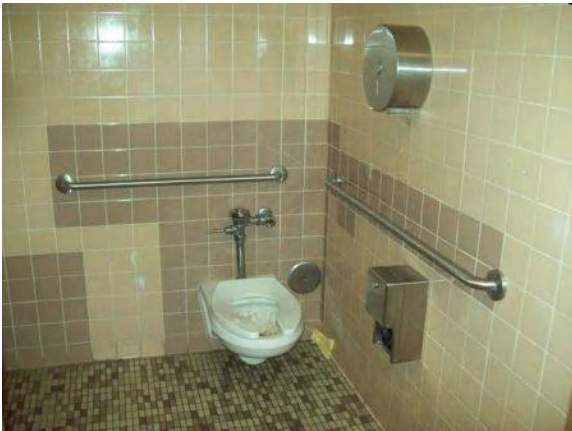
**System: C3010 - Wall Finishes**

**Location:** All interior walls.  
**Material:** System  
**Distress:** Beyond Expected Life  
**Category:** Capital Renewal  
**Priority:** 3 - Necessary/Not Yet Critical (Years 2-5)  
**Correction:** Renew System  
**Qty:** 1-Ea.  
**Estimate:** \$99,083.05  
**Assessor Name:** Eduardo Lopez  
**Date Created:** 01/21/2013

**Notes:** Wall finish system includes paint, vinyl all covering and ceramic tile.

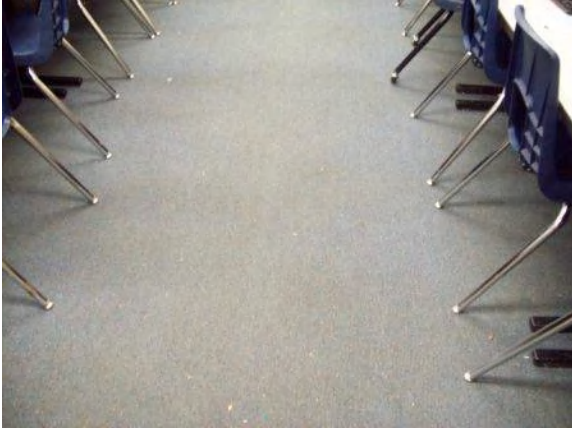
### System: C3020210 - Carpet

**Location:** Stacks area, reading room, multi-purpose room, office, computer room.

**Notes:** Carpet shows obvious wear and ter.

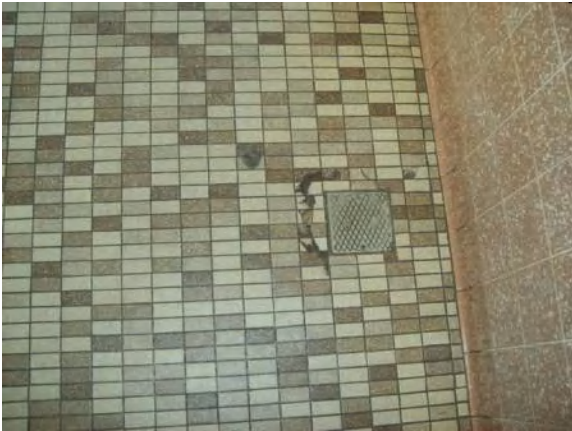
### System: C3020210 - Ceramic Tile

**Location:** Student and staff restroom floors.

**Notes:** Ceramic floor tile systems are expired.

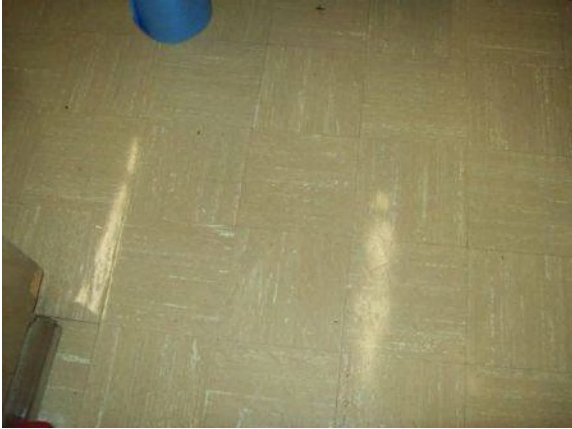
**System: C3020410 - VCT**

**Location:** Book storage, workroom, periodicals.  
**Material:** System  
**Distress:** Beyond Expected Life  
**Category:** Capital Renewal  
**Priority:** 3 - Necessary/Not Yet Critical (Years 2-5)  
**Correction:** Renew System  
**Qty:** 1-Ea.  
**Estimate:** \$9,580.03  
**Assessor Name:** Eduardo Lopez  
**Date Created:** 01/21/2013

**Notes:** 9" VAT is recommended for replacement.

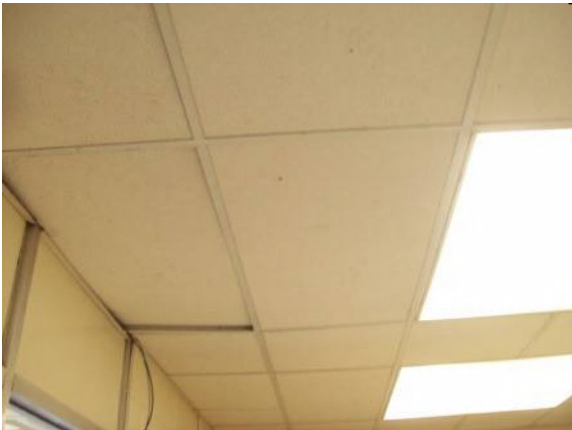
**Location:** Building wide.  
**Material:** System  
**Distress:** Beyond Expected Life  
**Category:** Capital Renewal  
**Priority:** 3 - Necessary/Not Yet Critical (Years 2-5)  
**Correction:** Renew System  
**Qty:** 1-Ea.  
**Estimate:** \$175,967.80  
**Assessor Name:** Eduardo Lopez  
**Date Created:** 01/21/2013

**Notes:** Typical ceilings are 2 x 4 lay-in acoustical systems. Hard lids are provided at restrooms. System replacement is recommended to facilitate general renovations and ACM abatement.

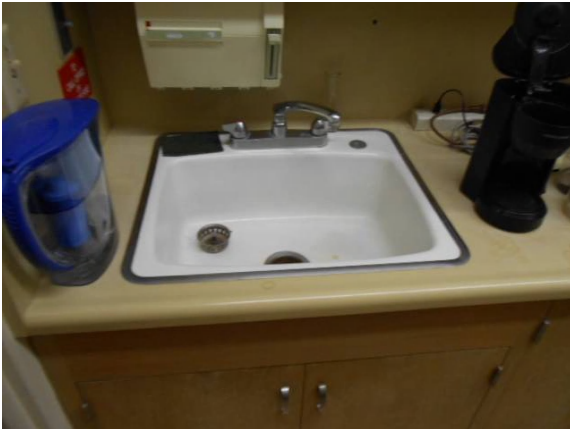
**Location:** Book Storage & Work Room  
**Material:** Sink, Stainless Steel  
**Distress:** Beyond Expected Life  
**Category:** Capital Renewal  
**Priority:** 4 - Recommended (Years 6-10)  
**Correction:** Replace sink, stainless steel  
**Qty:** 2-Ea.  
**Estimate:** \$3,020.28  
**Assessor Name:** Eduardo Lopez  
**Date Created:** 01/24/2013

**Notes:** Sinks are mostly original and beyond expected life and it is recommended to be replaced during next remodel or renovation.

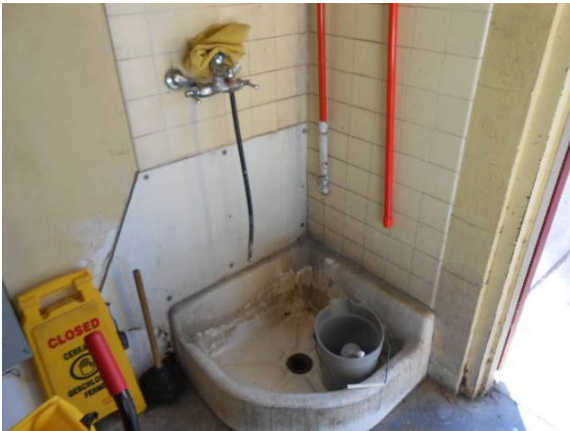
**Location:** Custodial Room  
**Material:** Service/Utility Sink  
**Distress:** Beyond Expected Life  
**Category:** Capital Renewal  
**Priority:** 4 - Recommended (Years 6-10)  
**Correction:** Replace sink and fixtures  
**Qty:** 1-Ea.  
**Estimate:** \$3,297.64  
**Assessor Name:** Eduardo Lopez  
**Date Created:** 01/22/2013

**Notes:** Replace during next remodel or renovation.

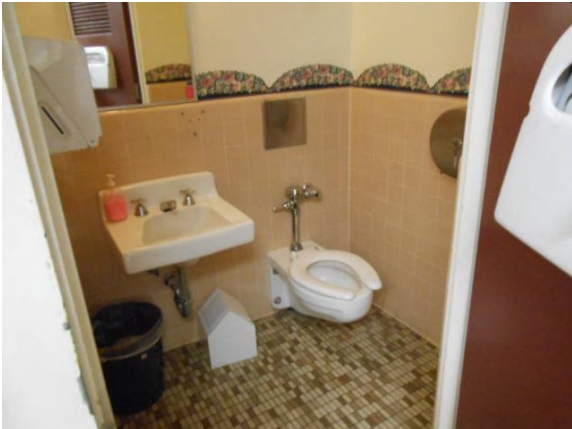
**Location:** Staff restroom  
**Material:** Lavatory, Vitreous China  
**Distress:** Beyond Expected Life  
**Category:** Capital Renewal  
**Priority:** 4 - Recommended (Years 6-10)  
**Correction:** Replace lavatory, vitreous china  
**Qty:** 1-Ea.  
**Estimate:** \$1,074.99  
**Assessor Name:** Eduardo Lopez  
**Date Created:** 01/22/2013

**Notes:** Replace during next remodel or renovation.

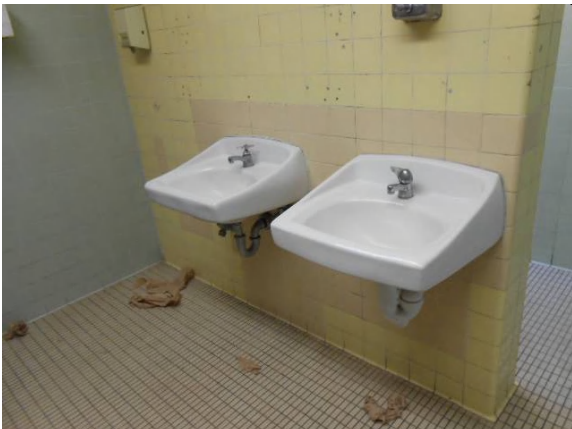
**Location:** Women and Men restrooms  
**Material:** Faucet  
**Distress:** Inadequate  
**Category:** Capital Renewal  
**Priority:** 4 - Recommended (Years 6-10)  
**Correction:** Replace lavatory faucet  
**Qty:** 4-Ea.  
**Estimate:** \$1,117.13  
**Assessor Name:** Eduardo Lopez  
**Date Created:** 01/25/2013

**Notes:** Sinks were replaced but not the faucets and it is recommended to be replaced during next remodel or renovation.

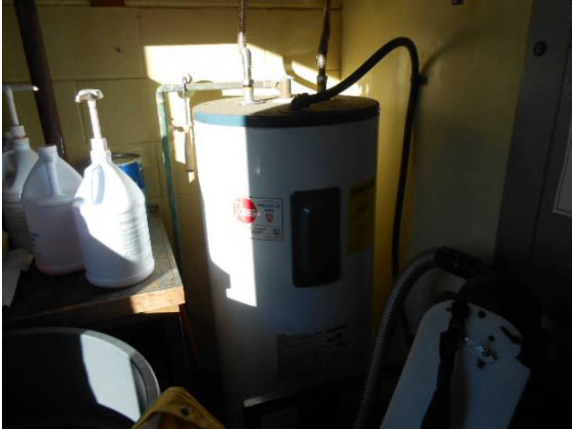
**Location:** Typical for entire building  
**Material:** System  
**Distress:** Beyond Service Life  
**Category:** Capital Renewal  
**Priority:** 4 - Recommended (Years 6-10)  
**Correction:** Renew System  
**Qty:** 1-Ea.  
**Estimate:** \$14,220.79  
**Assessor Name:** Eduardo Lopez  
**Date Created:** 01/24/2013

**Notes:** Domestic hot water was replaced in 2009; however it is recommended to replace the domestic water distribution system during next remodel or renovation.

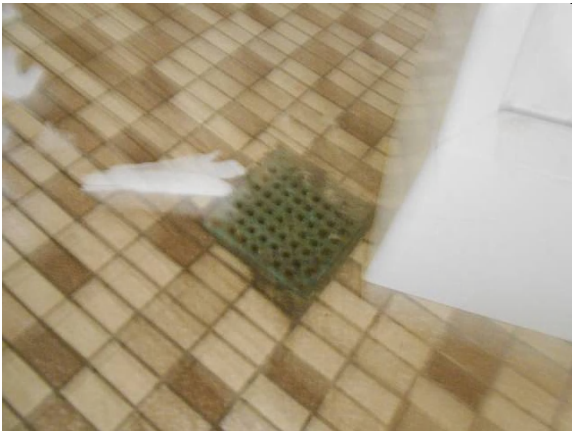
**Location:** Typical for entire building  
**Material:** System  
**Distress:** Beyond Service Life  
**Category:** Capital Renewal  
**Priority:** 4 - Recommended (Years 6-10)  
**Correction:** Renew System  
**Qty:** 1-Ea.  
**Estimate:** \$48,443.17  
**Assessor Name:** Eduardo Lopez  
**Date Created:** 01/24/2013

**Notes:** The Sanitary Sewer is original to the building age. Replace all above grade sanitary waste and vent piping during next remodel or renovation; below grade as needed.

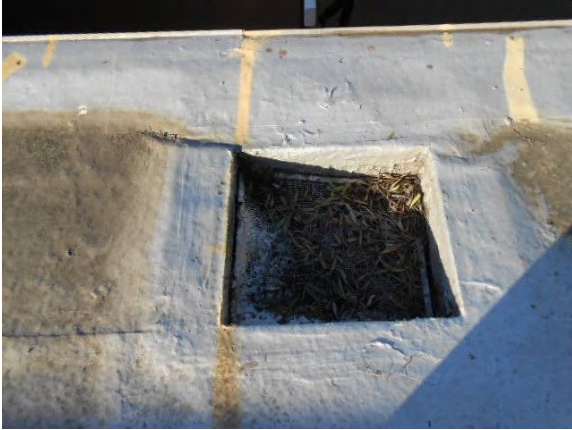
**Location:** Typical for entire building  
**Material:** System  
**Distress:** Beyond Service Life  
**Category:** Capital Renewal  
**Priority:** 4 - Recommended (Years 6-10)  
**Correction:** Renew System  
**Qty:** 1-Ea.  
**Estimate:** \$7,861.90  
**Assessor Name:** Eduardo Lopez  
**Date Created:** 01/24/2013

**Notes:** Replace system during next remodel or renovation.

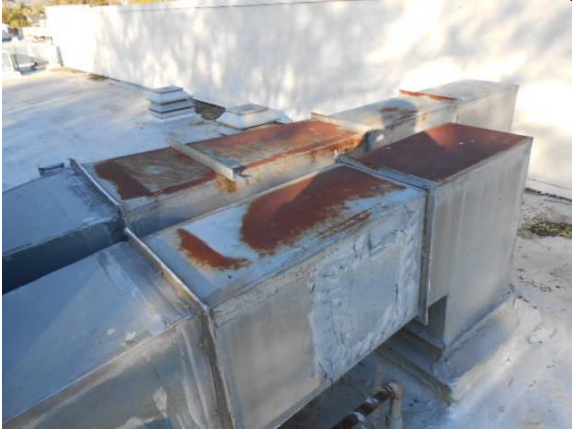
**Location:** Typical for entire building  
**Material:** System  
**Distress:** Beyond Service Life  
**Category:** Capital Renewal  
**Priority:** 4 - Recommended (Years 6-10)  
**Correction:** Renew System  
**Qty:** 1-Ea.  
**Estimate:** \$192,385.29  
**Assessor Name:** Eduardo Lopez  
**Date Created:** 01/24/2013

**Notes:** HVAC system was replaced in 2008, however the ductwork, ventilation diffusers/grilles and fresh air supply is recommended to be upgraded during the next major renovation.

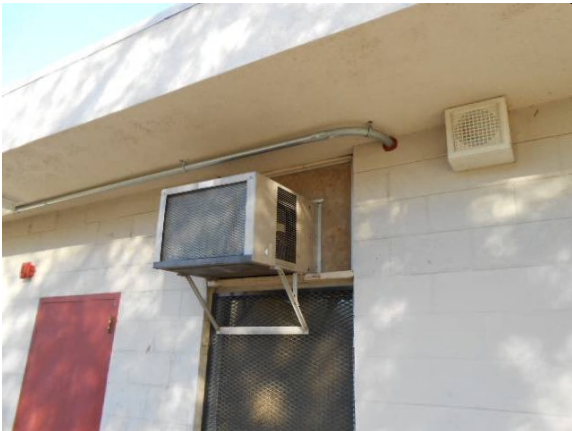
**Location:** Audio/Visual Storage  
**Material:** Air Conditioner, Window 1 Ton  
**Distress:** Damaged  
**Category:** Deferred Maintenance  
**Priority:** 2 - Potentially Critical (Year 1)  
**Correction:** Replace air conditioner, window, 1 ton  
**Qty:** 1-Ea.  
**Estimate:** \$1,494.50  
**Assessor Name:** Eduardo Lopez  
**Date Created:** 01/27/2013

**Notes:** Recommend replacing existing window A/C unit with additional or auxiliary A/C. Include cost for an evaluation by a PE for HVAC system in the next renovation project.

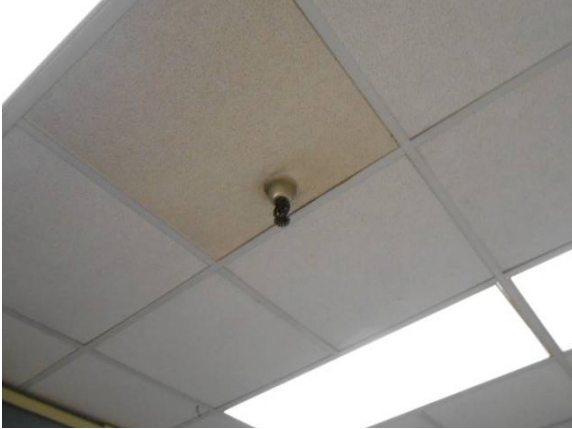
**Location:** Typical for entire building  
**Material:** System  
**Distress:** Beyond Expected Life  
**Category:** Capital Renewal  
**Priority:** 5 - Codes or Standards Compliance  
**Correction:** Renew System  
**Qty:** 1-Ea.  
**Estimate:** \$65,554.36  
**Assessor Name:** Eduardo Lopez  
**Date Created:** 01/24/2013

**Notes:** Building is partially sprinklered, wet type fire sprinklers are currently located in the storage/electrical room and it's recommended to be added throughout building wide during next major renovation.

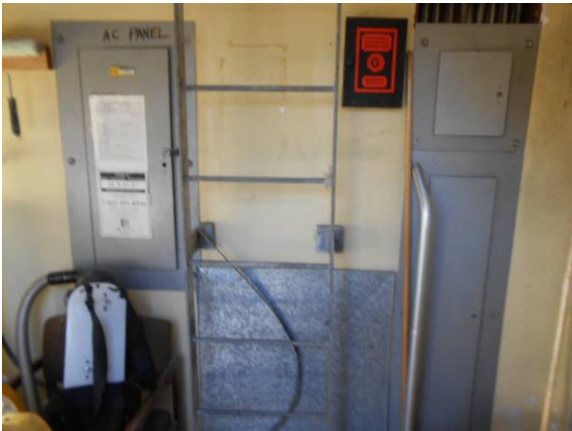
**Location:** Building Systems  
**Material:** System  
**Distress:** Beyond Service Life  
**Category:** Capital Renewal  
**Priority:** 3 - Necessary/Not Yet Critical (Years 2-5)  
**Correction:** Renew System  
**Qty:** 1-Ea.  
**Estimate:** \$72,144.48  
**Assessor Name:** Eduardo Lopez  
**Date Created:** 01/24/2013

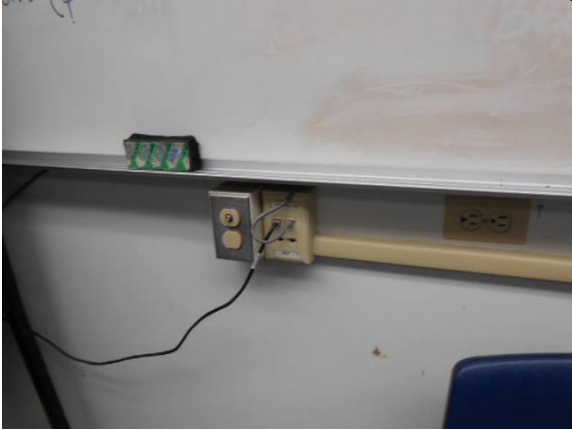
**Location:** Typical for entire building  
**Material:** System  
**Distress:** Beyond Service Life  
**Category:** Capital Renewal  
**Priority:** 4 - Recommended (Years 6-10)  
**Correction:** Renew System  
**Qty:** 1-Ea.  
**Estimate:** \$248,805.98  
**Assessor Name:** Eduardo Lopez  
**Date Created:** 01/24/2013

**Notes:** The branch wiring, electrical panels and devices are mostly original to the building age. It is recommended to be replaced during the next major renovation.

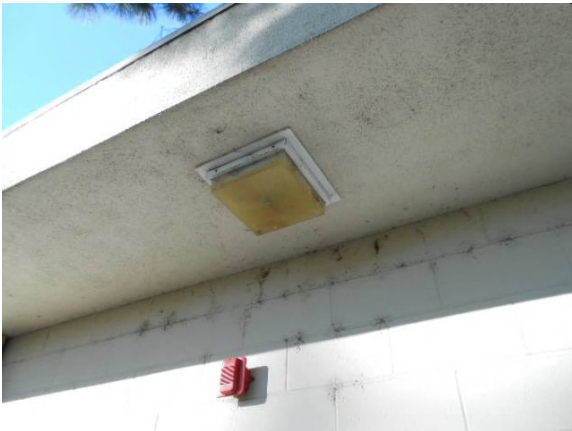
**Location:** Exterior Soffit Light  
**Material:** HP Sodium Fixture, 250 W  
**Distress:** Inadequate  
**Category:** Deferred Maintenance  
**Priority:** 1 - Currently Critical (Immediate)  
**Correction:** Replace fixture H.P. sodium fixture, 250 W  
**Qty:** 1-Ea.  
**Estimate:** \$2,138.57  
**Assessor Name:** Eduardo Lopez  
**Date Created:** 01/24/2013

**Notes:** There is water inside the refractor lens that has been filtering from the roof every time it rains. The Light fixture is not suitable to operate under these conditions. An engineering study by a PE is recommended prior replacement.

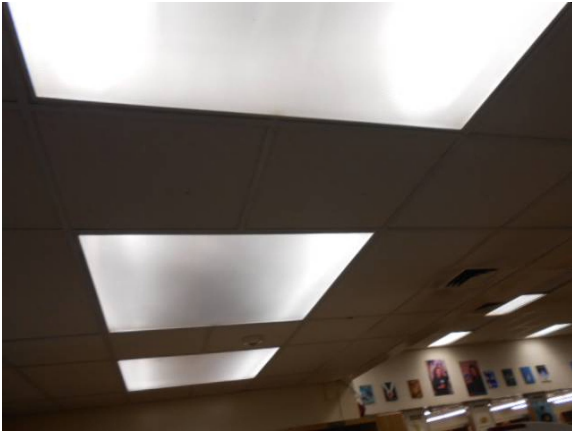
**Location:** Foyer  
**Material:** Fluorescent Lighting Fixture, 80 W  
**Distress:** Beyond Expected Life  
**Category:** Capital Renewal  
**Priority:** 4 - Recommended (Years 6-10)  
**Correction:** Replace fixture fluorescent lighting fixture, 80 W  
**Qty:** 3-Ea.  
**Estimate:** \$4,060.14  
**Assessor Name:** Eduardo Lopez  
**Date Created:** 01/25/2013

**Notes:** T8 fluorescent lamps and ballasts were updated in 2006; however it is recommended to replace lighting fixtures and related wiring during next remodel or renovation

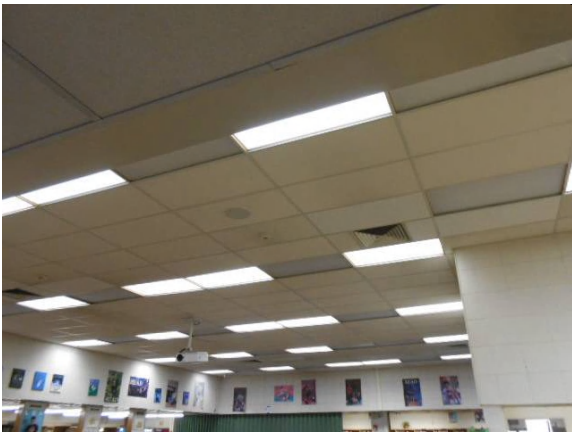
**Location:** Women & Men restroom, Multi-purpose room, Reading area, Video Lab and Audio/Visual Storage  
**Material:** Fluorescent Lighting Fixture, 80 W  
**Distress:** Beyond Expected Life  
**Category:** Capital Renewal  
**Priority:** 4 - Recommended (Years 6-10)  
**Correction:** Replace fixture fluorescent lighting fixture, 80 W  
**Qty:** 77-Ea.  
**Estimate:** \$39,194.81  
**Assessor Name:** Eduardo Lopez  
**Date Created:** 01/23/2013

**Notes:** Light switches with motion sensor, T8 fluorescent lamps and ballasts were updated in 2006; however it is recommended to replace lighting fixtures and related wiring during next remodel or renovation.

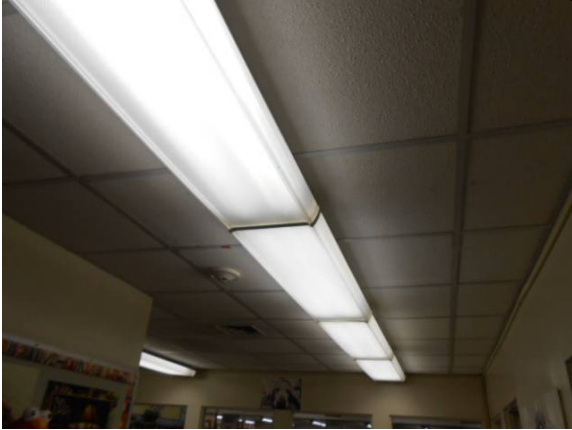
**Location:** Women & Men restroom, Main Office & Work Room

**Material:** Fluorescent Lighting Fixture, 80 W

**Notes:** T8 fluorescent lamps and ballasts were updated in 2006; however light fixtures, switches and wiring are original to building age and it is recommended to be replaced during next remodel or renovation.

**Correction:** Replace fixture fluorescent lighting fixture, 80 W

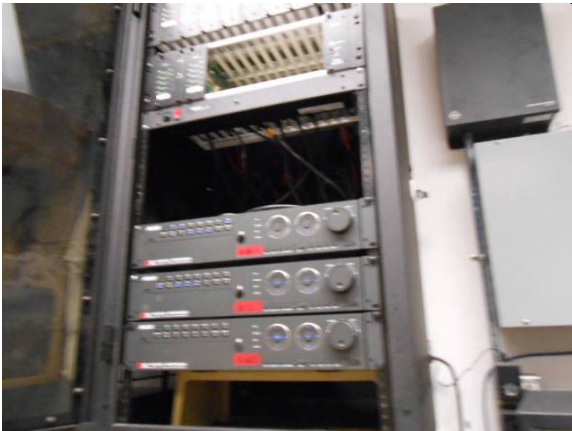
**Location:** Typical for entire building

**Notes:** Security Cameras are not being monitored local or remotely and it needs upgrades. Recommend replacing and enhancing during the next building renovation.

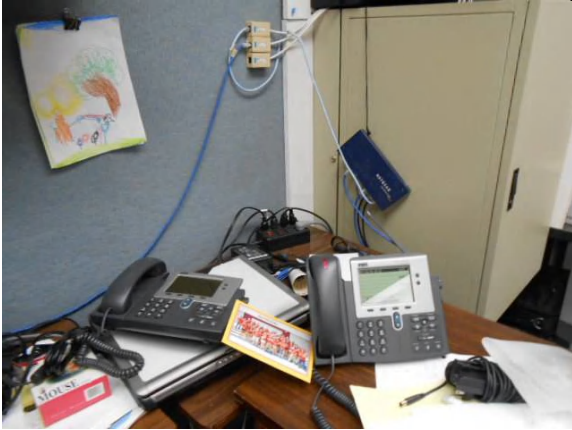
**Location:** Typical for entire building  
**Material:** Lan System  
**Distress:** Inadequate  
**Category:** Capital Renewal  
**Priority:** 4 - Recommended (Years 6-10)  
**Correction:** Replace LAN System Drop CAT6  
**Qty:** 50-Ea.  
**Estimate:** \$19,617.48  
**Assessor Name:** Eduardo Lopez  
**Date Created:** 01/24/2013

**Notes:** Most of the existing LAN outlets will require new drops and it is recommended to be enhanced during the next major building renovation.

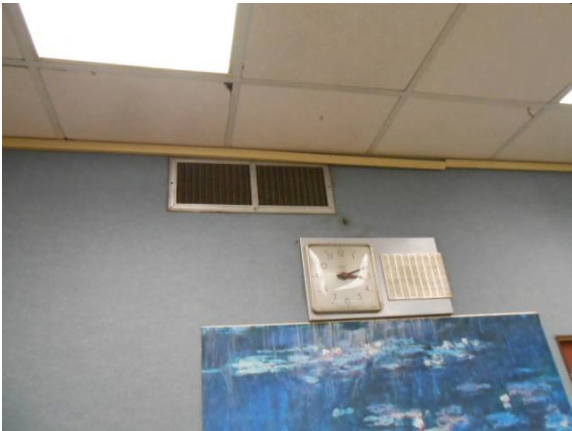
**Location:** Typical for entire building  
**Material:** System  
**Distress:** Beyond Expected Life  
**Category:** Capital Renewal  
**Priority:** 4 - Recommended (Years 6-10)  
**Correction:** Renew System  
**Qty:** 1-Ea.  
**Estimate:** \$11,351.40  
**Assessor Name:** Eduardo Lopez  
**Date Created:** 01/27/2013

**Notes:** Clock System is needing upgrades. Recommend replacing and enhancing during the next building renovation.

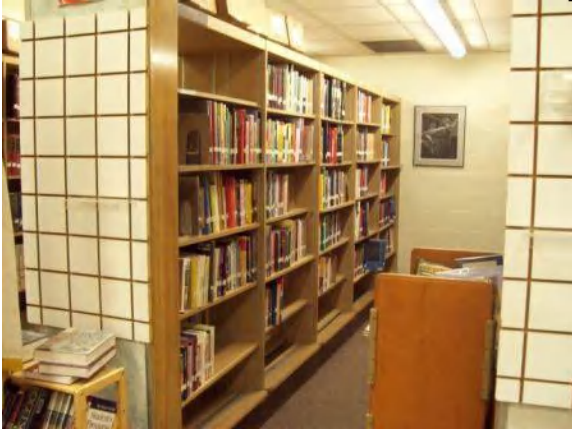
**Location:** Stacks, book storage, check-out desk.  
**Material:** Library Equipment  
**Distress:** Beyond Expected Life  
**Category:** Capital Renewal  
**Priority:** 3 - Necessary/Not Yet Critical (Years 2-5)  
**Correction:** Replace/add library equipment  
**Qty:** 100-L.F.  
**Estimate:** \$8,161.20  
**Assessor Name:** Ann Buerger Linden  
**Date Created:** 01/28/2013

**Notes:** Replace check-out desk. Provide seismic bracing at freestanding stacks.

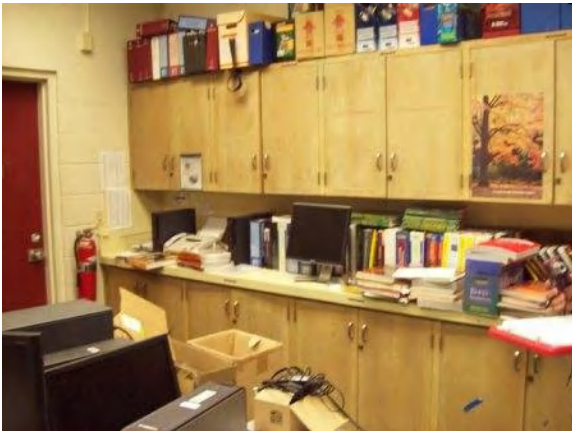
**Location:** Work room, audio visual storage, periodicals.  
**Material:** Fixed Casework  
**Distress:** Beyond Expected Life  
**Category:** Capital Renewal  
**Priority:** 3 - Necessary/Not Yet Critical (Years 2-5)  
**Correction:** Replace Casework OUSD  
**Qty:** 40-L.F.  
**Estimate:** \$21,010.03  
**Assessor Name:** Ann Buerger Linden  
**Date Created:** 01/28/2013

**Notes:** All millwork and cabinetry in the building is original and in generally poor condition.

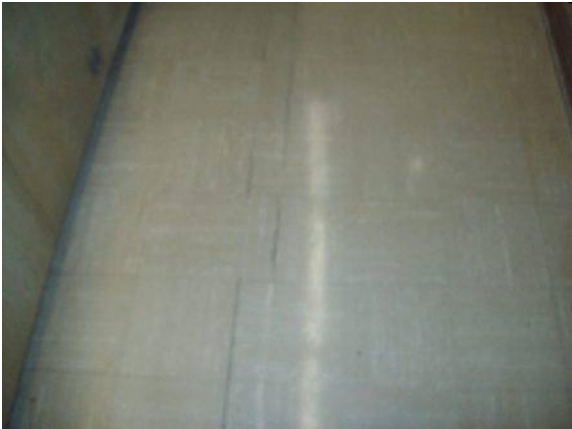
**Location:** Friable material above ceilings and fire door insulation. Non-friable material in exterior stucco soffits, above and below windows in transite panels, and 9" floor tiles.

**Material:** Removal of Hazardous Components

**Notes:** The AHERA six-month surveillance of asbestos-containing materials - Summer 2012, identifies ACM at this building. Complete abatement is recommended.

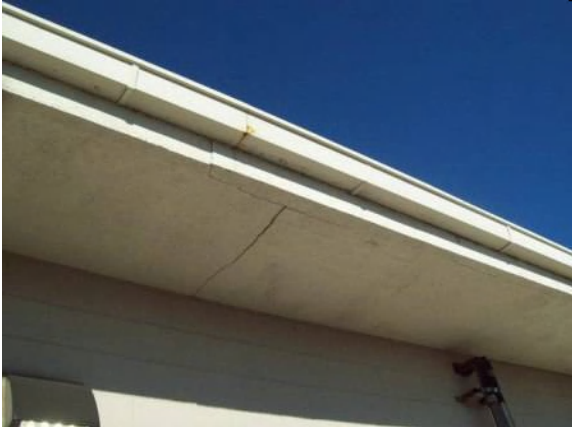
**Location:** Exterior soffits.  
**Material:** Plaster Soffits  
**Distress:** Beyond Expected Life  
**Category:** Capital Renewal  
**Priority:** 3 - Necessary/Not Yet Critical (Years 2-5)  
**Correction:** Replace plaster soffits  
**Qty:** 2,000-S.F.  
**Estimate:** \$13,648.32  
**Assessor Name:** Ann Buerger Linden  
**Date Created:** 01/28/2013

**Notes:** Exterior soffits are stained and cracking.

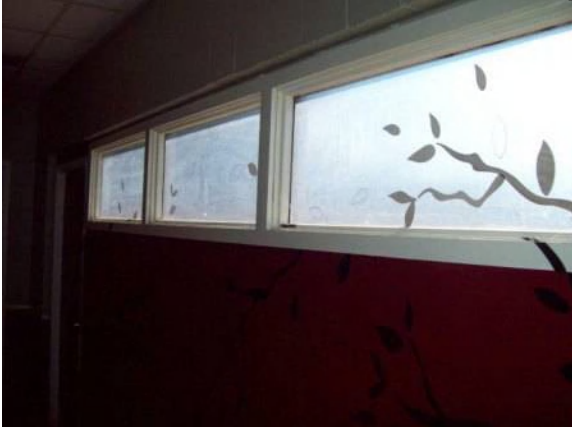
**Location:** Staff lounge and sandwich bar service windows.  
**Material:** System  
**Distress:** Beyond Expected Life  
**Category:** Capital Renewal  
**Priority:** 3 - Necessary/Not Yet Critical (Years 2-5)  
**Correction:** Renew System  
**Qty:** 1-Ea.  
**Estimate:** \$10,596.58  
**Assessor Name:** Eduardo Lopez  
**Date Created:** 01/21/2013

**Notes:** Windows are in poor condition.

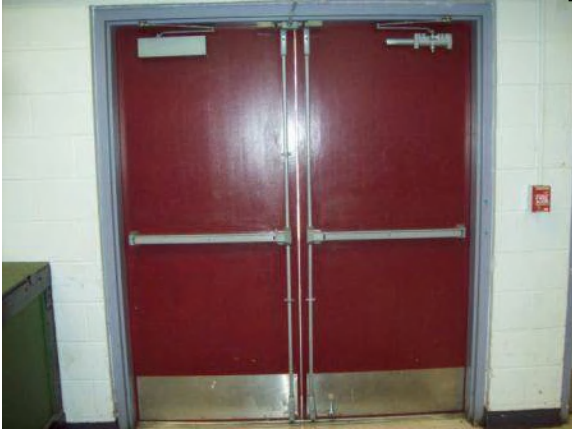
**Location:** Exterior doors. Includes Large rollin door to exterior amphiteater stage.

**Notes:** Doors are beyond their expected life. Stage doors are in poor condition.

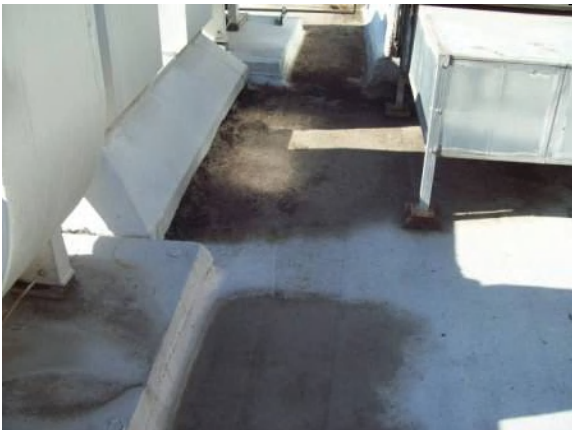
**Location:** Roofs

**Material:** Built-Up Roofing

**Distress:** Inadequate

**Notes:** Roof is not yet expired. Water stains on interior ceilings are assumed to be old. Visual inspection shows many areas of poor drainage with accumulation of debris. Removal of debris and close inspection is recommended. Also recommended is installtion of metal cap flashing at the top of the masonry wall at the east wall, south end.

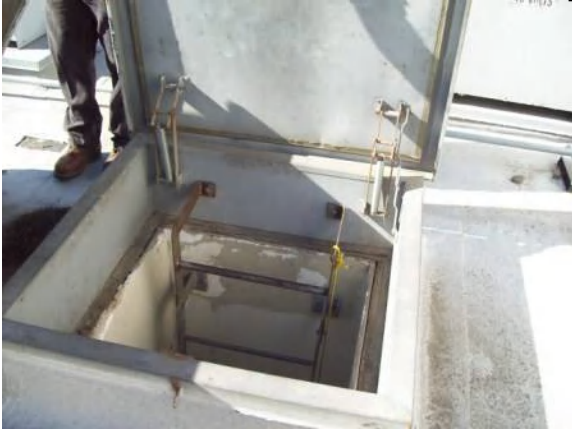
### System: B3020 - Roof Openings

**Location:** North and south roofs.

**Notes:** Roof hatches are beyond expected life. Ladders are not fully anchored. South hatch is installed so that the ladder faces the hinge side of the opening. Replacement with code compliant hatches is recommended.

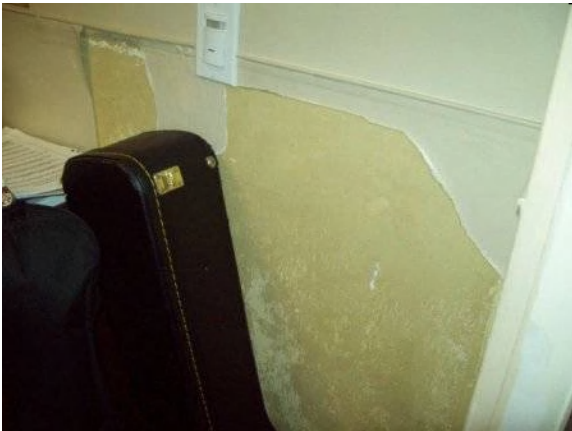
### System: C1010 - Partitions

**Location:** Building wide.

**Distress:** Damaged

**Notes:** Provide an allowance to make repairs to interior partitions due to related system work and existing water and impact damage. Repair/replace acoustical tile panels in multi-purpose room.

**Correction:** Allowance repair/remodel interior partitions  
OUSD

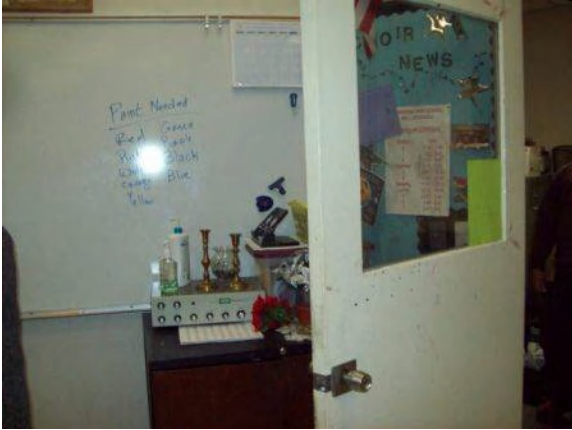
### System: C1020 - Interior Doors

**Location:** Building wide.  
**Material:** System  
**Distress:** Beyond Expected Life  
**Category:** Capital Renewal  
**Priority:** 3 - Necessary/Not Yet Critical (Years 2-5)  
**Correction:** Renew System  
**Qty:** 1-Ea.  
**Estimate:** \$130,102.71  
**Assessor Name:** Eduardo Lopez  
**Date Created:** 01/21/2013

**Notes:** Interior doors are typically original with failing hardware. Replacement of doors, frames, and hardware is recommended.
