## Orange Unified School District

Facilities Condition Assessment for:

**El Modena High School**  
**3920 Spring Street**  
**Orange, CA 92869**

# Campus Report

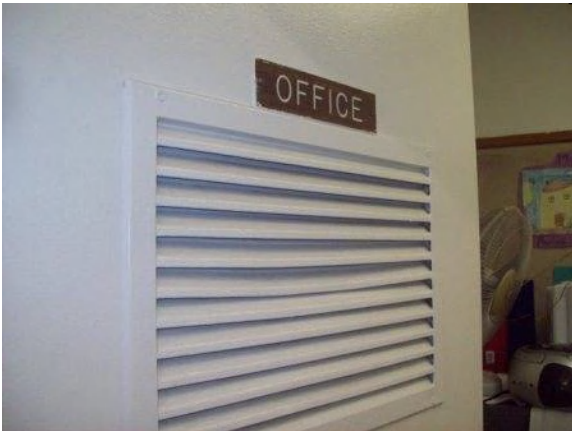
### System: C1030 - Fittings

**Location:** Building wide, particularly at doors.  
**Material:** Signage  
**Distress:** Beyond Expected Life  
**Category:** Capital Renewal  
**Priority:** 3 - Necessary/Not Yet Critical (Years 2-5)  
**Correction:** Replace/Install code compliant signage  
**Qty:** 15,204-S.F.  
**Estimate:** \$3,284.06  
**Assessor Name:** Ann Buerger Linden  
**Date Created:** 01/28/2013

**Notes:** Provide code compliant signage throughout the building.

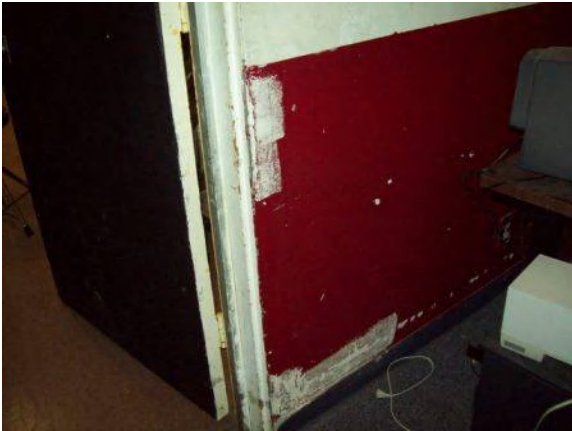
**System: C3010 - Wall Finishes**

**Location:** Kitchen, classrooms, back-of-house areas.  
**Material:** Wall Finishes  
**Distress:** Beyond Service Life  
**Category:** Capital Renewal  
**Priority:** 3 - Necessary/Not Yet Critical (Years 2-5)  
**Correction:** Refinish/Repaint  
**Qty:** 100,000-S.F.  
**Estimate:** \$60,480.00  
**Assessor Name:** Ann Buerger Linden  
**Date Created:** 02/04/2013

**Notes:** The multi-purpose room has been repainted. Student restrooms have been renovated. However other areas of the building will be affected by ACM abatement and other recommended system renewals. Provide an allowance to re-finish interior walls in the next renovation. This allowance will cover all wall finish types including paint, ceramic tile, and acoustical treatments.

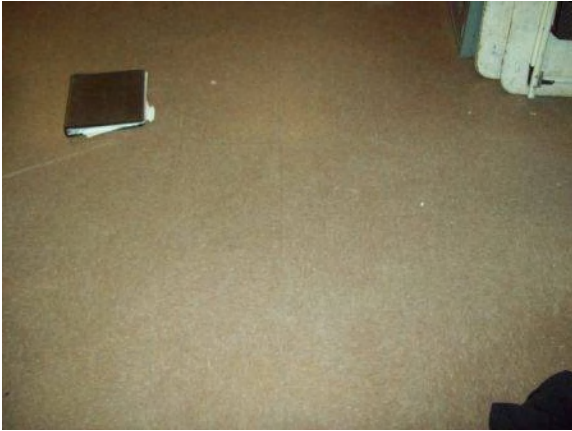
### System: C3020210 - Carpet

**Location:** Practice rooms.  
**Material:** System  
**Distress:** Beyond Expected Life  
**Category:** Capital Renewal  
**Priority:** 3 - Necessary/Not Yet Critical (Years 2-5)  
**Correction:** Renew System  
**Qty:** 1-Ea.  
**Estimate:** \$10,577.95  
**Assessor Name:** Eduardo Lopez  
**Date Created:** 01/21/2013

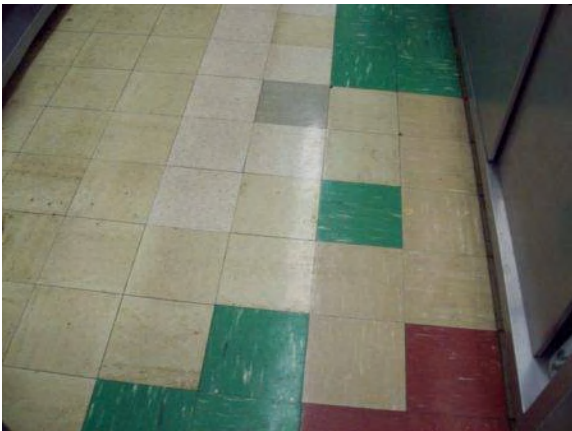
### System: C3020410 - VCT

**Location:** Band and choral rooms. Kitchen.  
**Material:** Vinyl  
**Distress:** Beyond Expected Life  
**Category:** Capital Renewal  
**Priority:** 3 - Necessary/Not Yet Critical (Years 2-5)  
**Correction:** Replace VCT Flooring and Resilient Base  
**Qty:** 5,000-S.F.  
**Estimate:** \$19,739.52  
**Assessor Name:** Ann Buerger Linden  
**Date Created:** 01/28/2013

**Notes:** VCT in band and choral rooms, and VAT in the kitchen are worn and failing. Replacement is recommended. The multi-purpose room and some ancilliary spaces appear to have been updated.

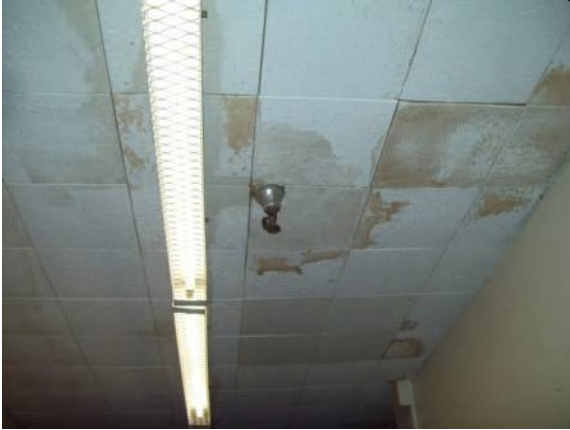
**System: C3030 - Ceiling Finishes**

**Location:** Band and choral rooms, practice, dressing, and storage rooms.

**Notes:** Although the main multi-purpose room has a new ceiling estimated at 2008, some areas of the building need ceiling replacements due to age and condition.

**Correction:** Replace acoustic tile ceiling, non fire-rated

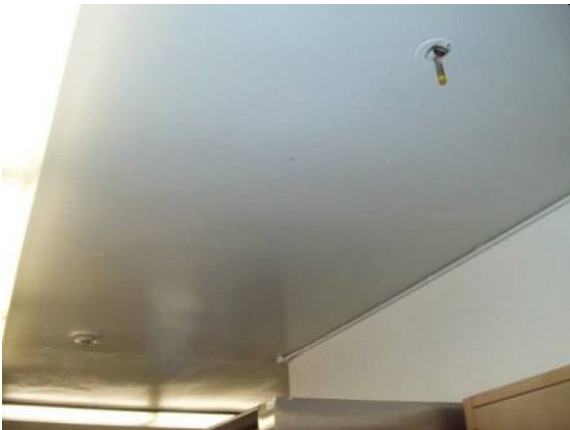
**System: C3030 - Ceiling Finishes**

**Location:** Kitchen and related spaces.

**Notes:** Although well maintained, the hard lid ceilings show signs of considerable repairs. Full replacement is recommended.

**Correction:** Replace sheetrock ceiling

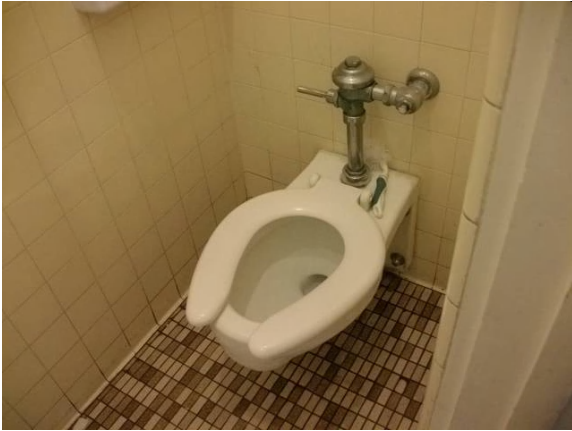
### System: D2010 - Plumbing Fixtures

**Location:** Kitchen Staff Toilet  
**Material:** Tankless Water Closet  
**Distress:** Beyond Expected Life  
**Category:** Capital Renewal  
**Priority:** 4 - Recommended (Years 6-10)  
**Correction:** Replace tankless water closet  
**Qty:** 1-Ea.  
**Estimate:** \$1,235.46  
**Assessor Name:** Eduardo Lopez  
**Date Created:** 01/22/2013

**Notes:** Water Closets were replaced in 2003 during last remodelation but this one. Replace during next remodel or renovation.

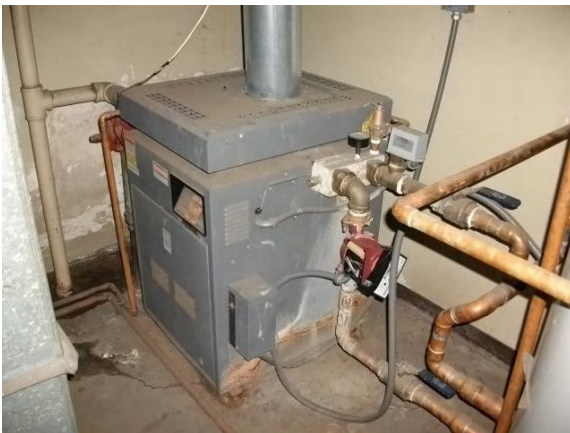
**System: D2020 - Domestic Water Distribution**

**Location:** Typical for entire building  
**Material:** System  
**Distress:** Beyond Service Life  
**Category:** Capital Renewal  
**Priority:** 4 - Recommended (Years 6-10)  
**Correction:** Renew System  
**Qty:** 1-Ea.  
**Estimate:** \$29,622.26  
**Assessor Name:** Eduardo Lopez  
**Date Created:** 01/24/2013

**Notes:** (2) Domestic hot water were replaced in 2006 & 2002 and a storage tank replaced in 2006; however it is recommended to replace the domestic water distribution system during next remodel or renovation.

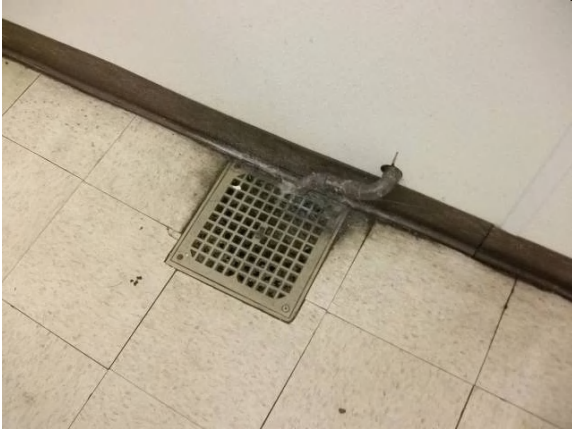
### System: D2030 - Sanitary Waste

**Location:** Typical for entire building  
**Material:** System  
**Distress:** Beyond Service Life  
**Category:** Capital Renewal  
**Priority:** 4 - Recommended (Years 6-10)  
**Correction:** Renew System  
**Qty:** 1-Ea.  
**Estimate:** \$100,908.34  
**Assessor Name:** Eduardo Lopez  
**Date Created:** 01/24/2013

**Notes:** Replace all above grade sanitary waste and vent piping during next remodel or renovation; below grade as needed.

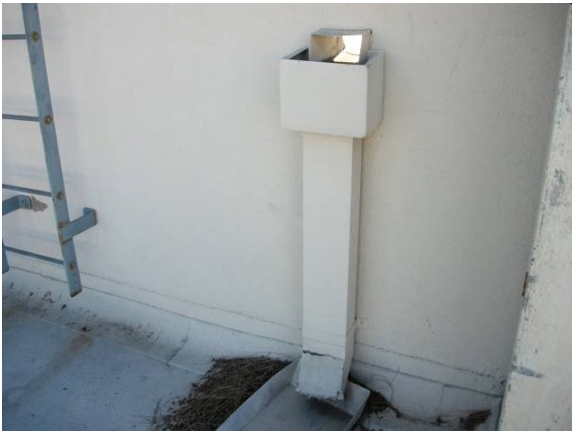
### System: D2040 - Rain Water Drainage

**Location:** Typical for entire building  
**Material:** System  
**Distress:** Beyond Service Life  
**Category:** Capital Renewal  
**Priority:** 4 - Recommended (Years 6-10)  
**Correction:** Renew System  
**Qty:** 1-Ea.  
**Estimate:** \$16,376.53  
**Assessor Name:** Eduardo Lopez  
**Date Created:** 01/24/2013

**Notes:** Replace system during next remodel or renovation.

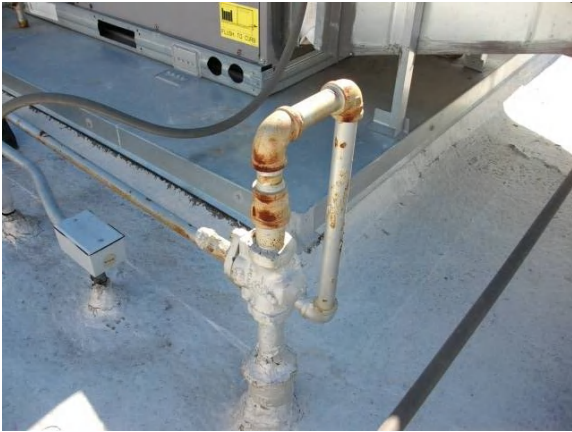
### System: D2090 - Other Plumbing Systems-Nat Gas

**Location:** Typical for entire building  
**Material:** System  
**Distress:** Beyond Service Life  
**Category:** Capital Renewal  
**Priority:** 4 - Recommended (Years 6-10)  
**Correction:** Renew System  
**Qty:** 1-Ea.  
**Estimate:** \$27,454.78  
**Assessor Name:** Eduardo Lopez  
**Date Created:** 01/24/2013

**Notes:** Natural Gas distribution is original to the building age. It is recommended to be replaced during the next major renovation.

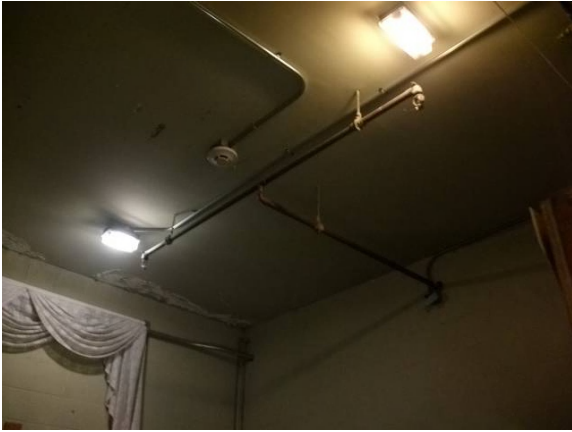
**System: D4010 - Sprinklers**

**Location:** Typical for entire building  
**Material:** System  
**Distress:** Beyond Expected Life  
**Category:** Capital Renewal  
**Priority:** 5 - Codes or Standards Compliance  
**Correction:** Renew System  
**Qty:** 1-Ea.  
**Estimate:** \$136,551.38  
**Assessor Name:** Eduardo Lopez  
**Date Created:** 01/24/2013

**Notes:** Building is partially sprinklered, wet type fire sprinklers are currently located in the storage/electrical room and it's recommended to be added throughout building wide during next major renovation.

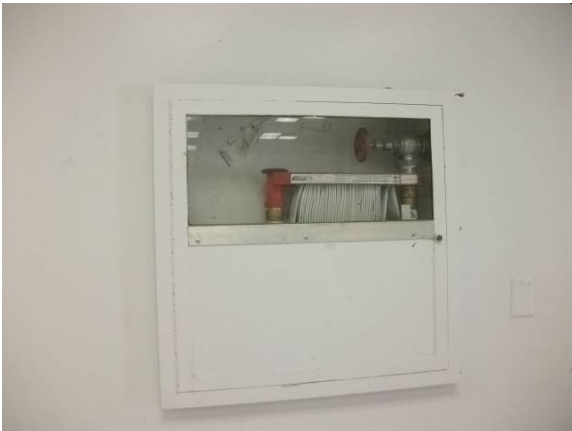
**System: D4020 - Standpipes**

**Location:** Typical for entire building  
**Material:** System  
**Distress:** Beyond Service Life  
**Category:** Capital Renewal  
**Priority:** 4 - Recommended (Years 6-10)  
**Correction:** Renew System  
**Qty:** 1-Ea.  
**Estimate:** \$12,282.40  
**Assessor Name:** Eduardo Lopez  
**Date Created:** 01/25/2013

**Notes:** Replace system during next remodel or renovation.

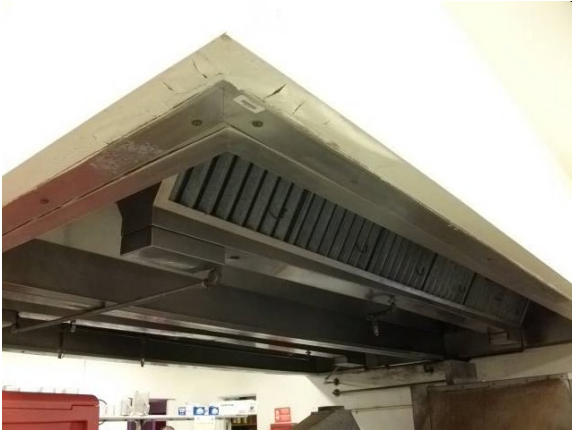
**System: D4090 - Other Fire Protection Systems**

**Location:** Kitchen  
**Material:** System  
**Distress:** Beyond Service Life  
**Category:** Capital Renewal  
**Priority:** 4 - Recommended (Years 6-10)  
**Correction:** Renew System  
**Qty:** 1-Ea.  
**Estimate:** \$39,737.17  
**Assessor Name:** Eduardo Lopez  
**Date Created:** 01/25/2013

**Notes:** Agent cylinder, control box and a manual pull station were replaced during 2003 renovation; However the system is original and it is recommended to be replaced during next renovation.

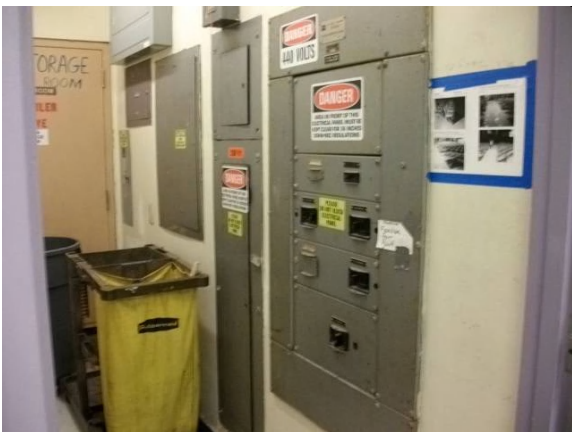
**System: D5010 - Electrical Service/Distribution**

**Location:** Typical for entire building  
**Material:** System  
**Distress:** Beyond Service Life  
**Category:** Capital Renewal  
**Priority:** 4 - Recommended (Years 6-10)  
**Correction:** Renew System  
**Qty:** 1-Ea.  
**Estimate:** \$150,278.77  
**Assessor Name:** Eduardo Lopez  
**Date Created:** 01/24/2013

**Notes:** The main electrical panels, distribution panel boards and feeders are mostly original to the building age. It is recommended to be replaced during the next major renovation.

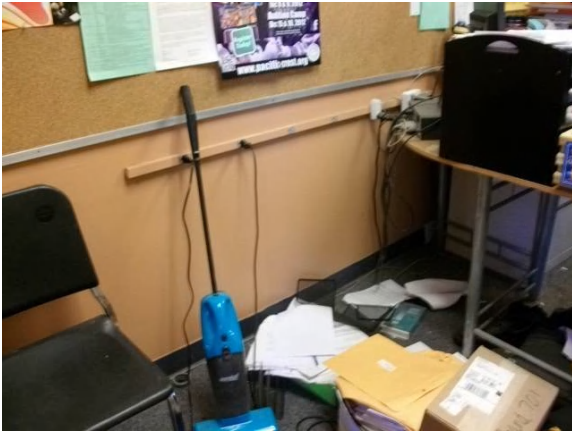
### System: D5020 - Branch Wiring

**Location:** Typical for entire building  
**Material:** System  
**Distress:** Beyond Service Life  
**Category:** Capital Renewal  
**Priority:** 4 - Recommended (Years 6-10)  
**Correction:** Renew System  
**Qty:** 1-Ea.  
**Estimate:** \$518,509.92  
**Assessor Name:** Eduardo Lopez  
**Date Created:** 01/24/2013

**Notes:** The branch wiring, electrical panels and devices are mostly original to the building age. It is recommended to be replaced during the next major renovation.

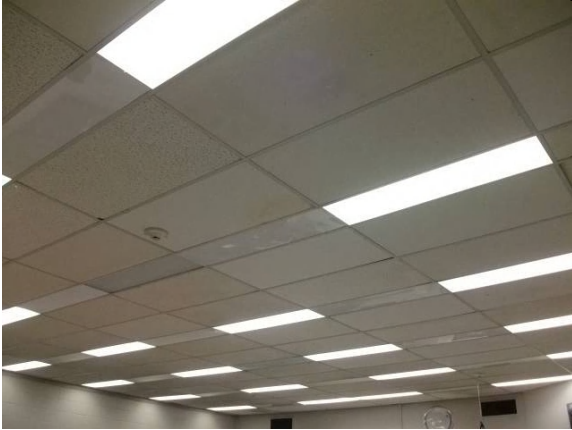
### System: D5020 - Lighting

**Location:** Staff Lounge Area, Classrooms 701 & 702  
**Material:** Fluorescent Lighting Fixture, 80 W  
**Distress:** Beyond Expected Life  
**Category:** Capital Renewal  
**Priority:** 4 - Recommended (Years 6-10)  
**Correction:** Replace fixture fluorescent lighting fixture, 80 W  
**Qty:** 70-Ea.  
**Estimate:** \$26,097.36  
**Assessor Name:** Eduardo Lopez  
**Date Created:** 01/23/2013

**Notes:** T8 fluorescent lamps and ballasts were updated in 2006; however light fixtures, switches and wiring are original to building age and it is recommended to be replaced during next remodel or renovation.

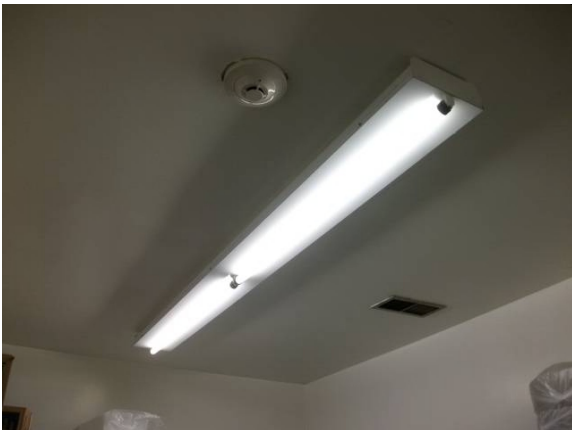
### System: D5020 - Lighting

**Location:** Boys and Girls dressing room 701, Custodial room, Kitchen Storage (3)  
**Material:** Fluorescent Lighting Fixture, 80 W  
**Distress:** Beyond Expected Life  
**Category:** Capital Renewal  
**Priority:** 4 - Recommended (Years 6-10)  
**Correction:** Replace fixture fluorescent lighting fixture, 80 W  
**Qty:** 22-Ea.  
**Estimate:** \$9,556.53  
**Assessor Name:** Eduardo Lopez  
**Date Created:** 01/24/2013

**Notes:** T8 fluorescent lamps and ballasts were updated in 2006; however light fixtures, switches and wiring are original to building age and it is recommended to be replaced during next remodel or renovation.

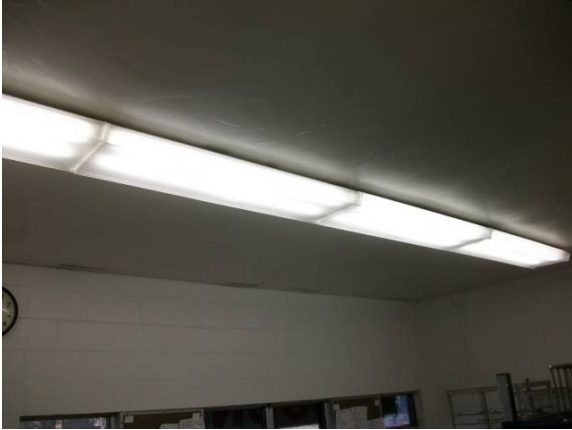
**System: D5020 - Lighting**

**Location:** Kitchen Area, Sandwith Bar and Kithcen Office  
**Material:** Fluorescent Lighting Fixture, 80 W  
**Distress:** Beyond Expected Life  
**Category:** Capital Renewal  
**Priority:** 4 - Recommended (Years 6-10)  
**Correction:** Replace fixture fluorescent lighting fixture, 80 W  
**Qty:** 35-Ea.  
**Estimate:** \$11,620.97  
**Assessor Name:** Eduardo Lopez  
**Date Created:** 01/24/2013

**Notes:** T8 fluorescent lamps and ballasts were updated in 2006; however light fixtures, switches and wiring are original to building age and it is recommended to be replaced during next remodel or renovation.

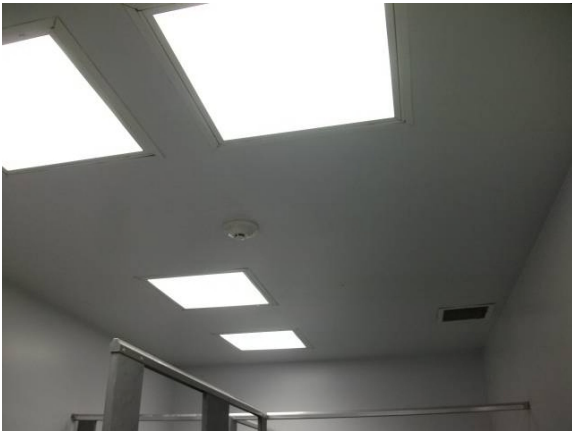
**System: D5020 - Lighting**

**Location:** Women and Men restrooms from Multi-purpose Room  
**Material:** Fluorescent Lighting Fixture, 80 W  
**Distress:** Beyond Expected Life  
**Category:** Capital Renewal  
**Priority:** 4 - Recommended (Years 6-10)  
**Correction:** Replace fixture fluorescent lighting fixture, 80 W  
**Qty:** 8-Ea.  
**Estimate:** \$2,849.44  
**Assessor Name:** Eduardo Lopez  
**Date Created:** 01/23/2013

**Notes:** Light switches with motion sensor, T8 fluorescent lamps and ballasts were updated in 2006; however it is recommended to replace lighting fixtures and related wiring during next remodel or renovation.

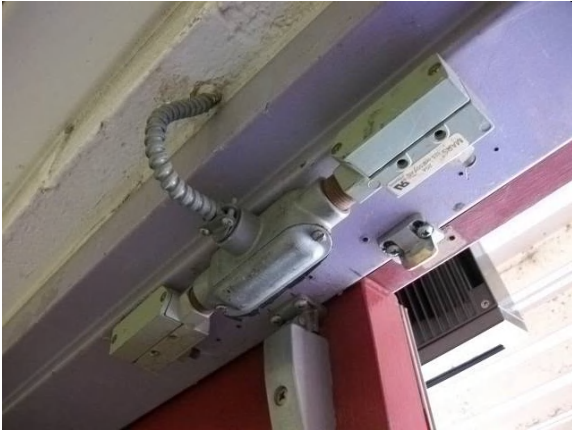
**System: D5030910 - Security System, Camers, Access Control**

**Location:** Typical for entire building  
**Material:** System  
**Distress:** Beyond Expected Life  
**Category:** Capital Renewal  
**Priority:** 4 - Recommended (Years 6-10)  
**Correction:** Renew System  
**Qty:** 1-Ea.  
**Estimate:** \$23,645.26  
**Assessor Name:** Eduardo Lopez  
**Date Created:** 01/27/2013

**Notes:** Security is needing upgrades. Recommend replacing and enhancing during the next building renovation.

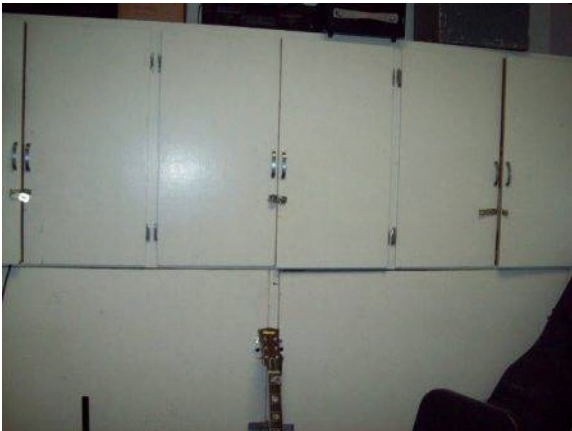
**System: E1020 - Institutional Equipment**

**Location:** Band and band storage rooms.  
**Material:** Instrumental Equipment  
**Distress:** Beyond Expected Life  
**Category:** Capital Renewal  
**Priority:** 3 - Necessary/Not Yet Critical (Years 2-5)  
**Correction:** Replace instrument storage.  
**Qty:** 1-Job  
**Estimate:** \$17,625.60  
**Assessor Name:** Ann Buerger Linden  
**Date Created:** 01/28/2013

**Notes:** Existing storage is beat up.

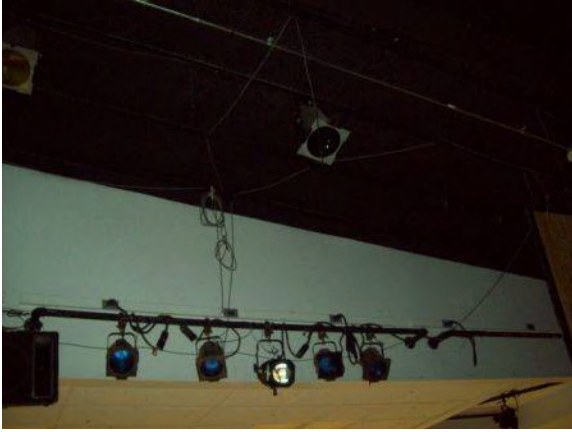
### System: E1020 - Institutional Equipment - theater

**Location:** Multi-purpose room stage.  
**Material:** System  
**Distress:** Beyond Expected Life  
**Category:** Capital Renewal  
**Priority:** 3 - Necessary/Not Yet Critical (Years 2-5)  
**Correction:** Renew System  
**Qty:** 1-Ea.  
**Estimate:** \$93,691.75  
**Assessor Name:** Ann Buerger Linden  
**Date Created:** 02/04/2013

**Notes:** Renew theater equipment system including lighting, sound, curtains, etc.

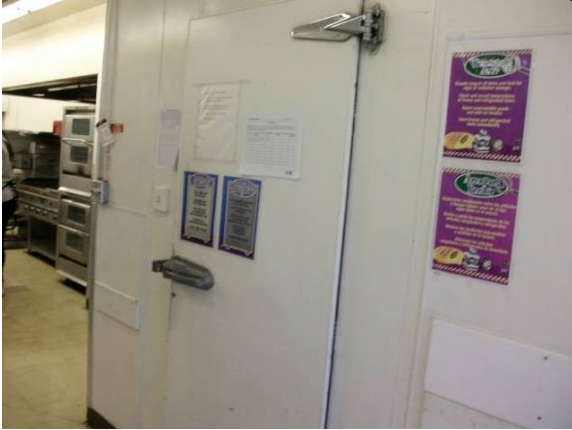
### System: E1090360 - Walk-in Cooler/Freezer

**Location:** Kitchen  
**Material:** System  
**Distress:** Beyond Service Life  
**Category:** Capital Renewal  
**Priority:** 4 - Recommended (Years 6-10)  
**Correction:** Renew System  
**Qty:** 1-Ea.  
**Estimate:** \$83,135.57  
**Assessor Name:** Eduardo Lopez  
**Date Created:** 01/25/2013

**Notes:** Kitchen Walk-in Cooler/Freezer is original since 1965 and is beyond expected life. It is recommended to be scheduled for replacement during next remodel or renovation.

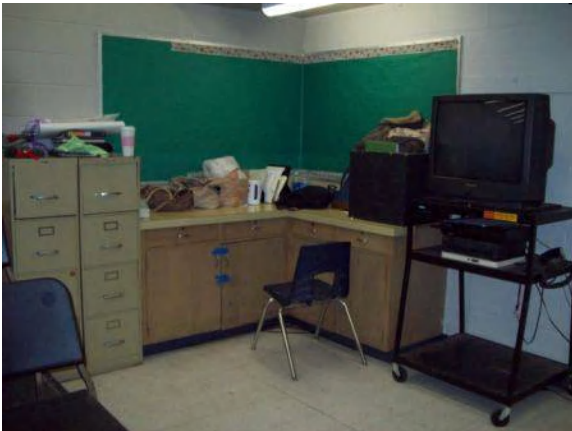
**Location:** Choral room.  
**Material:** Fixed Casework  
**Distress:** Beyond Expected Life  
**Category:** Capital Renewal  
**Priority:** 3 - Necessary/Not Yet Critical (Years 2-5)  
**Correction:** Replace Casework OUSD  
**Qty:** 16-L.F.  
**Estimate:** \$7,275.80  
**Assessor Name:** Ann Buerger Linden  
**Date Created:** 01/28/2013

**Notes:** Renew expired casework systems.

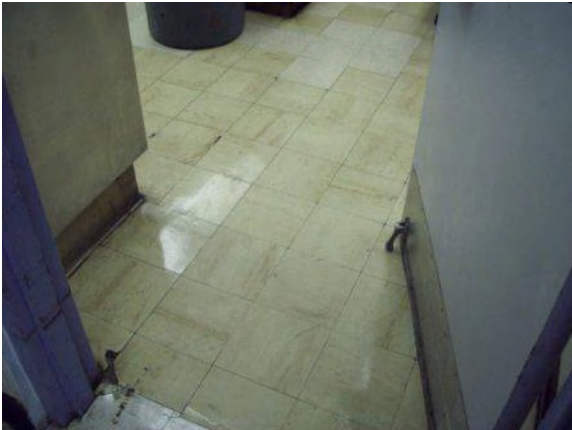
**Location:** Friable material in pipe insulation, kitchen oven, spotlight wire insulation. Non-friable in interior plaster and 9" VAT  
**Material:** Removal of Hazardous Components  
**Distress:** Beyond Expected Life  
**Category:** Capital Renewal  
**Priority:** 3 - Necessary/Not Yet Critical (Years 2-5)  
**Correction:** Abate all ACM in building  
**Qty:** 15,204-S.F.  
**Estimate:** \$133,989.81  
**Assessor Name:** Ann Buerger Linden  
**Date Created:** 01/28/2013

**Notes:** The AHERA six-month surveillance of asbestos-containing materials - Summer 2012, identifies ACM at this building. Complete abatement is recommended.

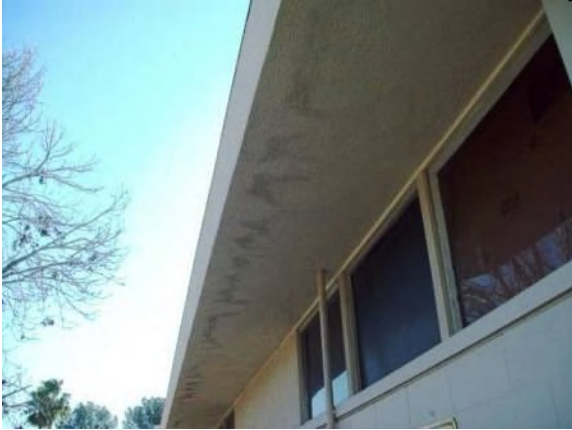
**Location:** Building exterior  
**Material:** Plaster Soffits  
**Distress:** Beyond Expected Life  
**Category:** Capital Renewal  
**Priority:** 3 - Necessary/Not Yet Critical (Years 2-5)  
**Correction:** Replace plaster soffits  
**Qty:** 2,400-S.F.  
**Estimate:** \$150,819.84  
**Assessor Name:** Ann Buerger Linden  
**Date Created:** 01/29/2013

**Notes:** Stucco soffits are cracked and water stained. Replacement is recommended.

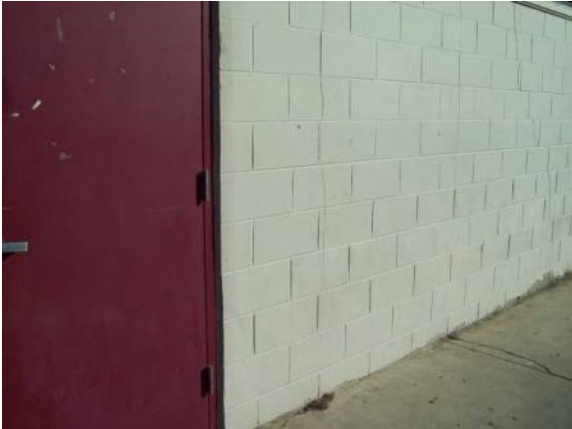
**Location:** Exterior walls - west elevation  
**Material:** Exterior Walls  
**Distress:** Damaged  
**Category:** Capital Renewal  
**Priority:** 3 - Necessary/Not Yet Critical (Years 2-5)  
**Correction:** Engineering study - exterior wall cracks  
**Qty:** 1-Job  
**Estimate:** \$7,344.00  
**Assessor Name:** Ann Buerger Linden  
**Date Created:** 01/29/2013

**Notes:** There are numerous vertical cracks in exterior masonry walls, notably on the west elevation. Cracks are through blocks, not stairstepped. Investigation by a structural engineer is recommended.

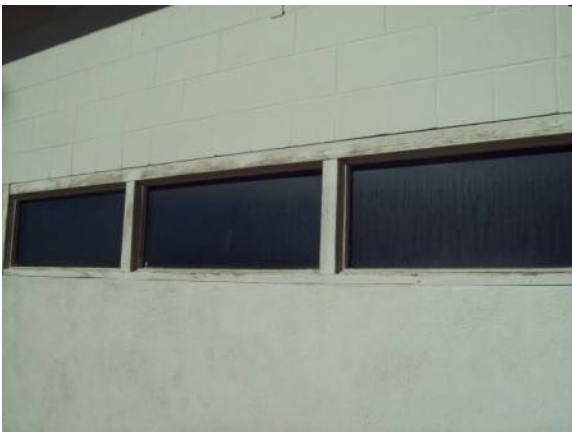
**Location:** East and west elevations.  
**Material:** System  
**Distress:** Beyond Expected Life  
**Category:** Capital Renewal  
**Priority:** 3 - Necessary/Not Yet Critical (Years 2-5)  
**Correction:** Renew System  
**Qty:** 1-Ea.  
**Estimate:** \$36,256.81  
**Assessor Name:** Eduardo Lopez  
**Date Created:** 01/21/2013

**Notes:** Windows are original and in poor condition. Complete replacement including frames is recommended.

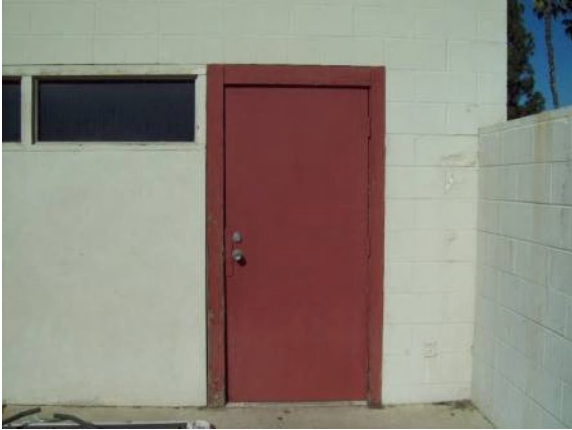
**Location:** All exterior doors.  
**Material:** System  
**Distress:** Beyond Expected Life  
**Category:** Capital Renewal  
**Priority:** 3 - Necessary/Not Yet Critical (Years 2-5)  
**Correction:** Renew System  
**Qty:** 1-Ea.  
**Estimate:** \$161,114.34  
**Assessor Name:** Eduardo Lopez  
**Date Created:** 01/21/2013

**Notes:** System includes personnel doors and overhead roll-up doors at shop spaces. All are original in well maintained but overall poor condition. Provide interior locking lever latches at classrooms.

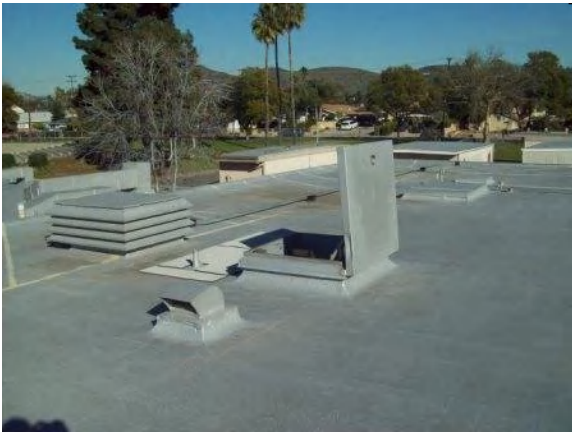
**Location:** Roof  
**Material:** System  
**Distress:** Beyond Expected Life  
**Category:** Capital Renewal  
**Priority:** 3 - Necessary/Not Yet Critical (Years 2-5)  
**Correction:** Renew System  
**Qty:** 1-Ea.  
**Estimate:** \$12,067.10  
**Assessor Name:** Eduardo Lopez  
**Date Created:** 01/21/2013

**Notes:** Replace original roof hatches and access ladders with code compliant assembly.

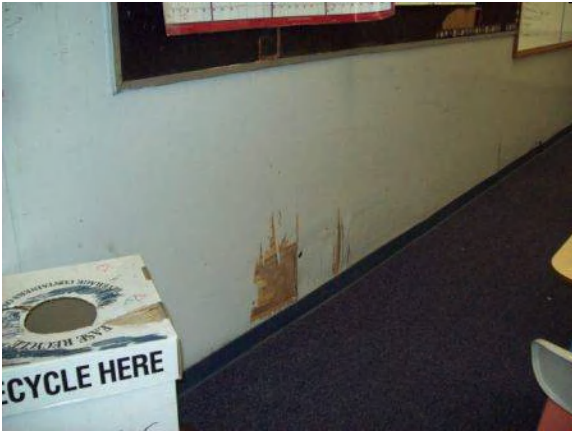
**Location:** Building wide  
**Material:** Interior Partitions  
**Distress:** Inadequate  
**Category:** Capital Renewal  
**Priority:** 3 - Necessary/Not Yet Critical (Years 2-5)  
**Correction:** Allowance repair/remodel interior partitions  
OUSD  
**Qty:** 1-Job  
**Estimate:** \$36,720.00  
**Assessor Name:** Ann Buerger Linden  
**Date Created:** 01/29/2013

**Notes:** There is a fair amount of damage to interior partitions in this building. Partial height walls have been constructed to divide areas, creating noise problems. Provide an allowance to repair and remodel interior partitions as needed to accommodate renovations to adjacent systems and update configurations for ADA compliance and operational efficiency.

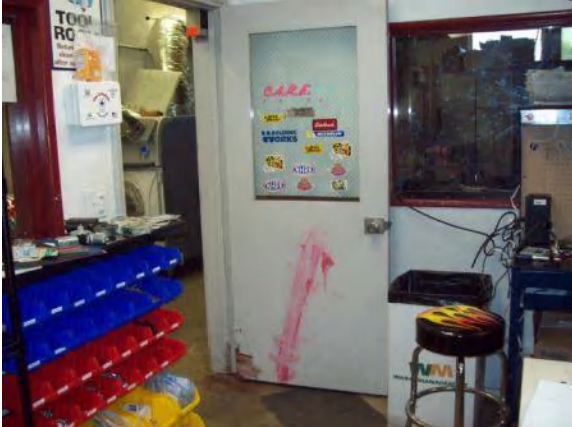
**Location:** All interior doors.  
**Material:** System  
**Distress:** Beyond Expected Life  
**Category:** Capital Renewal  
**Priority:** 3 - Necessary/Not Yet Critical (Years 2-5)  
**Correction:** Renew System  
**Qty:** 1-Ea.  
**Estimate:** \$77,340.86  
**Assessor Name:** Eduardo Lopez  
**Date Created:** 01/21/2013

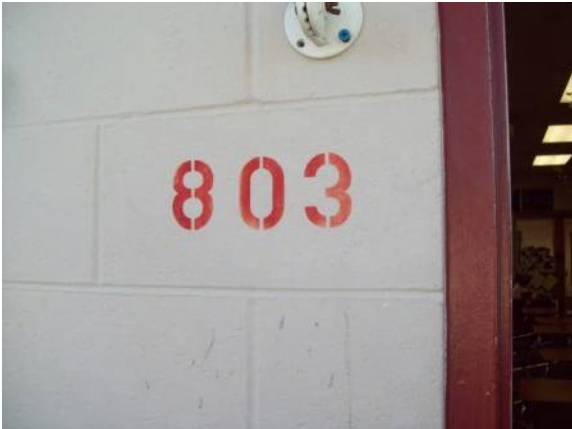
**Location:** Entire building.  
**Material:** Signage  
**Distress:** Inadequate  
**Category:** Capital Renewal  
**Priority:** 3 - Necessary/Not Yet Critical (Years 2-5)  
**Correction:** Replace/Install code compliant signage  
**Qty:** 16,840-S.F.  
**Estimate:** \$3,637.44  
**Assessor Name:** Ann Buerger Linden  
**Date Created:** 01/29/2013

**Notes:** Provide code compliant signage throughout the building.

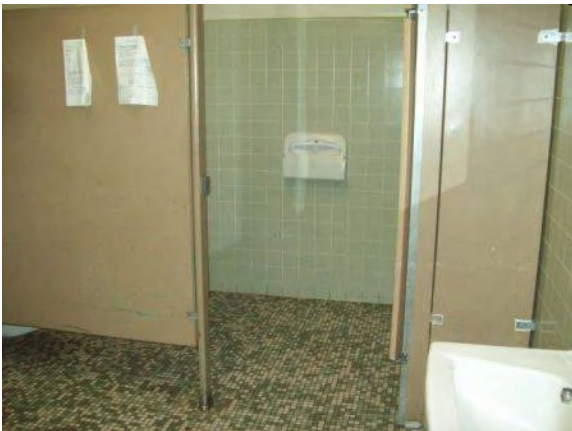
**Location:** Boys restroom.  
**Material:** Toilet Partitions  
**Distress:** Beyond Service Life  
**Category:** ADA Non Compliance  
**Priority:** 3 - Necessary/Not Yet Critical (Years 2-5)  
**Correction:** Replace toilet partitions and accessories  
OUSD  
**Qty:** 1-Ea.  
**Estimate:** \$12,903.39  
**Assessor Name:** Ann Buerger Linden  
**Date Created:** 01/29/2013

**Notes:** Some accessories have been updated in this restroom. It is anticipated that an additional women's restroom may be added for gender equity and ADA compliance.

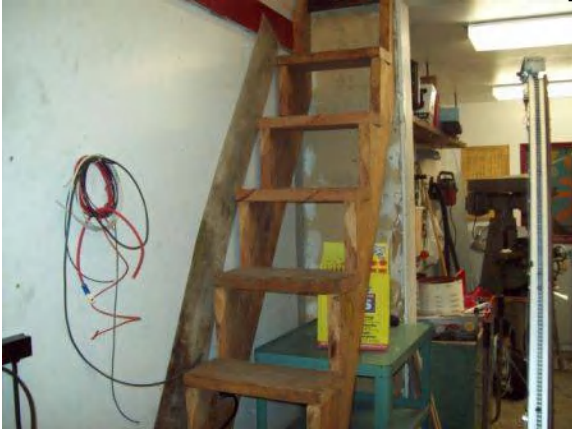
**Location:** Stairs to mezzanine/storage at 806B and lumber storage.

**Notes:** Replace stairs with code compliant assemblies. Treads at stair in 806B are damaged. Handrails missing or not to code.

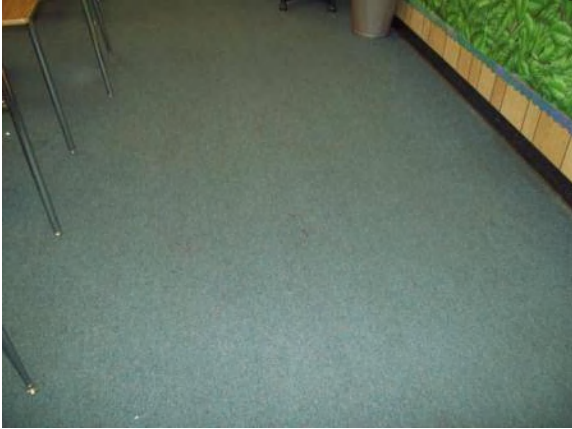
**Location:** Classrooms 803, 805, 806B, and office 14, finishing room 8, storage 21, office 24.

**Notes:** Carpeting in this building is worn and stained. Replacement is recommended.

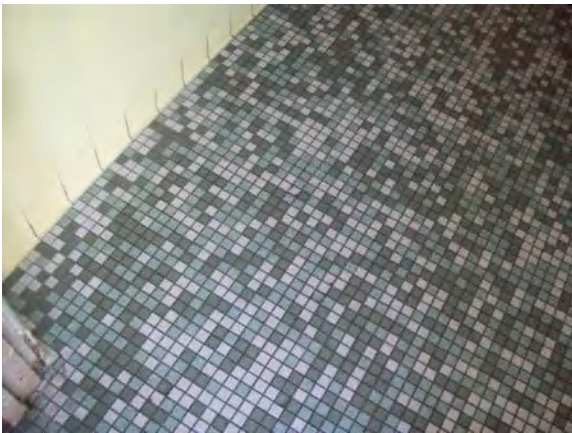
**Location:** Boys restroom.

**Notes:** Ceramic floor tile is original and beyond its expected life. Anticipated renovations will further damage the floor.

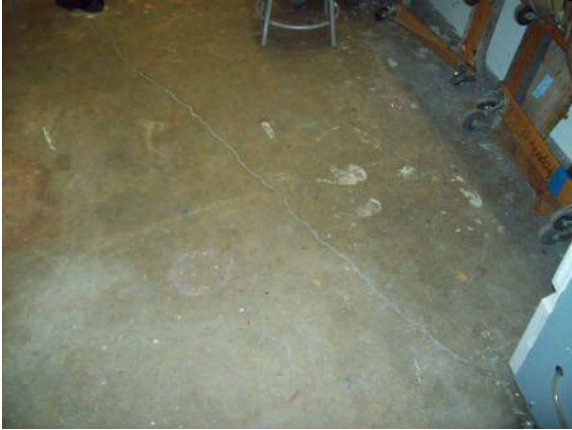
**Location:** Shop classrooms, electric room.  
**Material:** System  
**Distress:** Beyond Expected Life  
**Category:** Capital Renewal  
**Priority:** 3 - Necessary/Not Yet Critical (Years 2-5)  
**Correction:** Renew System  
**Qty:** 1-Ea.  
**Estimate:** \$11,825.35  
**Assessor Name:** Eduardo Lopez  
**Date Created:** 01/21/2013

**Notes:** Powerwash concrete floors and apply sealant.

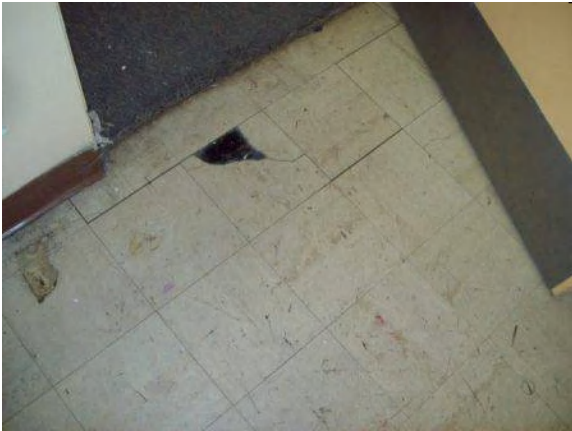
**Location:** Classrooms 802, 804 and miscellaneous storage rooms and offices.  
**Material:** Vinyl  
**Distress:** Beyond Expected Life  
**Category:** Code Compliance  
**Priority:** 2 - Potentially Critical (Year 1)  
**Correction:** Replace VCT Flooring and Resilient Base  
**Qty:** 4,000-S.F.  
**Estimate:** \$16,139.52  
**Assessor Name:** Ann Buerger Linden  
**Date Created:** 01/29/2013

**Notes:** Some original 9" VAT is present. 12" vinyl is also in poor condition where it is present. Replacement is recommended. Newer VCT is installed at 806A and is not included in the correction quantity.

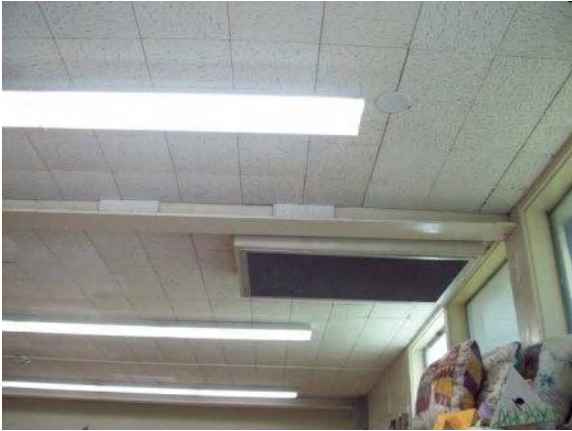
**Location:** Classrooms 802, 805, 807 806A & B, miscellaneous storage rooms and office.  
**Material:** Acoustic Tile  
**Distress:** Beyond Expected Life  
**Category:** Capital Renewal  
**Priority:** 1 - Currently Critical (Immediate)  
**Correction:** Replace acoustic tile ceiling, non fire-rated  
**Qty:** 123-C.S.F.  
**Estimate:** \$82,006.56  
**Assessor Name:** Ann Buerger Linden  
**Date Created:** 01/29/2013

**Notes:** Ceiling finishes in these rooms are typically painted structure or expired 12" glue-on tile. Installation of new acoustical tile ceilings to provide acoustical value is recommended.

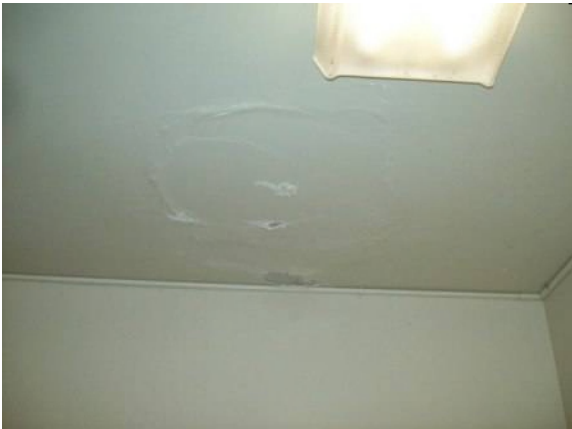
**Location:** Boys restroom and electrical closet.  
**Material:** Plaster  
**Distress:** Beyond Expected Life  
**Category:** Capital Renewal  
**Priority:** 1 - Currently Critical (Immediate)  
**Correction:** Replace plaster ceiling  
**Qty:** 40-S.Y.  
**Estimate:** \$5,355.65  
**Assessor Name:** Ann Buerger Linden  
**Date Created:** 01/29/2013

**Notes:** Plaster ceilings are damaged and beyond their expected life. Replacement is recommended.

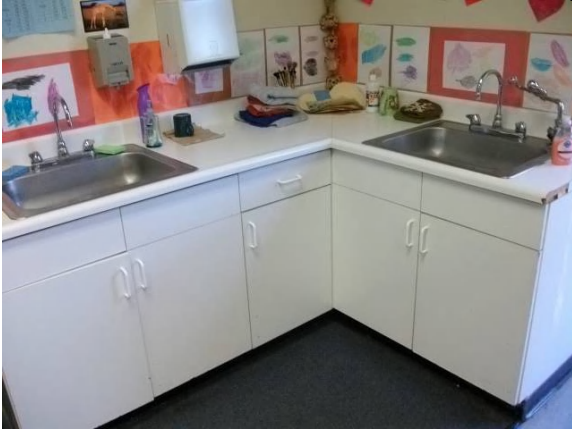
**Location:** Classroom 803 & 804  
**Material:** Sink, Stainless Steel  
**Distress:** Beyond Expected Life  
**Category:** Capital Renewal  
**Priority:** 4 - Recommended (Years 6-10)  
**Correction:** Replace sink, stainless steel  
**Qty:** 4-Ea.  
**Estimate:** \$7,117.32  
**Assessor Name:** Eduardo Lopez  
**Date Created:** 01/24/2013

**Notes:** Sinks are beyond expected life and it is recommended to be replaced during next remodel or renovation.

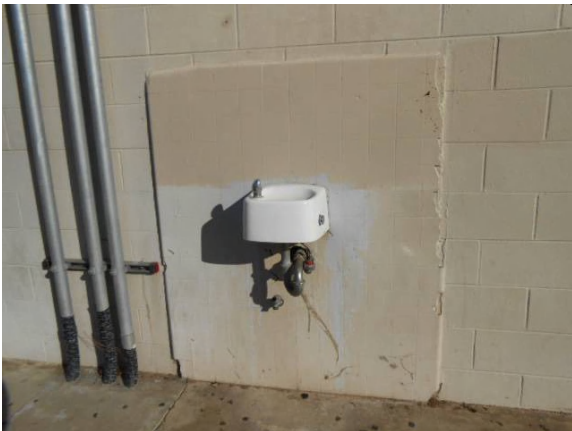
**Location:** East side of building  
**Material:** Drinking Fountain  
**Distress:** Beyond Expected Life  
**Category:** Capital Renewal  
**Priority:** 4 - Recommended (Years 6-10)  
**Correction:** Replace fountain drinking fountain  
**Qty:** 2-Ea.  
**Estimate:** \$4,813.01  
**Assessor Name:** Eduardo Lopez  
**Date Created:** 01/22/2013

**Notes:** A drinking fountain is beyond its expected life and it is recommended to be replaced during next remodel or renovation.

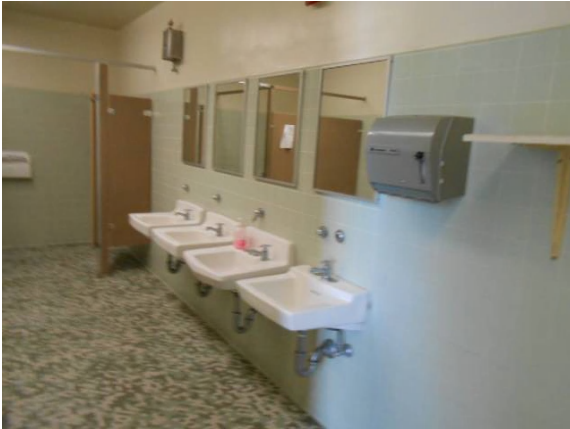
**Location:** Men restrooms at North end  
**Material:** Lavatory, Vitreous China  
**Distress:** Beyond Expected Life  
**Category:** Capital Renewal  
**Priority:** 4 - Recommended (Years 6-10)  
**Correction:** Replace lavatory, vitreous china  
**Qty:** 4-Ea.  
**Estimate:** \$4,299.96  
**Assessor Name:** Eduardo Lopez  
**Date Created:** 01/22/2013

**Notes:** Different types of hand sinks and non-ADA. Replace during next remodel or renovation.

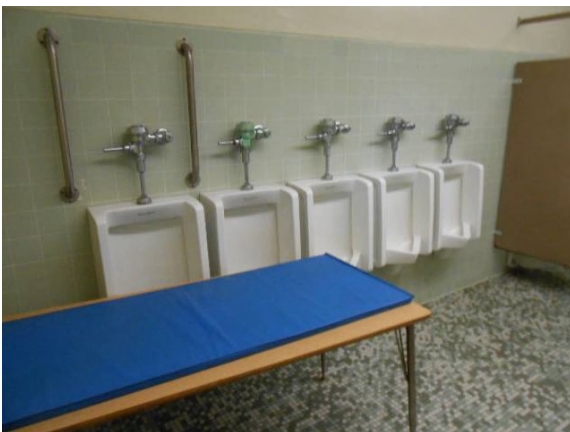
**Location:** Men restrooms at North end  
**Material:** Urinal  
**Distress:** Beyond Expected Life  
**Category:** Capital Renewal  
**Priority:** 4 - Recommended (Years 6-10)  
**Correction:** Replace wall-hung urinal  
**Qty:** 5-Ea.  
**Estimate:** \$7,756.56  
**Assessor Name:** Eduardo Lopez  
**Date Created:** 01/22/2013

**Notes:** Replace during next remodel or renovation.

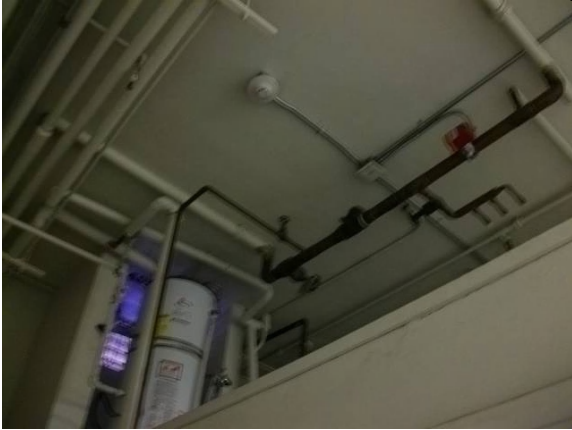
**Location:** Typical for entire building  
**Material:** System  
**Distress:** Beyond Service Life  
**Category:** Capital Renewal  
**Priority:** 4 - Recommended (Years 6-10)  
**Correction:** Renew System  
**Qty:** 1-Ea.  
**Estimate:** \$33,609.95  
**Assessor Name:** Eduardo Lopez  
**Date Created:** 01/24/2013

**Notes:** Domestic hot water were replaced in 2006; however it is recommended to replace the domestic water distribution system during next remodel or renovation.

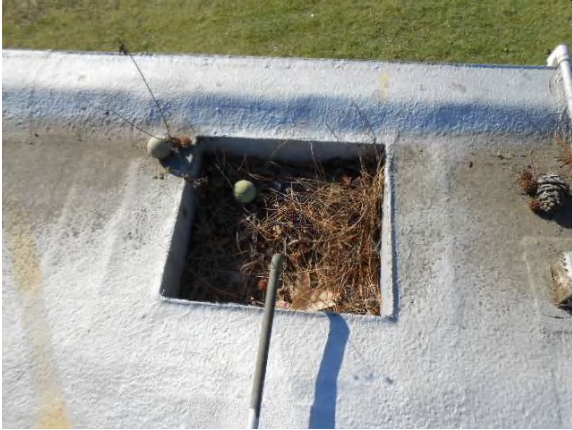
**Location:** Typical for entire building  
**Material:** System  
**Distress:** Beyond Service Life  
**Category:** Capital Renewal  
**Priority:** 4 - Recommended (Years 6-10)  
**Correction:** Renew System  
**Qty:** 1-Ea.  
**Estimate:** \$18,405.45  
**Assessor Name:** Eduardo Lopez  
**Date Created:** 01/24/2013

**Notes:** Replace system during next remodel or renovation.

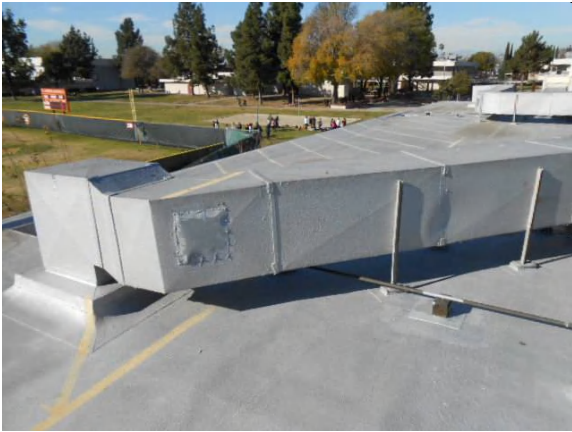
**Location:** Typical for entire building  
**Material:** System  
**Distress:** Beyond Service Life  
**Category:** Capital Renewal  
**Priority:** 4 - Recommended (Years 6-10)  
**Correction:** Renew System  
**Qty:** 1-Ea.  
**Estimate:** \$453,734.27  
**Assessor Name:** Eduardo Lopez  
**Date Created:** 01/24/2013

**Notes:** HVAC system was replaced in 2000 and 2008, however the ductwork, ventilation diffusers/grilles and fresh air supply is recommended to be upgraded during the next major renovation.

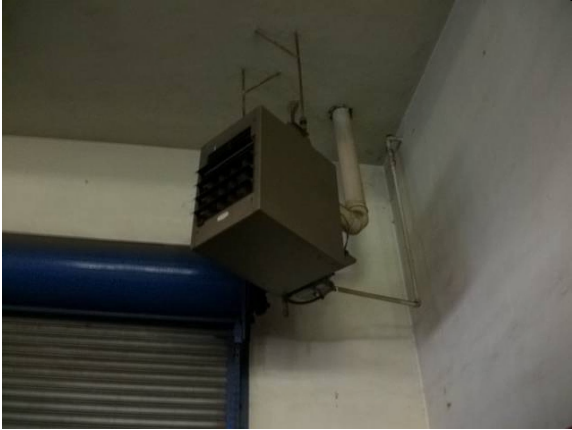
**Location:** Engine Area & Gen Purpose Room  
**Material:** Standard Suspended Heater  
**Distress:** Beyond Expected Life  
**Category:** Capital Renewal  
**Priority:** 4 - Recommended (Years 6-10)  
**Correction:** Replace heater standard suspended heater  
**Qty:** 2-Ea.  
**Estimate:** \$2,579.21  
**Assessor Name:** Eduardo Lopez  
**Date Created:** 01/27/2013

**Notes:** Unit heaters are beyond expected life and it is recommended to be replaced during next remodel or renovation.

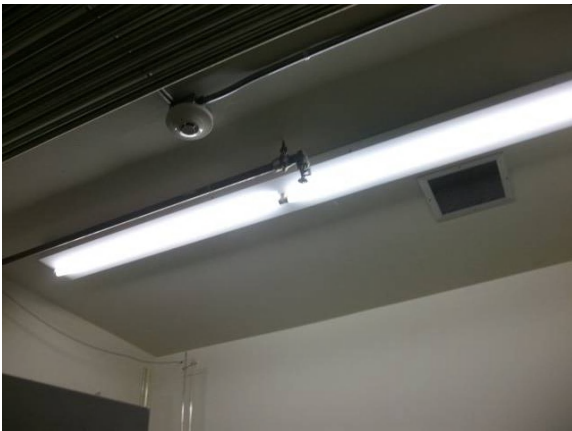
**Location:** Typical for entire building  
**Material:** System  
**Distress:** Beyond Expected Life  
**Category:** Capital Renewal  
**Priority:** 5 - Codes or Standards Compliance  
**Correction:** Renew System  
**Qty:** 1-Ea.  
**Estimate:** \$154,445.70  
**Assessor Name:** Eduardo Lopez  
**Date Created:** 01/24/2013

**Notes:** Building is partially sprinklered, wet type fire sprinklers are currently located in the storage/electrical room and it's recommended to be added throughout building wide during next major renovation.

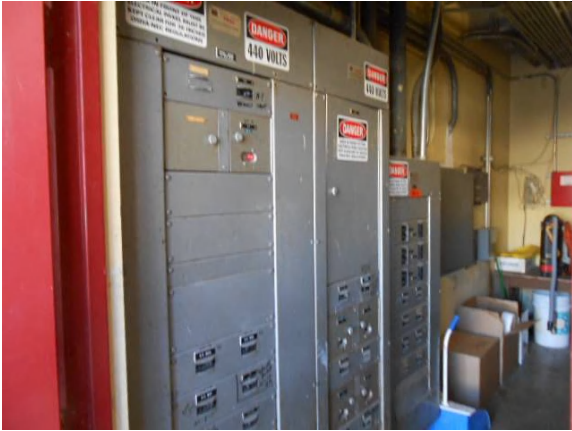
**Location:** Typical for entire building  
**Material:** System  
**Distress:** Beyond Service Life  
**Category:** Capital Renewal  
**Priority:** 4 - Recommended (Years 6-10)  
**Correction:** Renew System  
**Qty:** 1-Ea.  
**Estimate:** \$170,183.69  
**Assessor Name:** Eduardo Lopez  
**Date Created:** 01/24/2013

**Notes:** The main electrical panels, distribution panel boards and feeders are mostly original to the building age. It is recommended to be replaced during the next major renovation.

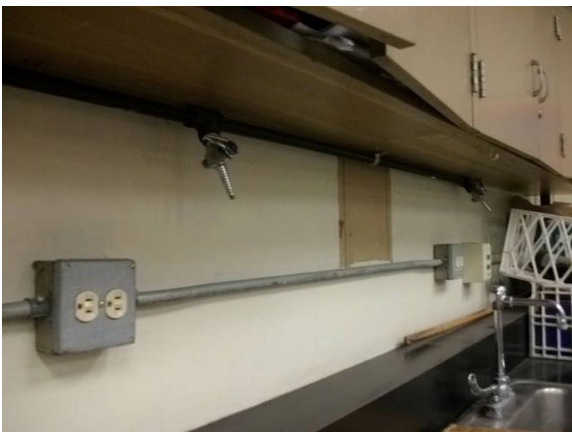
**Location:** Typical for entire building  
**Material:** System  
**Distress:** Beyond Service Life  
**Category:** Capital Renewal  
**Priority:** 4 - Recommended (Years 6-10)  
**Correction:** Renew System  
**Qty:** 1-Ea.  
**Estimate:** \$586,840.32  
**Assessor Name:** Eduardo Lopez  
**Date Created:** 01/24/2013

**Notes:** The branch wiring, electrical panels and devices are mostly original to the building age. It is recommended to be replaced during the next major renovation.

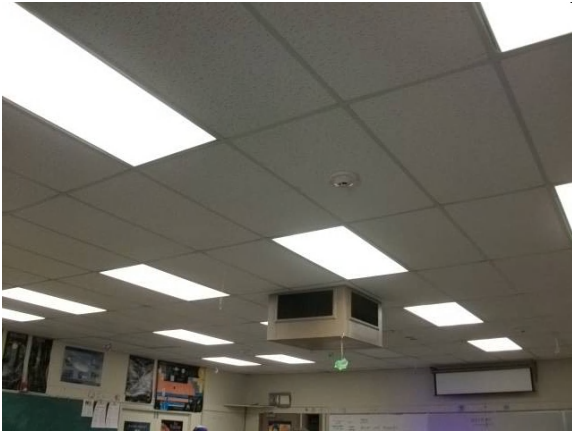
**Location:** Classroom 801, 803 & 804  
**Material:** Fluorescent Lighting Fixture, 80 W  
**Distress:** Beyond Expected Life  
**Category:** Capital Renewal  
**Priority:** 4 - Recommended (Years 6-10)  
**Correction:** Replace fixture fluorescent lighting fixture, 80 W  
**Qty:** 52-Ea.  
**Estimate:** \$21,001.12  
**Assessor Name:** Eduardo Lopez  
**Date Created:** 01/23/2013

**Notes:** T8 fluorescent lamps and ballasts were updated in 2006; however light fixtures, switches and wiring are original to building age and it is recommended to be replaced during next remodel or renovation.

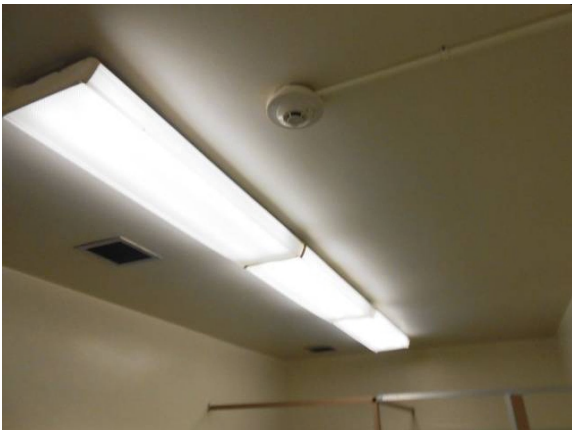
**Location:** Radio Room from Classroom 801, Storage from classroom 803, Office in Classroom 804, Machine Shop 805, Office from 807, Exterior Storage 808, Projects Storage 806B, Classroom 802 including Blueprint Room & Office and Men Restroom.  
**Material:** Fluorescent Lighting Fixture, 80 W  
**Distress:** Beyond Expected Life  
**Category:** Capital Renewal  
**Priority:** 4 - Recommended (Years 6-10)  
**Correction:** Replace fixture fluorescent lighting fixture, 80 W  
**Qty:** 72-Ea.  
**Estimate:** \$35,466.97  
**Assessor Name:** Eduardo Lopez  
**Date Created:** 01/24/2013

**Notes:** T8 fluorescent lamps and ballasts were updated in 2006; however light fixtures, switches and wiring are original to building age and it is recommended to be replaced during next remodel or renovation.

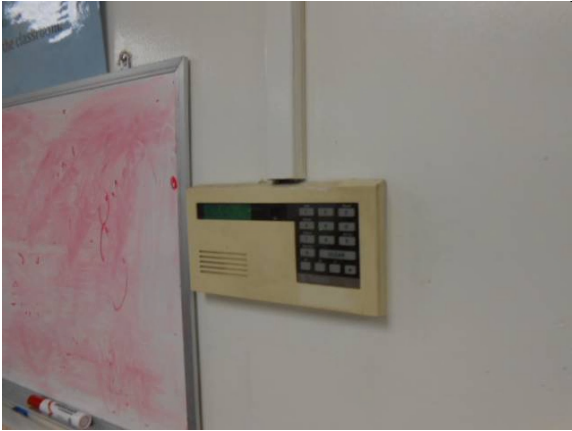
**Location:** Typical for entire building  
**Material:** System  
**Distress:** Beyond Expected Life  
**Category:** Capital Renewal  
**Priority:** 4 - Recommended (Years 6-10)  
**Correction:** Renew System  
**Qty:** 1-Ea.  
**Estimate:** \$26,674.56  
**Assessor Name:** Eduardo Lopez  
**Date Created:** 01/27/2013

**Notes:** Security is needing upgrades. Recommend replacing and enhancing during the next building renovation.

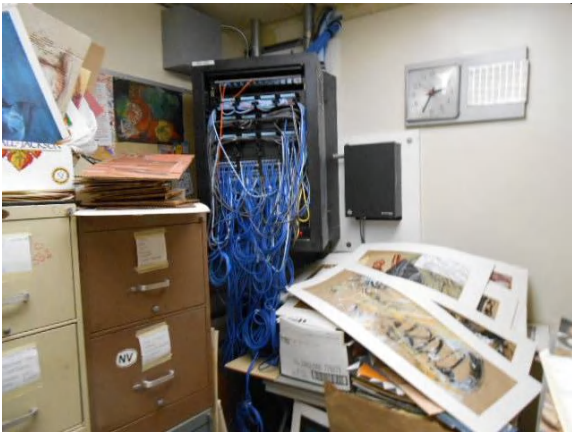
**Location:** Typical for entire building  
**Material:** System  
**Distress:** Beyond Expected Life  
**Category:** Capital Renewal  
**Priority:** 4 - Recommended (Years 6-10)  
**Correction:** Renew System  
**Qty:** 1-Ea.  
**Estimate:** \$26,674.56  
**Assessor Name:** Eduardo Lopez  
**Date Created:** 01/27/2013

**Notes:** Clock System is needing upgrades. Recommend replacing and enhancing during the next building renovation.

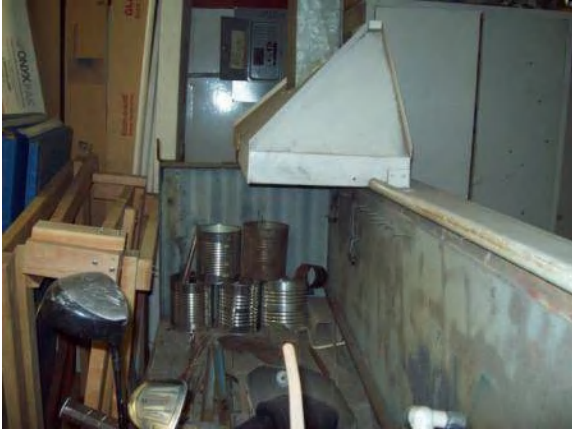
**Location:** All classrooms.  
**Material:** System  
**Distress:** Beyond Expected Life  
**Category:** Capital Renewal  
**Priority:** 3 - Necessary/Not Yet Critical (Years 2-5)  
**Correction:** Renew System  
**Qty:** 1-Ea.  
**Estimate:** \$604,445.53  
**Assessor Name:** Ann Buerger Linden  
**Date Created:** 01/29/2013

**Notes:** This category includes marker, tack and Smart boards, and shop/technical equipment, and darkroom equipment. The academic program has changed, (e.g. automotive shop is no longer taught) making some equipment unused. Much is obsolete. System renewal to include removal of obsolete/unused items and to provide new equipment to meet current demands is recommended.
