## Orange Unified School District

Facilities Condition Assessment for:

**El Modena High School**  
**3920 Spring Street**  
**Orange, CA 92869**

# Campus Report

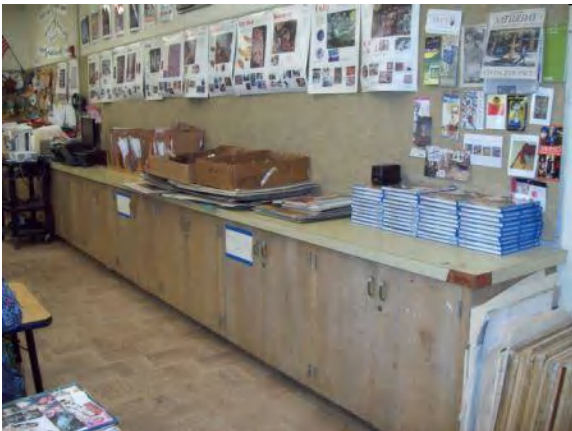
**Location:** Building wide - primarily classrooms.  
**Material:** System  
**Distress:** Beyond Expected Life  
**Category:** Capital Renewal  
**Priority:** 3 - Necessary/Not Yet Critical (Years 2-5)  
**Correction:** Renew System  
**Qty:** 1-Ea.  
**Estimate:** \$201,659.67  
**Assessor Name:** Ann Buerger Linden  
**Date Created:** 01/29/2013

**Notes:** Casework is original and in decrepit condition. System renewal is recommended.

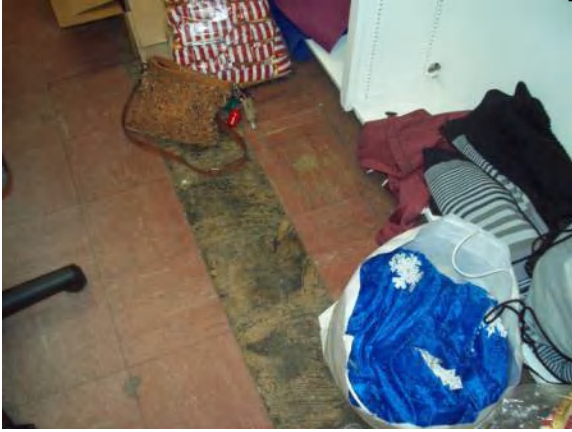
**Location:** Friable material on pipe fitting insulation and in fire door insulation. Non-friable material in 9" floor tile, transite wall panels, transite pipe, transite welding screen.

**Notes:** The AHERA six-month surveillance of asbestos-containing materials - Summer 2012, identifies ACM at this building. Complete abatement is recommended.

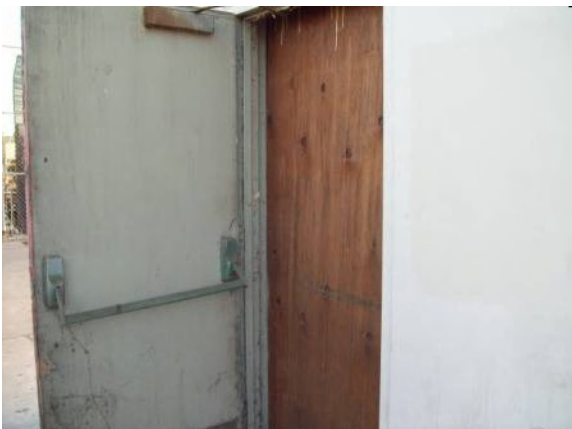
**Location:** Exterior wall at "drying room".  
**Material:** Concrete Block  
**Distress:** Inadequate  
**Category:** Deferred Maintenance  
**Priority:** 1 - Currently Critical (Immediate)  
**Correction:** Replace 8" concrete block wall - 1st floor  
**Qty:** 0-C.S.F.  
**Estimate:** \$439.95  
**Assessor Name:** Ann Buerger Linden  
**Date Created:** 01/29/2013

**Notes:** Remove abandoned door and infill with CMU to match surrounding construction.

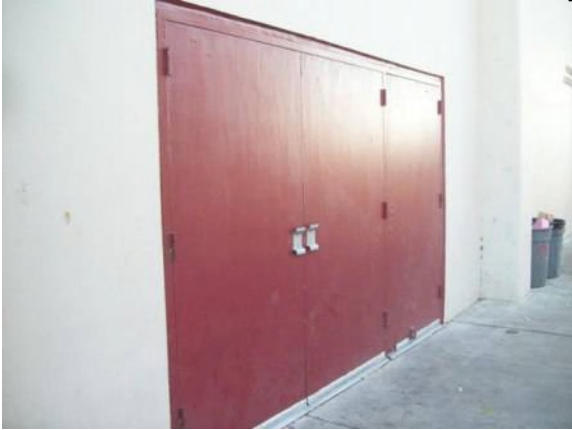
**Location:** All exterior doors.  
**Material:** System  
**Distress:** Beyond Expected Life  
**Category:** Capital Renewal  
**Priority:** 3 - Necessary/Not Yet Critical (Years 2-5)  
**Correction:** Renew System  
**Qty:** 1-Ea.  
**Estimate:** \$244,283.55  
**Assessor Name:** Eduardo Lopez  
**Date Created:** 01/21/2013

**Notes:** Exterior doors are typically original and well beyond their expected life. Replace doors, frames, and hardware. Installation of an ADA operator at one or two main entrance doors is recommended.

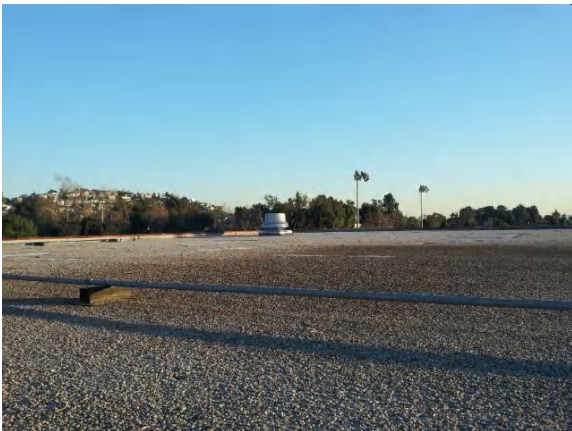
**Location:** Building Systems  
**Material:** System  
**Distress:** Beyond Expected Life  
**Category:** Capital Renewal  
**Priority:** 3 - Necessary/Not Yet Critical (Years 2-5)  
**Correction:** Renew System  
**Qty:** 1-Ea.  
**Estimate:** \$798,516.10  
**Assessor Name:** Eduardo Lopez  
**Date Created:** 01/21/2013

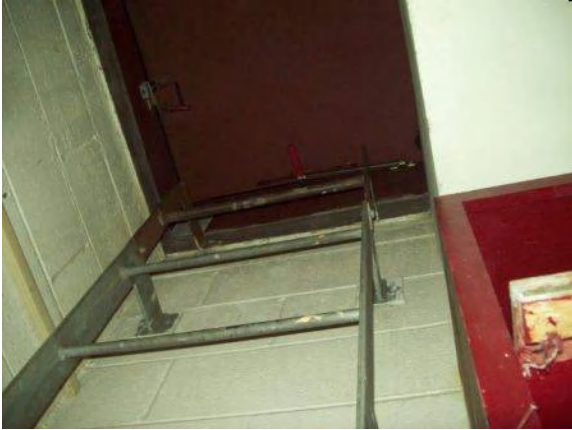
**Location:** Roof access from janitor's closet.  
**Material:** System  
**Distress:** Beyond Expected Life  
**Category:** Capital Renewal  
**Priority:** 3 - Necessary/Not Yet Critical (Years 2-5)  
**Correction:** Renew System  
**Qty:** 1-Ea.  
**Estimate:** \$71,996.17  
**Assessor Name:** Eduardo Lopez  
**Date Created:** 01/21/2013

**Notes:** Roof hatch is beyond it's expected life. Ladder does not have code required extension. Bolts at top of ladder are loosened.

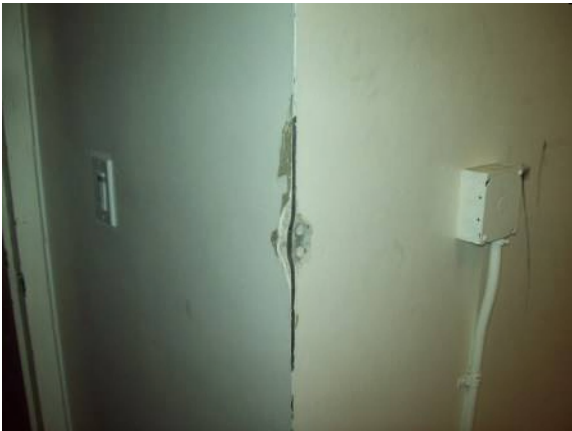
**Location:** Building wide.  
**Material:** Interior Partitions  
**Distress:** Damaged  
**Category:** Capital Renewal  
**Priority:** 3 - Necessary/Not Yet Critical (Years 2-5)  
**Correction:** Allowance repair/remodel interior partitions  
OUSD  
**Qty:** 1-Job  
**Estimate:** \$44,064.00  
**Assessor Name:** Ann Buerger Linden  
**Date Created:** 01/29/2013

**Notes:** Interior partitions exhibit some damage throughout the building. Provide an allowance to repair and remodel interior partitions as needed to accommodate renovations to adjacent systems and update configurations for ADA compliance and operational efficiency.

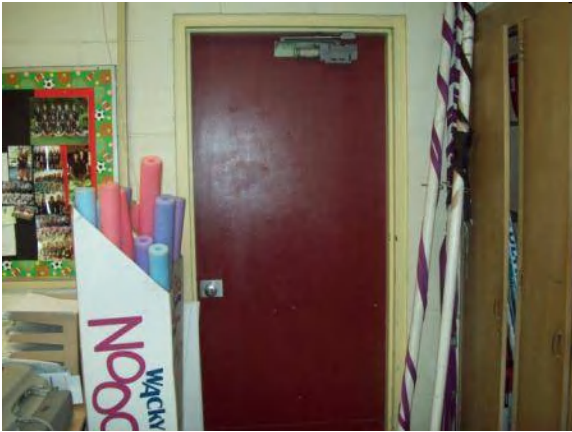
**Location:** All interior doors.  
**Material:** System  
**Distress:** Beyond Expected Life  
**Category:** Capital Renewal  
**Priority:** 3 - Necessary/Not Yet Critical (Years 2-5)  
**Correction:** Renew System  
**Qty:** 1-Ea.  
**Estimate:** \$89,740.33  
**Assessor Name:** Eduardo Lopez  
**Date Created:** 01/21/2013

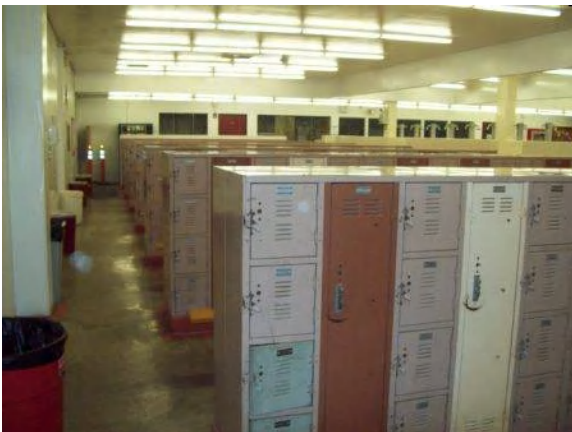
**Location:** Locker rooms.  
**Material:** Fixed Furnishings - Lockers  
**Distress:** Beyond Expected Life  
**Category:** Capital Renewal  
**Priority:** 3 - Necessary/Not Yet Critical (Years 2-5)  
**Correction:** Student lockers stacked 2-high  
**Qty:** 1,600-Ea.  
**Estimate:** \$670,538.88  
**Assessor Name:** Ann Buerger Linden  
**Date Created:** 01/29/2013

**Notes:** Most lockers in the building are original and in poor condition. Also replace locker room benches.

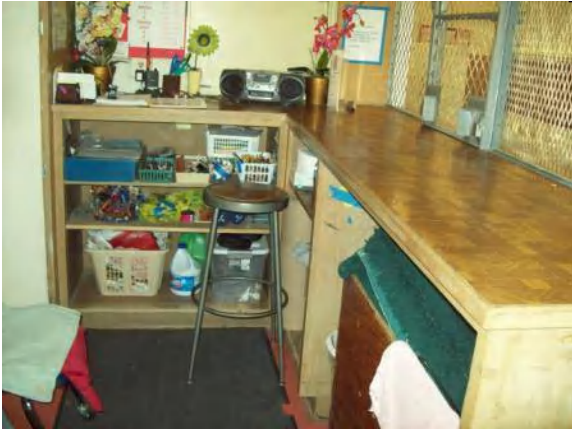
**Location:** Equipment, storage, and offices.  
**Material:** Fixed Casework  
**Distress:** Beyond Expected Life  
**Category:** Capital Renewal  
**Priority:** 3 - Necessary/Not Yet Critical (Years 2-5)  
**Correction:** Replace Casework OUSD  
**Qty:** 80-L.F.  
**Estimate:** \$36,174.89  
**Assessor Name:** Ann Buerger Linden  
**Date Created:** 01/29/2013

**Notes:** Casework appears to be original and is in poor condition.

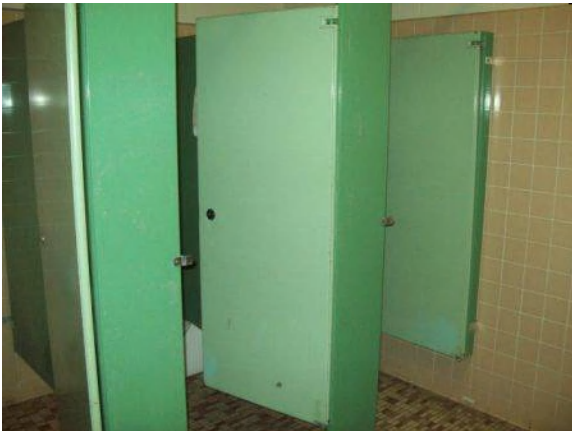
**Location:** Restrooms  
**Material:** Toilet Partitions  
**Distress:** Beyond Expected Life  
**Category:** Capital Renewal  
**Priority:** 3 - Necessary/Not Yet Critical (Years 2-5)  
**Correction:** Replace toilet partitions and accessories OUSD  
**Qty:** 1-Ea.  
**Estimate:** \$37,354.49  
**Assessor Name:** Ann Buerger Linden  
**Date Created:** 01/29/2013

**Notes:** Toilet partitions and accessories are typically original - or very old - and are in need of updating. Some items in locker rooms, including ADA toilets and showers in both boys and girls, have been updated. Upgrading of public facilities is recommended.

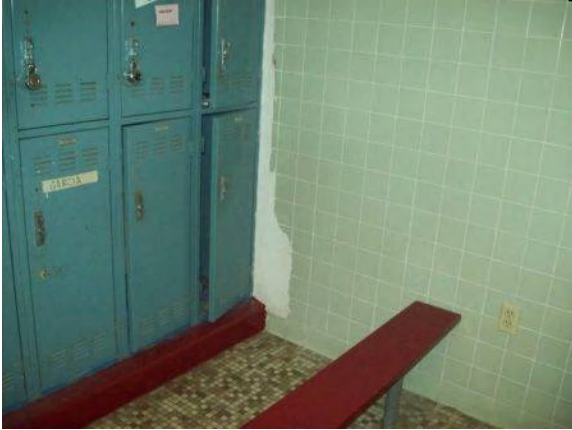
**Location:** Building wide.  
**Material:** System  
**Distress:** Beyond Expected Life  
**Category:** Capital Renewal  
**Priority:** 3 - Necessary/Not Yet Critical (Years 2-5)  
**Correction:** Renew System  
**Qty:** 1-Ea.  
**Estimate:** \$396,692.02  
**Assessor Name:** Eduardo Lopez  
**Date Created:** 01/21/2013

**Notes:** Wall finishes are typically paint and ceramic tile. Ceramic tile in all restrooms and the girls locker/shower room is expired. Ceramic in the boys room appears to be more recent. Renovations to related building systems will result in the need to renew all wall finish systems.

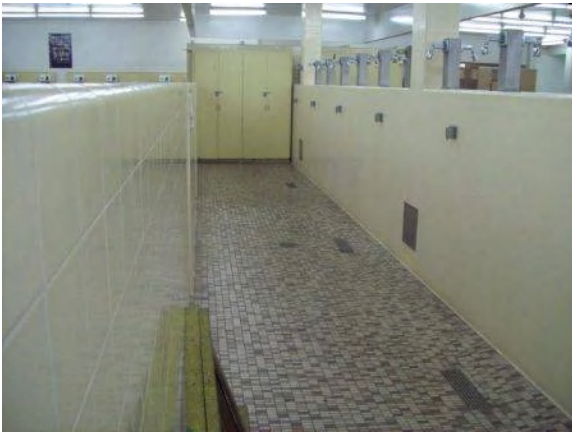
**Location:** All restrooms and shower rooms except boys' showers.  
**Material:** Ceramic Tile  
**Distress:** Beyond Expected Life  
**Category:** Capital Renewal  
**Priority:** 3 - Necessary/Not Yet Critical (Years 2-5)  
**Correction:** Replace 2" x 2" thin set ceramic tile floor  
**Qty:** 13-C.S.F.  
**Estimate:** \$32,647.68  
**Assessor Name:** Ann Buerger Linden  
**Date Created:** 01/29/2013

**Notes:** Ceramic floor tiles are typically original and fair condition.

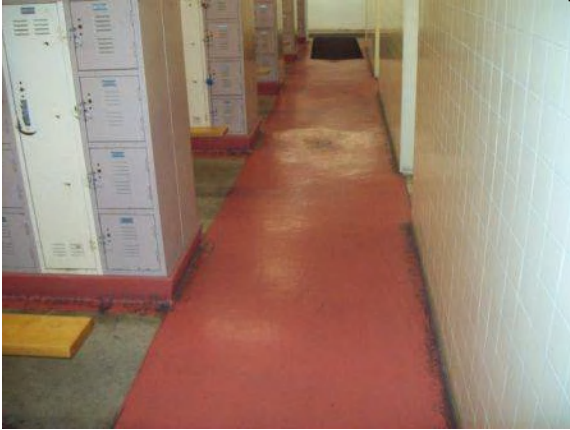
**Location:** Locker rooms between showers and locker areas.

**Notes:** Install a non-slip epoxy surface.

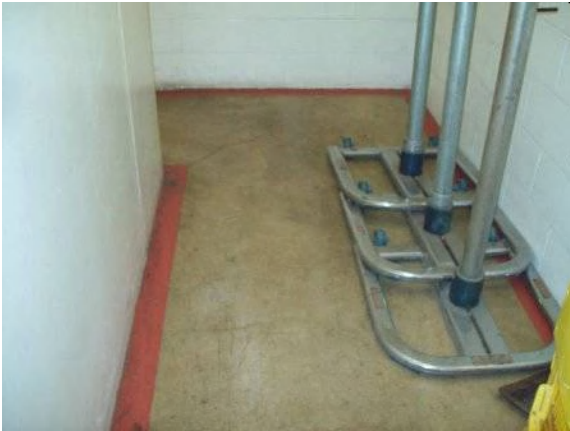
**Location:** Primarily locker rooms. Also mechanical, storage, and janitor closets.

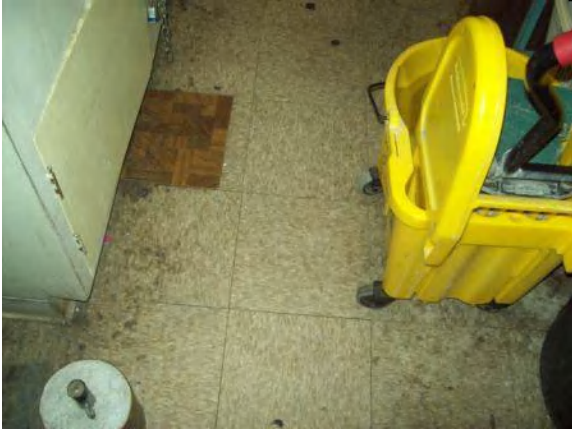
**Location:** Vestibules, coach offices.  
**Material:** System  
**Distress:** Beyond Expected Life  
**Category:** Capital Renewal  
**Priority:** 3 - Necessary/Not Yet Critical (Years 2-5)  
**Correction:** Renew System  
**Qty:** 1-Ea.  
**Estimate:** \$17,742.38  
**Assessor Name:** Eduardo Lopez  
**Date Created:** 01/21/2013

**Notes:** Most resilient flooring is ACM. Abatement is covered elsewhere. Replace vinyl floor and base system.

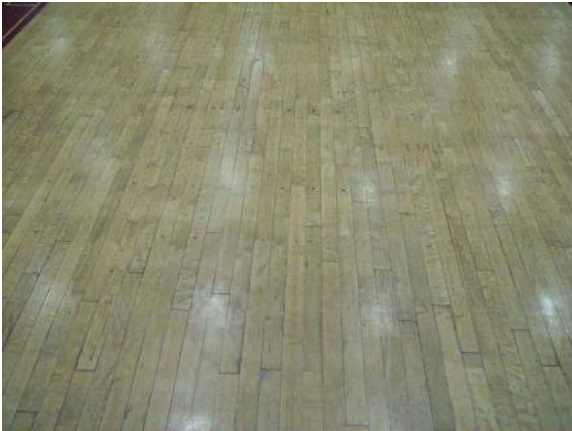
### System: C3020410 - Wood

**Location:** Gymnasium, wrestling room, weight room.  
**Material:** System  
**Distress:** Beyond Expected Life  
**Category:** Capital Renewal  
**Priority:** 3 - Necessary/Not Yet Critical (Years 2-5)  
**Correction:** Renew System  
**Qty:** 1-Ea.  
**Estimate:** \$490,834.08  
**Assessor Name:** Eduardo Lopez  
**Date Created:** 01/21/2013

**Notes:** Wood floors are original and beyond their expected life. "Dead" spots are present.

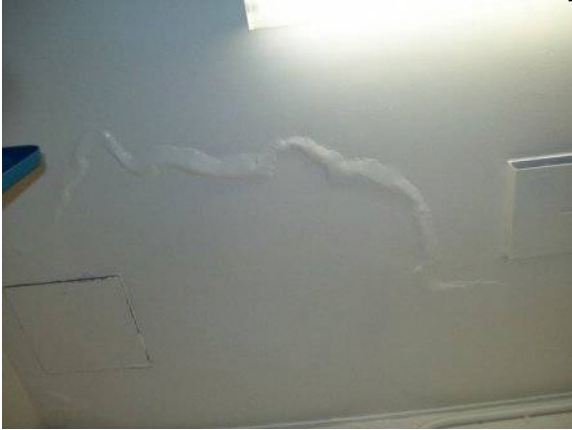
### System: C3030 - Ceiling Finishes

**Location:** Building wide.  
**Material:** System  
**Distress:** Beyond Expected Life  
**Category:** Capital Renewal  
**Priority:** 3 - Necessary/Not Yet Critical (Years 2-5)  
**Correction:** Renew System  
**Qty:** 1-Ea.  
**Estimate:** \$704,751.16  
**Assessor Name:** Eduardo Lopez  
**Date Created:** 01/21/2013

**Notes:** Ceilings are in generally poor condition. Plaster ceilings have moisture damage. Glue-on tiles are stained and falling down. Spray on ceilings are ACM and are recommended for abatement.

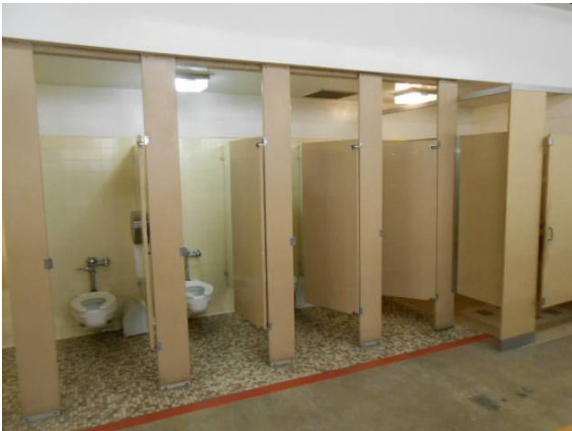
### System: D2010 - Plumbing Fixtures

**Location:** Typical for entire building  
**Material:** System  
**Distress:** Beyond Expected Life  
**Category:** Capital Renewal  
**Priority:** 4 - Recommended (Years 6-10)  
**Correction:** Renew System  
**Qty:** 1-Ea.  
**Estimate:** \$564,854.94  
**Assessor Name:** Eduardo Lopez  
**Date Created:** 01/27/2013

**Notes:** Plumbing Fixtures are beyond expected life and it is recommended to be schedule for replacemene during next remodel or renovation.

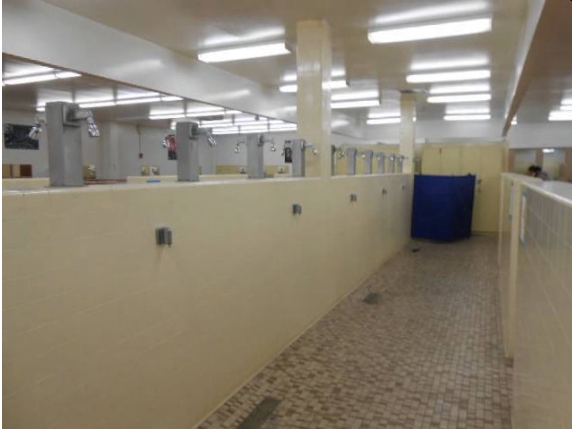
### System: D2020 - Domestic Water Distribution

**Location:** Typical for entire building  
**Material:** System  
**Distress:** Beyond Service Life  
**Category:** Capital Renewal  
**Priority:** 4 - Recommended (Years 6-10)  
**Correction:** Renew System  
**Qty:** 1-Ea.  
**Estimate:** \$57,012.50  
**Assessor Name:** Eduardo Lopez  
**Date Created:** 01/24/2013

**Notes:** Domestic water distribution is beyond its expected life and it is recommended to be replaced during next remodel or renovation.

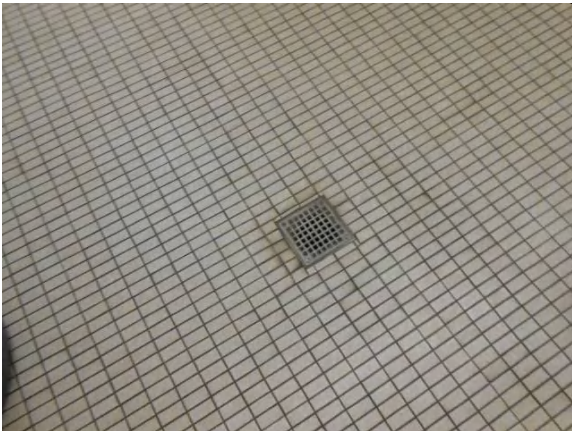
### System: D2030 - Sanitary Waste

**Location:** Typical for entire building  
**Material:** System  
**Distress:** Beyond Service Life  
**Category:** Capital Renewal  
**Priority:** 4 - Recommended (Years 6-10)  
**Correction:** Renew System  
**Qty:** 1-Ea.  
**Estimate:** \$194,034.14  
**Assessor Name:** Eduardo Lopez  
**Date Created:** 01/24/2013

**Notes:** Replace all above grade sanitary waste and vent piping during next remodel or renovation; below grade as needed.

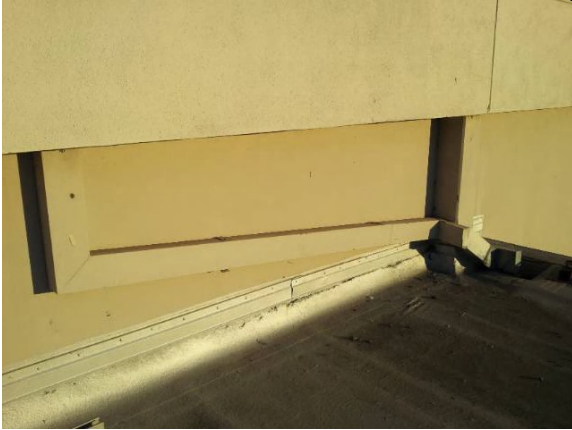
### System: D2040 - Rain Water Drainage

**Location:** Typical for entire building  
**Material:** System  
**Distress:** Beyond Service Life  
**Category:** Capital Renewal  
**Priority:** 4 - Recommended (Years 6-10)  
**Correction:** Renew System  
**Qty:** 1-Ea.  
**Estimate:** \$31,141.28  
**Assessor Name:** Eduardo Lopez  
**Date Created:** 01/24/2013

**Notes:** Replace system during next remodel or renovation.

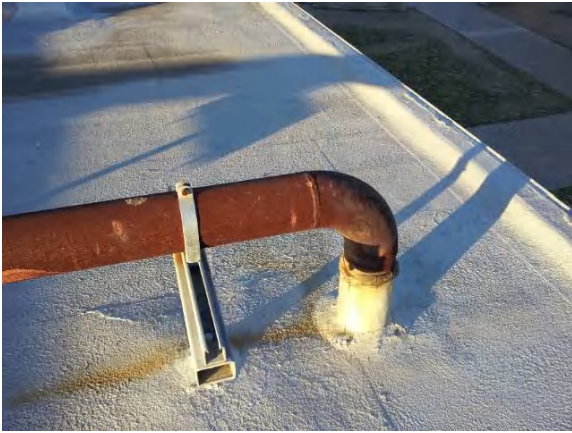
### System: D2090 - Other Plumbing Systems-Nat Gas

**Location:** Typical for entire building  
**Material:** System  
**Distress:** Beyond Service Life  
**Category:** Capital Renewal  
**Priority:** 4 - Recommended (Years 6-10)  
**Correction:** Renew System  
**Qty:** 1-Ea.  
**Estimate:** \$52,700.63  
**Assessor Name:** Eduardo Lopez  
**Date Created:** 01/24/2013

**Notes:** The Natural Gas distribution is original to the building age. It is recommended to be replaced during the next major renovation.

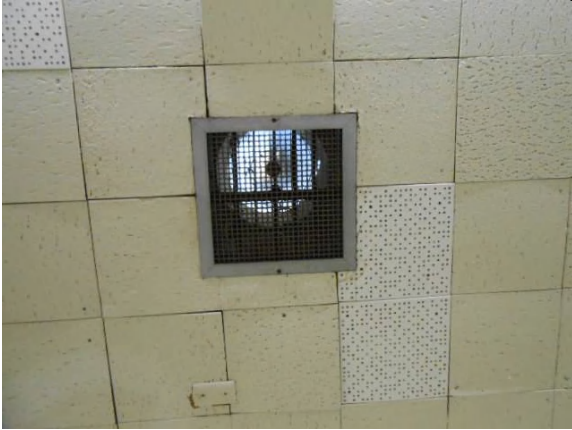
### System: D3040 - Distribution Systems

**Location:** Typical for entire building  
**Material:** System  
**Distress:** Beyond Service Life  
**Category:** Capital Renewal  
**Priority:** 4 - Recommended (Years 6-10)  
**Correction:** Renew System  
**Qty:** 1-Ea.  
**Estimate:** \$770,387.40  
**Assessor Name:** Eduardo Lopez  
**Date Created:** 01/24/2013

**Notes:** HVAC system was mostly replaced in 2008, however the ductwork, ventilation diffusers/grilles and fresh air supply is recommended to be upgraded during the next major renovation.

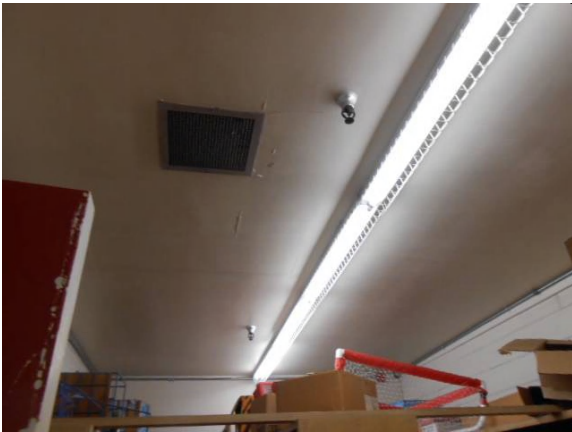
### System: D4010 - Sprinklers

**Location:** Typical for entire building  
**Material:** System  
**Distress:** Beyond Expected Life  
**Category:** Capital Renewal  
**Priority:** 5 - Codes or Standards Compliance  
**Correction:** Renew System  
**Qty:** 1-Ea.  
**Estimate:** \$262,065.86  
**Assessor Name:** Eduardo Lopez  
**Date Created:** 01/24/2013

**Notes:** Building is partially sprinklered, wet type fire sprinklers are currently located in the storage/electrical/custodial room and it's recommended to be added throughout building wide during next major renovation.

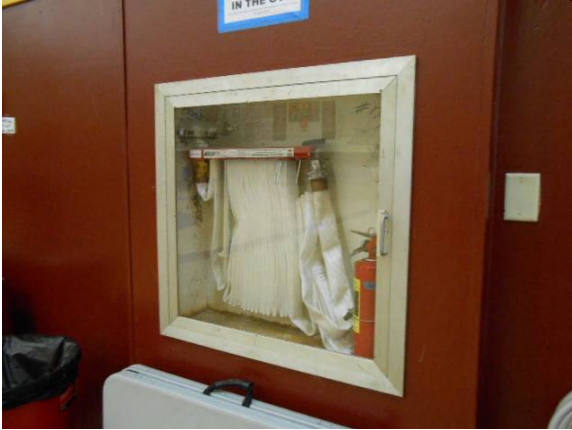
### System: D4020 - Standpipes

**Location:** Typical for entire building  
**Material:** System  
**Distress:** Beyond Service Life  
**Category:** Capital Renewal  
**Priority:** 4 - Recommended (Years 6-10)  
**Correction:** Renew System  
**Qty:** 1-Ea.  
**Estimate:** \$18,684.77  
**Assessor Name:** Eduardo Lopez  
**Date Created:** 01/24/2013

**Notes:** Replace system during next remodel or renovation.

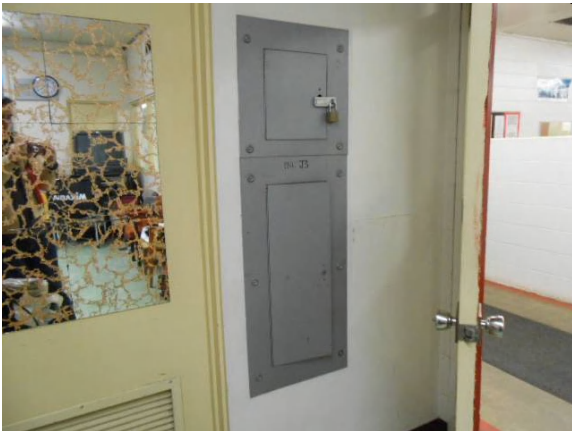
### System: D5010 - Electrical Service/Distribution

**Location:** Typical for entire building  
**Material:** System  
**Distress:** Beyond Service Life  
**Category:** Capital Renewal  
**Priority:** 4 - Recommended (Years 6-10)  
**Correction:** Renew System  
**Qty:** 1-Ea.  
**Estimate:** \$288,895.27  
**Assessor Name:** Eduardo Lopez  
**Date Created:** 01/24/2013

**Notes:** The main electrical panels, distribution panel boards and feeders are mostly original to the building age. It is recommended to be replaced during the next major renovation.

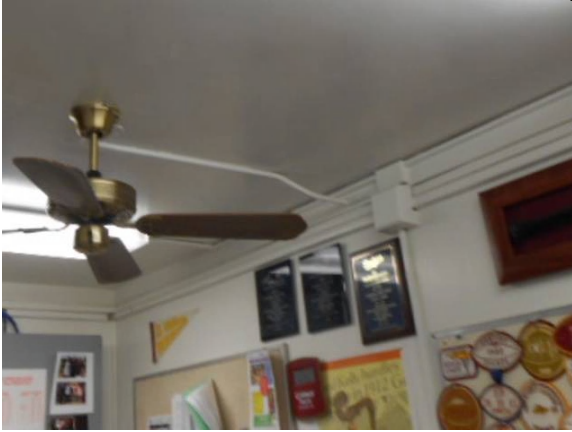
**System: D5020 - Branch Wiring**

**Location:** Typical for entire building  
**Material:** System  
**Distress:** Beyond Service Life  
**Category:** Capital Renewal  
**Priority:** 4 - Recommended (Years 6-10)  
**Correction:** Renew System  
**Qty:** 1-Ea.  
**Estimate:** \$996,041.91  
**Assessor Name:** Eduardo Lopez  
**Date Created:** 01/24/2013

**Notes:** The branch wiring, electrical panels and devices are mostly original to the building age. It is recommended to be replaced during the next major renovation.

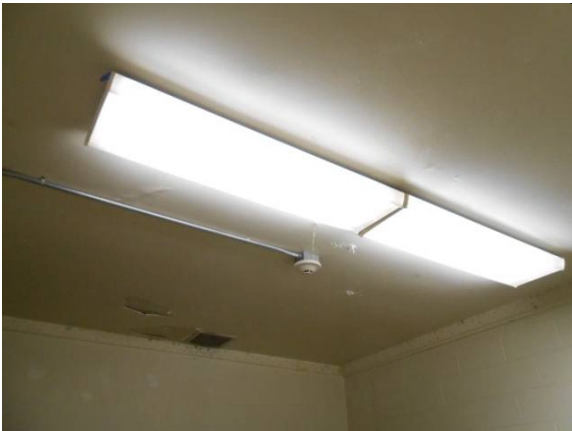
**System: D5020 - Lighting**

**Location:** Typical for entire building  
**Material:** System  
**Distress:** Beyond Expected Life  
**Category:** Capital Renewal  
**Priority:** 4 - Recommended (Years 6-10)  
**Correction:** Renew System  
**Qty:** 1-Ea.  
**Estimate:** \$783,323.01  
**Assessor Name:** Eduardo Lopez  
**Date Created:** 01/30/2013

**Notes:** T8 fluorescent lamps and ballasts were updated; however light fixtures, switches and wiring are original to building age and it is recommended to be replaced during next remodel or renovation.

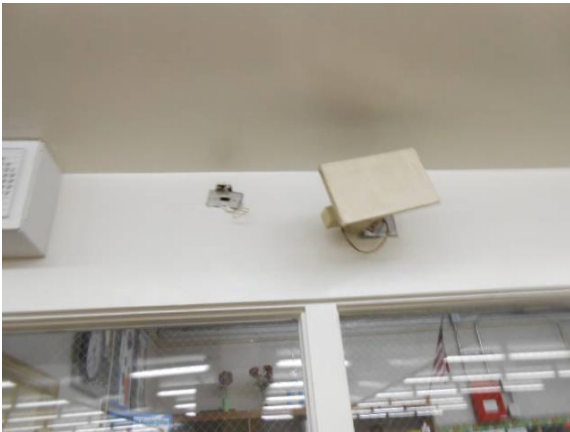
**System: D5030920 - Public Address / Clock System**

**Location: Typical for entire building**

**Priority: 4 - Recommended (Years 6-10)**

Notes: Clock System is needing upgrades. Recommend replacing and enhancing during the next building renovation.

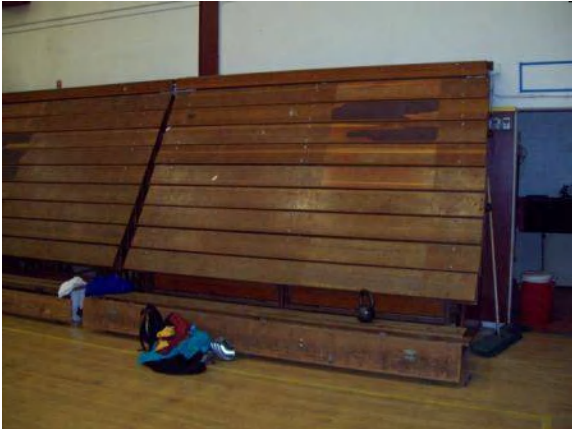
**System: E2010 - Fixed Furnishings**

**Location:** Building wide.  
**Material:** Fixed Furnishings - Bleachers telescoping  
**Distress:** Beyond Expected Life  
**Category:** Capital Renewal  
**Priority:** 3 - Necessary/Not Yet Critical (Years 2-5)  
**Correction:** Gym bleachers telescoping minimum  
**Qty:** 1,600-Seat  
**Estimate:** \$595,975.68  
**Assessor Name:** Ann Buerger Linden  
**Date Created:** 01/29/2013

**Notes:** Bleachers are original and in worn condition and difficult to operate.

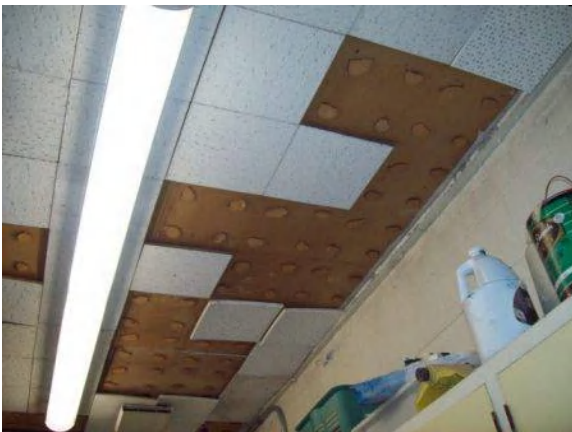
**System: F2020 - Hazardous Components Abatement**

**Location:** Friable material in flex collars at gym ceiling, pipe fitting insulation may remain inside walls, weight and wrestling room ceilings, and fire door insulation. Non-friable material in floor tiles, ceiling tile glue, gym interior plaster, and exterior stucco soffits  
**Material:** Removal of Hazardous Components  
**Distress:** Beyond Expected Life  
**Category:** Capital Renewal  
**Priority:** 3 - Necessary/Not Yet Critical (Years 2-5)  
**Correction:** Abate all ACM in building  
**Qty:** 30,246-S.F.  
**Estimate:** \$266,551.95  
**Assessor Name:** Ann Buerger Linden  
**Date Created:** 01/29/2013

**Notes:** The AHERA six-month surveillance of asbestos-containing materials - Summer 2012, identifies ACM at this building. Complete abatement is recommended.

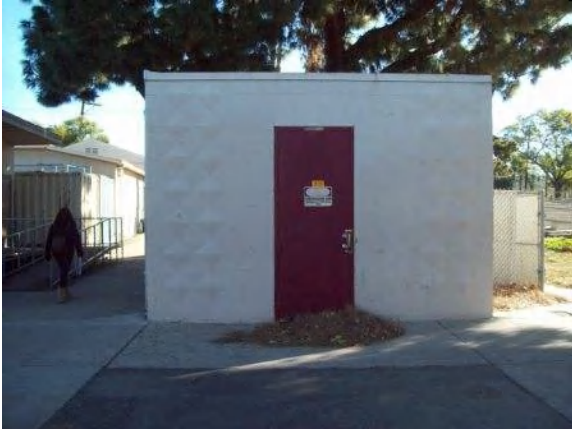
### System: B2030 - Exterior Doors

**Location:** Exterior doors.  
**Material:** System  
**Distress:** Beyond Expected Life  
**Category:** Capital Renewal  
**Priority:** 4 - Recommended (Years 6-10)  
**Correction:** Renew System  
**Qty:** 1-Ea.  
**Estimate:** \$20,703.58  
**Assessor Name:** Eduardo Lopez  
**Date Created:** 01/27/2013

**Notes:** Doors, while expired, are infrequently used and in fair condition. System renewal at the next renovation is recommended.

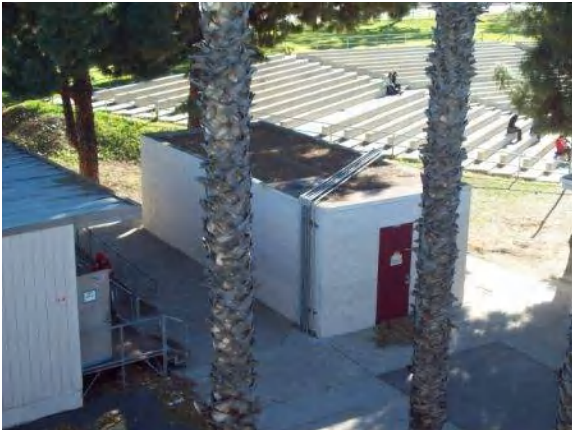
### System: B3010105 - Built-Up

**Location:** Roof  
**Material:** System  
**Distress:** Beyond Expected Life  
**Category:** Capital Renewal  
**Priority:** 3 - Necessary/Not Yet Critical (Years 2-5)  
**Correction:** Renew System  
**Qty:** 1-Ea.  
**Estimate:** \$5,486.18  
**Assessor Name:** Eduardo Lopez  
**Date Created:** 01/27/2013

**Notes:** The roof is assumed to be at the end of its expected life.

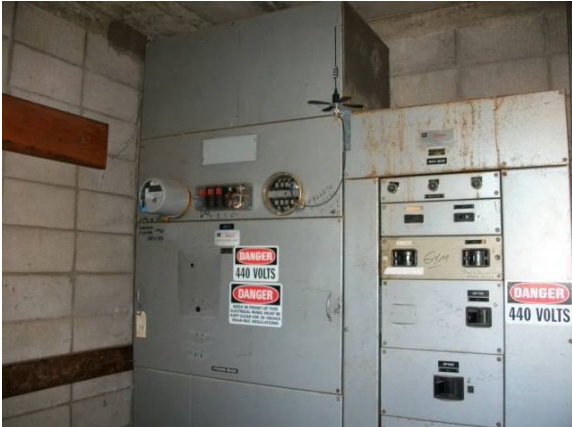
**System: D5010 - Electrical Service/Distribution**

**Location:** Typical for entire building  
**Material:** System  
**Distress:** Beyond Expected Life  
**Category:** Capital Renewal  
**Priority:** 4 - Recommended (Years 6-10)  
**Correction:** Renew System  
**Qty:** 1-Ea.  
**Estimate:** \$6,614.78  
**Assessor Name:** Eduardo Lopez  
**Date Created:** 01/27/2013

Notes: Electrical/Service Distribution is original to building construction date and it is recommended to be replaced during next remodel or renovation.

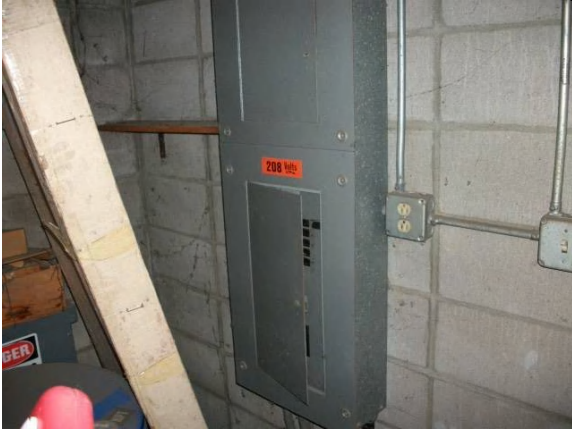
### System: D5020 - Branch Wiring

**Location:** Typical for entire building

**Priority:** 4 - Recommended (Years 6-10)

**Notes:** Branch Wiring is original to building construction date and it is recommended to be replaced during next remodel or renovation.

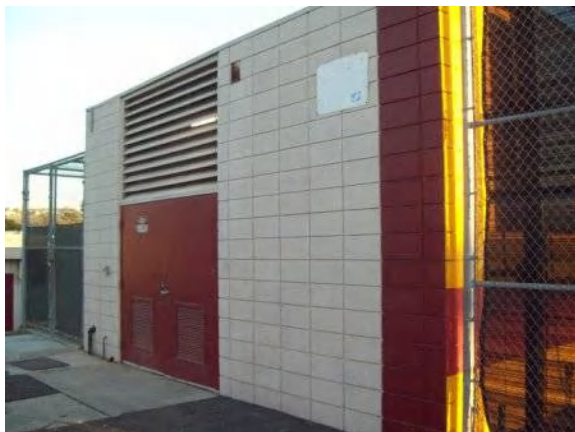
### System: B2030 - Exterior Doors

**Location:** Exterior doors.  
**Material:** System  
**Distress:** Beyond Expected Life  
**Category:** Capital Renewal  
**Priority:** 3 - Necessary/Not Yet Critical (Years 2-5)  
**Correction:** Renew System  
**Qty:** 1-Ea.  
**Estimate:** \$29,297.47  
**Assessor Name:** Eduardo Lopez  
**Date Created:** 01/27/2013

**Notes:** Exterior doors are beyond their expected life. Replace doors, hardware and frames.

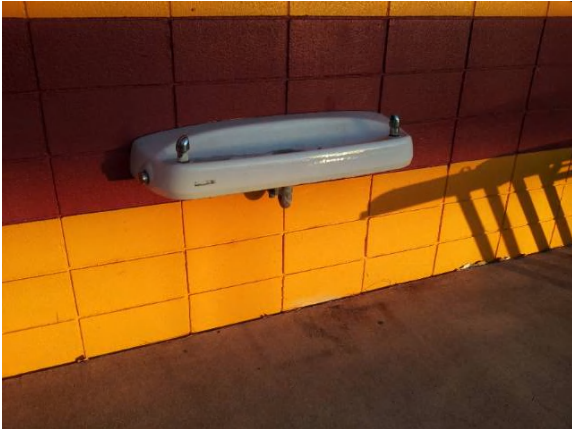
**System: D2010810 - Drinking Fountain Systems**

**Location:** West side of building  
**Material:** System  
**Distress:** Beyond Expected Life  
**Category:** Capital Renewal  
**Priority:** 4 - Recommended (Years 6-10)  
**Correction:** Renew System  
**Qty:** 1-Ea.  
**Estimate:** \$2,689.63  
**Assessor Name:** Eduardo Lopez  
**Date Created:** 01/27/2013

**Notes:** Drinking Fountain is original to building construction date and it is recommended to be replaced during next remodel or renovation.

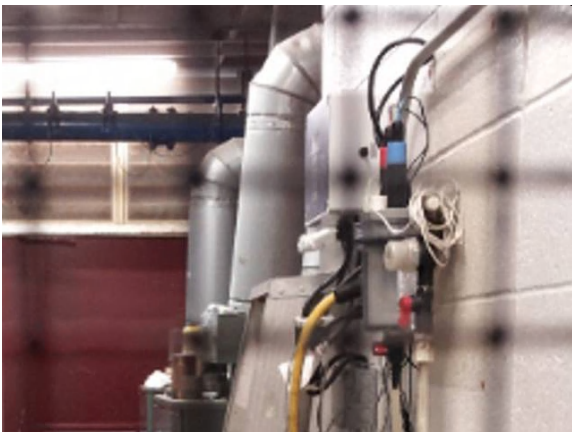
**System: D3040 - Distribution Systems**

**Location:** Typical for entire building  
**Material:** System  
**Distress:** Beyond Expected Life  
**Category:** Capital Renewal  
**Priority:** 4 - Recommended (Years 6-10)  
**Correction:** Renew System  
**Qty:** 1-Ea.  
**Estimate:** \$16,061.76  
**Assessor Name:** Eduardo Lopez  
**Date Created:** 01/27/2013

**Notes:** Distribution System is beyond its expected life and it is recommended to be replaced during the next major renovation.

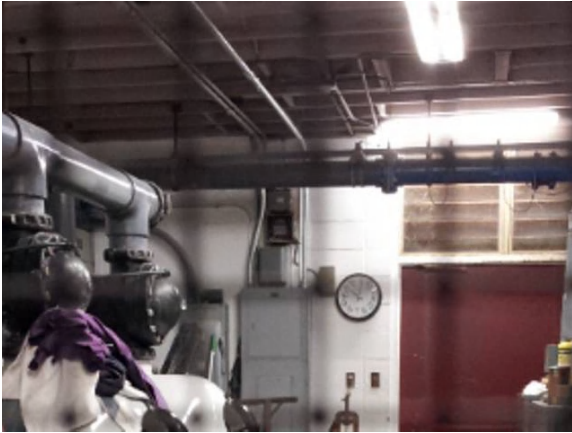
**System: D4010 - Sprinklers**

**Location:** Typical for entire building  
**Material:** System  
**Distress:** Missing  
**Category:** Capital Renewal  
**Priority:** 5 - Codes or Standards Compliance  
**Correction:** Renew System  
**Qty:** 1-Ea.  
**Estimate:** \$5,464.80  
**Assessor Name:** Eduardo Lopez  
**Date Created:** 01/27/2013

**Notes:** Building is not sprinklered and it's recommended to be added during next major renovation.

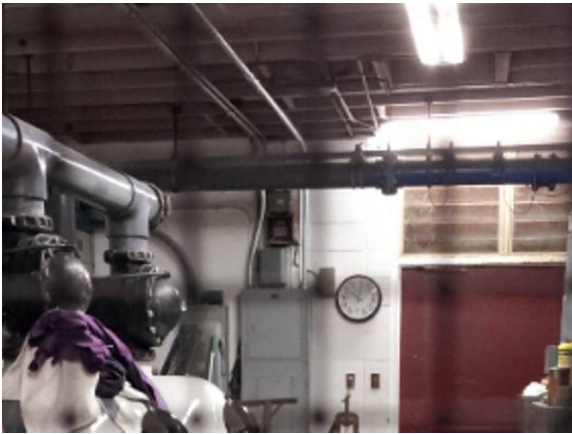
**System: D5010 - Electrical Service/Distribution**

**Location:** Typical for entire building  
**Material:** System  
**Distress:** Beyond Expected Life  
**Category:** Capital Renewal  
**Priority:** 4 - Recommended (Years 6-10)  
**Correction:** Renew System  
**Qty:** 1-Ea.  
**Estimate:** \$6,016.03  
**Assessor Name:** Eduardo Lopez  
**Date Created:** 01/27/2013

**Notes:** The main electrical panels, distribution panel boards and feeders are mostly original to the building age. It is recommended to be replaced during the next major renovation.

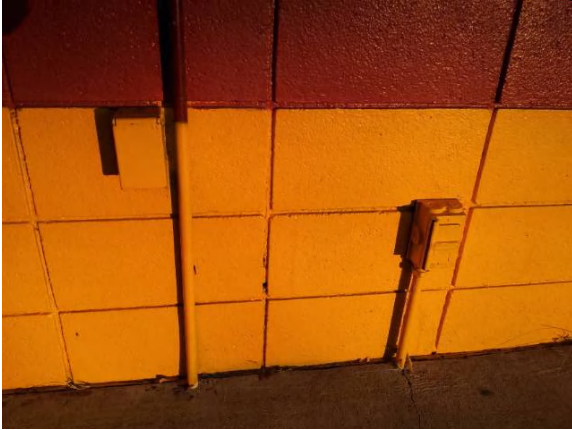
### System: D5020 - Branch Wiring

**Location:** Typical for entire building  
**Material:** System  
**Distress:** Beyond Expected Life  
**Category:** Capital Renewal  
**Priority:** 4 - Recommended (Years 6-10)  
**Correction:** Renew System  
**Qty:** 1-Ea.  
**Estimate:** \$16,517.95  
**Assessor Name:** Eduardo Lopez  
**Date Created:** 01/27/2013

**Notes:** The branch wiring, electrical panels and devices are mostly original to the building age. It is recommended to be replaced during the next major renovation.

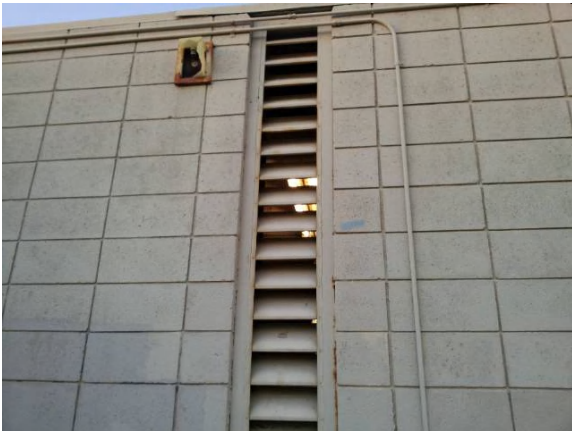
### System: D5020 - Lighting

**Location:** Typical for entire building  
**Material:** System  
**Distress:** Beyond Expected Life  
**Category:** Capital Renewal  
**Priority:** 4 - Recommended (Years 6-10)  
**Correction:** Renew System  
**Qty:** 1-Ea.  
**Estimate:** \$13,685.76  
**Assessor Name:** Eduardo Lopez  
**Date Created:** 01/27/2013

**Notes:** System is beyond its expected life and it is recommended to be scheduled for replacement during next remodel or renovation.

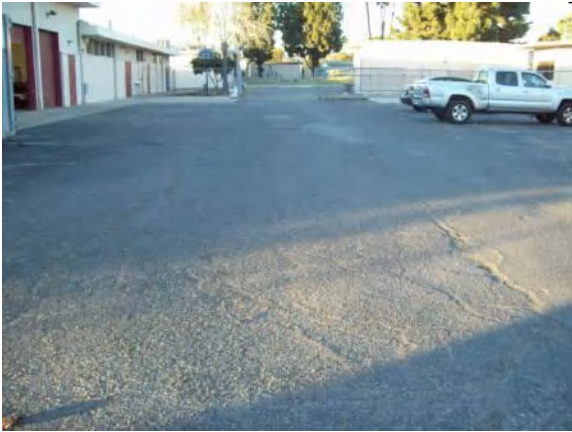
### System: G2010 - Roadways

**Location:** Asphalt areas around portables buildings G and H. Site entry to visitor parking.

**Notes:** Although a good portion of asphalt parking lots are recently refurbished, a considerable are of asphalt in poor condition remains. Some of these areas support student foot traffic and constitute tripping hazards. System renewal is recommended.

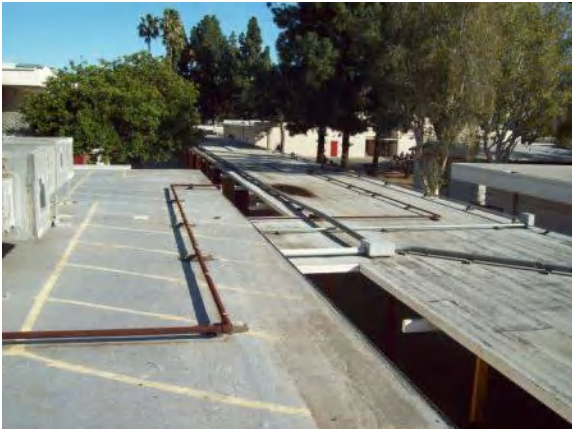
### System: G2030 - Pedestrian Paving

**Location:** Campus site main east west sidewalk.

**Material:** Covered Pedestrain Walkways

**Distress:** Failing

**Notes:** Covered walkways are deteriorating. Roofs are failing causing peeling paint and deck degradation.

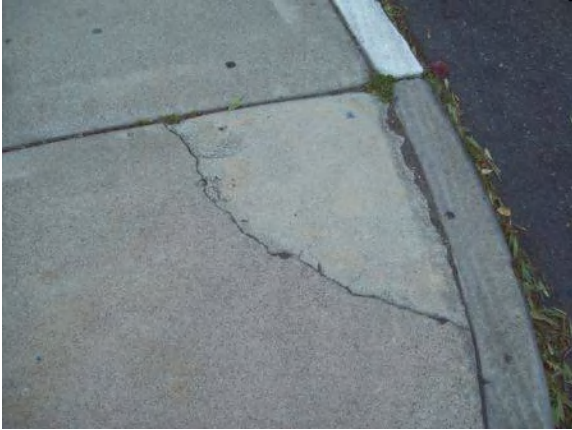
### System: G2030 - Pedestrian Paving

**Location:** Site pedestrian paving.  
**Material:** Concrete Roads & Walkways  
**Distress:** Damaged  
**Category:** Deferred Maintenance  
**Priority:** 3 - Necessary/Not Yet Critical (Years 2-5)  
**Correction:** Remove and replace concrete sidewalk  
**Qty:** 15,000-S.F.  
**Estimate:** \$224,856.00  
**Assessor Name:** Ann Buerger Linden  
**Date Created:** 02/05/2013

**Notes:** A fair amount of site pedestrian pavements including concrete and colored concrete patio pavers, are in distressed condition with cracking, settlement, and heaving.

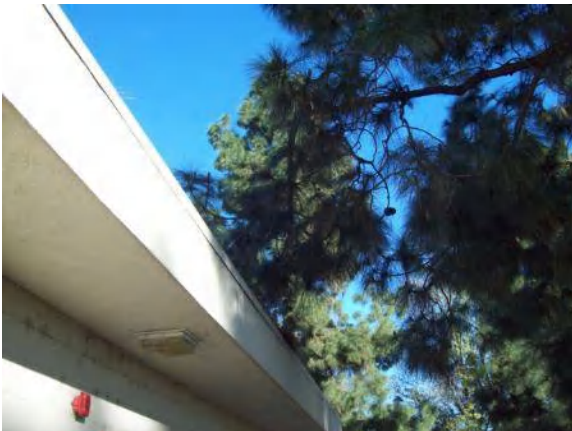
### System: G2050 - Landscaping and Irrigation

**Location:** Campus site.  
**Material:** System  
**Distress:** Beyond Expected Life  
**Category:** Capital Renewal  
**Priority:** 3 - Necessary/Not Yet Critical (Years 2-5)  
**Correction:** Renew System  
**Qty:** 1-Ea.  
**Estimate:** \$500,646.33  
**Assessor Name:** Ann Buerger Linden  
**Date Created:** 02/04/2013

**Notes:** Landscape and irrigation systems are beyond their expected life. Mature trees and shrubs frequently overhang building roofs creating maintenance issues with leaves, flowers, and seeds clogging roof drains. Root systems have heaved pavements. System renewal is recommended.

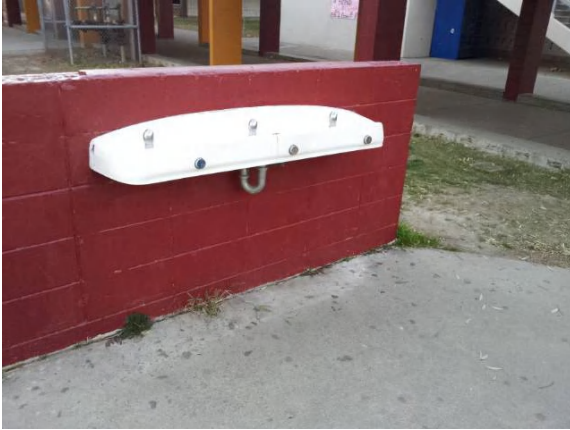
### System: G3010 - Water Supply

**Location:** Site Drinking Fountains  
**Material:** Drinking Fountain  
**Distress:** Beyond Expected Life  
**Category:** Deferred Maintenance  
**Priority:** 1 - Currently Critical (Immediate)  
**Correction:** Replace fountain drinking fountain  
**Qty:** 4-Ea.  
**Estimate:** \$8,513.16  
**Assessor Name:** Sonny Satterfield  
**Date Created:** 01/28/2013

**Notes:** Replace Drinking Fountains during next remodel or renovation.

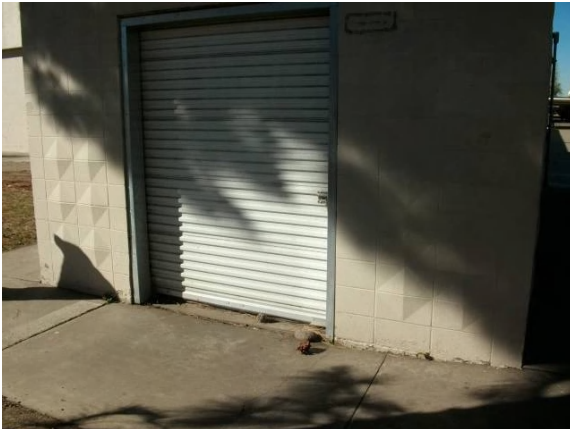
### System: G4010 - Electrical Distribution

**Location:** Site Main Electrical Distrubution and UG feeders to buildings  
**Material:** System  
**Distress:** Beyond Expected Life  
**Category:** Capital Renewal  
**Priority:** 4 - Recommended (Years 6-10)  
**Correction:** Renew System  
**Qty:** 1-Ea.  
**Estimate:** \$563,057.52  
**Assessor Name:** Eduardo Lopez  
**Date Created:** 01/27/2013

**Notes:** Site electrical incoming power switchgear, panels, equipment and underground feeders to buildings are beyond expected life; all are recommended to be replaced as part of the next major renovation.

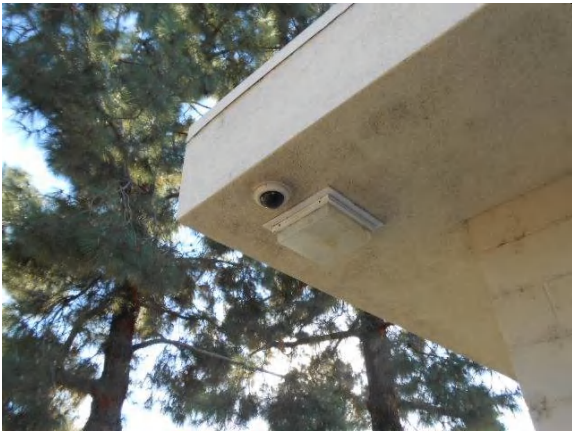
### System: G4030 - Site Communications and Security

**Location:** Site Communications and Security  
**Material:** Site Communications  
**Distress:** Inadequate  
**Category:** Capital Renewal  
**Priority:** 4 - Recommended (Years 6-10)  
**Correction:** Replace communications and security cabling  
**Qty:** 200-C.L.F.  
**Estimate:** \$275,927.04  
**Assessor Name:** Eduardo Lopez  
**Date Created:** 01/28/2013

**Notes:** Recommend upgrades and replacing as needed all communications and security cabling and equipment for enhancements.
