Orange Unified School District

Facilities Condition Assessment for:

Villa Park High School
18042 Taft Avenue
Villa Park, CA 92861

Campus Report

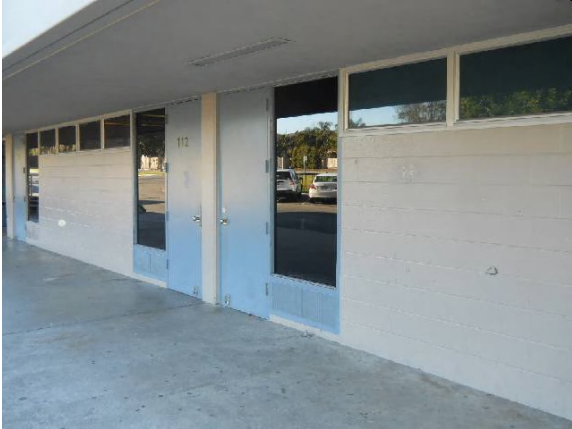
System: B2020 - Exterior Windows

Location: Throught the building
Material: System
Distress: Beyond Service Life
Category: Capital Renewal
Priority: 3 - Necessary/Not Yet Critical (Years 2-5)
Correction: Renew System
Qty: 1-Ea.
Estimate: \$629,707.48
Assessor Name: Dave Cunningham
Date Created: 01/25/2013

Notes: Exterior window systems are original construction, not energy efficient, beyond expected service life.
Recommend replacement during school renovations

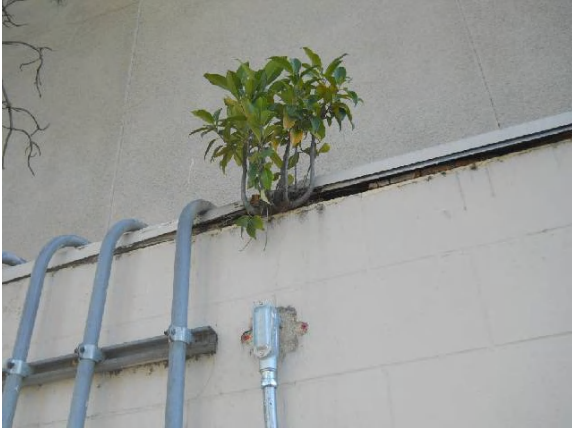
System: B3010105 - Built-Up

Location: Roof, West End, lower level
Material: Built-Up Roofing
Distress: Damaged
Category: Deferred Maintenance
Priority: 1 - Currently Critical (Immediate)
Correction: Minor membrane repairs - (2% of roof area) built-u
Qty: 2-Sq.
Estimate: \$1,549.09
Assessor Name: Dave Cunningham
Date Created: 01/28/2013

Notes: Roof had a small tree/bush growing our of a flashing/coping joint. Repair

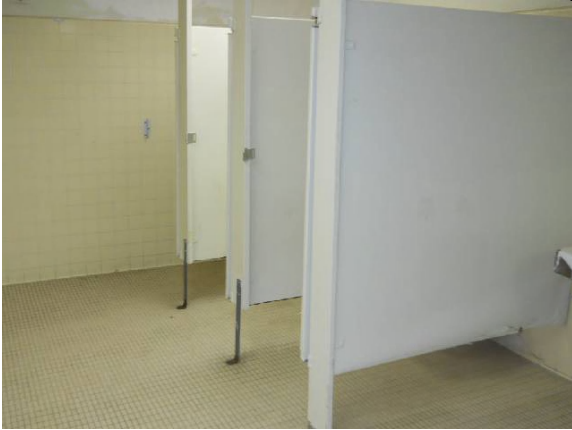
System: C1030 - Fittings

Location: All Restrooms(except Boys Toilet 17 - remodeled in 2004)

Notes: All fittings are original construction equipment and are damaged, rusted, and beyond expected useful service life. Recommend replacement during school renovations

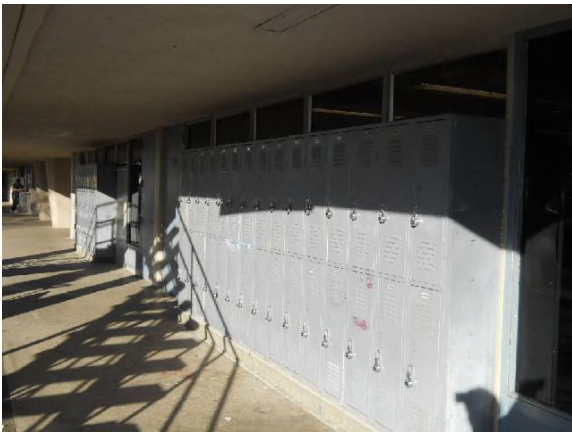
System: C1030 - Fittings

Location: Exterior hallways, circulation area

Material: Fixed Furnishings - Lockers

Priority: 4 - Recommended (Years 6-10)

Notes: All student lockers are beyond expected service life.

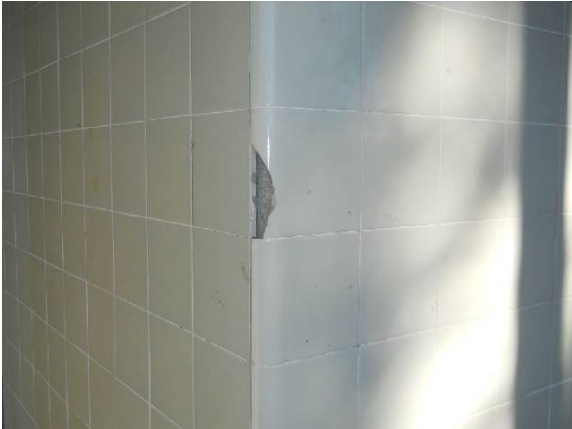
System: C3010 - Wall Finishes

Location: Throughout the building
Material: System
Distress: Beyond Service Life
Category: Deferred Maintenance
Priority: 3 - Necessary/Not Yet Critical (Years 2-5)
Correction: Renew System
Qty: 1-Ea.
Estimate: \$616,066.62
Assessor Name: Dave Cunningham
Date Created: 01/25/2013

Notes: Wall finishes, painted CMU, painted stucco, painted drywall, ceramic tiles in RR's, are all beyond expected service life. Recommend renewal of system during school renovations.

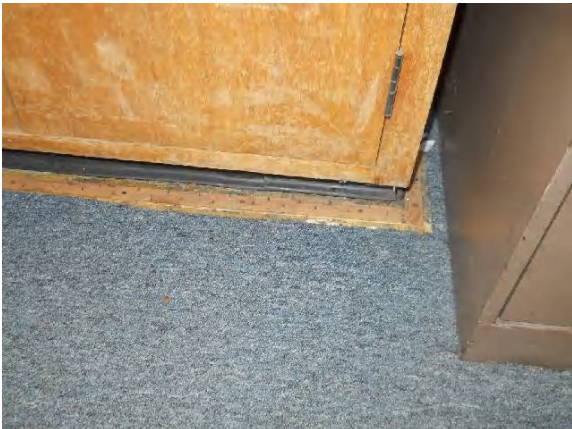
System: C3020210 - Carpet

Location: Classrooms/Offices ;Career center,Library,
Principal Office Classroom/office
01,07,08,111, 215
Material: System
Distress: Beyond Service Life
Category: Capital Renewal
Priority: 4 - Recommended (Years 6-10)
Correction: Renew System
Qty: 1-Ea.
Estimate: \$87,201.81
Assessor Name: Dave Cunningham
Date Created: 01/25/2013

Notes: Carpet in many areas is aged, worn, stained, and beyond service life. Recommend replacement during school renovations.

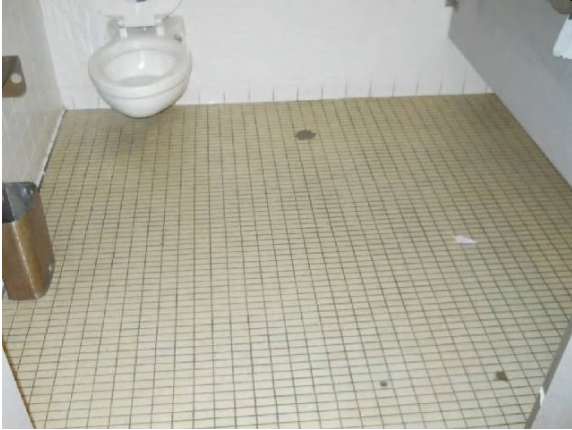
System: C3020210 - Ceramic Tile

Location: Girls toilet 08, Girls toilet11, Boys toilet 15.
Boys tiilet 17 was remodeled in 2004

Priority: 4 - Recommended (Years 6-10)

Notes: Ceramic floor tile is original construction, beyond expected service life. Recommend replacement during school renovations.

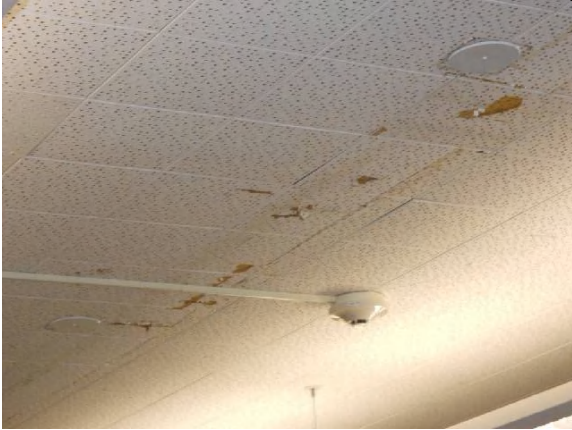
System: C3030 - Ceiling Finishes

Location: Throughout the building
Material: System
Distress: Beyond Service Life
Category: Capital Renewal
Priority: 4 - Recommended (Years 6-10)
Correction: Renew System
Qty: 1-Ea.
Estimate: \$1,094,301.39
Assessor Name: Dave Cunningham
Date Created: 01/25/2013

Notes: Ceilings are glue on accoustical tile, on concrete and hard deck ceilings. All ceilings have been identified as Asbestos Containing materials. Recommend replacement during next school renovation

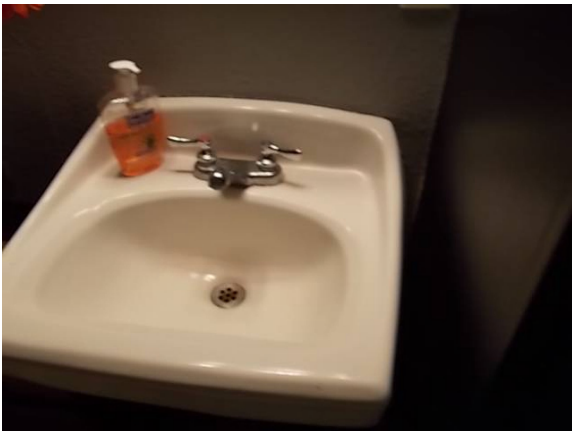
System: D2010 - Plumbing Fixtures

Location: Staff Restroom-Principal Office, Library, Teachers Workroom, Girls/Boys restrooms 100/200
Material: Lavatory, Vitreous China
Distress: Beyond Expected Life
Category: Deferred Maintenance
Priority: 3 - Necessary/Not Yet Critical (Years 2-5)
Correction: Replace lavatory, vitreous china
Qty: 15-Ea.
Estimate: \$16,124.83
Assessor Name: Sonny Satterfield
Date Created: 01/21/2013

Notes: Replace during next remodel or renovation

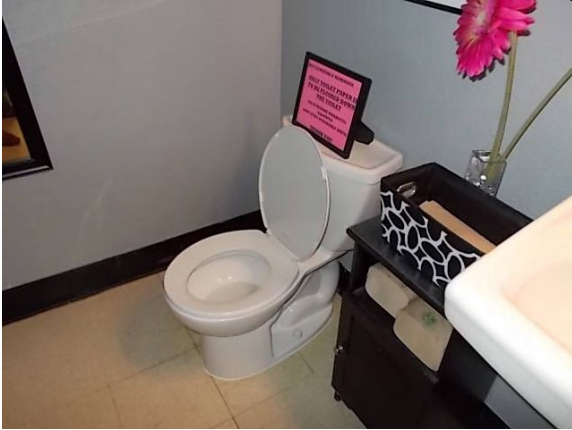
System: D2010 - Plumbing Fixtures

Location: Staff Restroom-Principal Office, Library, Teachers Workroom, Girls/Boys restrooms 100/200

Material: Flush-Tank Water Closet

Priority: 4 - Recommended (Years 6-10)

Correction: Replace two piece water closet flush-tank

Notes: Replace during next remodel or renovation

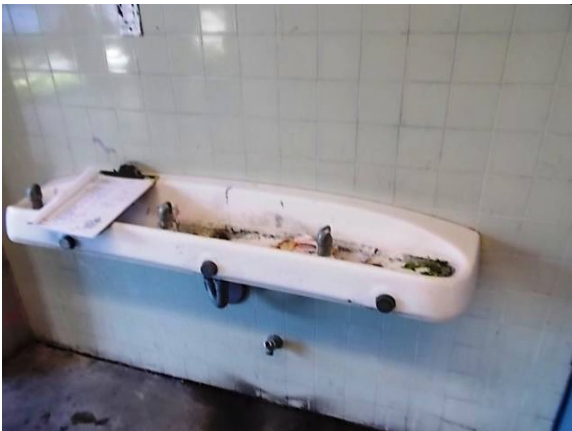
System: D2010 - Plumbing Fixtures

Location: 100/200 East and West locations-typical for (4)

Material: Drinking Fountain

Priority: 4 - Recommended (Years 6-10)

Correction: Replace fountain drinking fountain

Notes: Replace wall mounted bubblers with (2) each electric drinking fountains at location and (1) ADA each

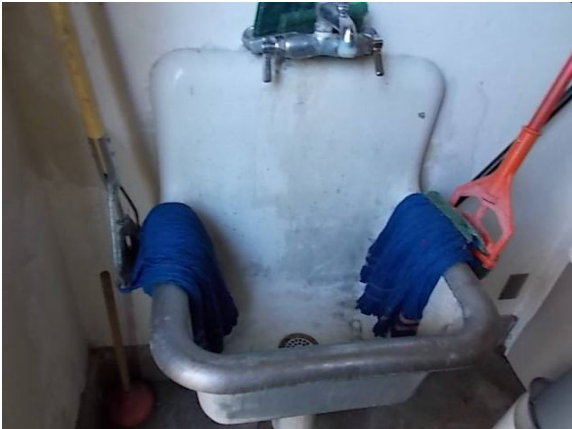
System: D2010 - Plumbing Fixtures

Location: Custodial closets
Material: Service/Utility Sink
Distress: Beyond Expected Life
Category: Capital Renewal
Priority: 4 - Recommended (Years 6-10)
Correction: Replace sink and fixtures
Qty: 4-Ea.
Estimate: \$25,905.77
Assessor Name: Sonny Satterfield
Date Created: 01/21/2013

Notes: Replace during next remodel or renovation

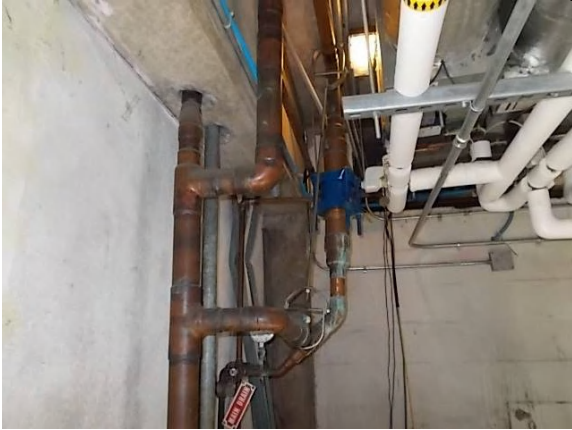
System: D2020 - Domestic Water Distribution

Location: Typical for system-all locations
Material: System
Distress: Beyond Expected Life
Category: Capital Renewal
Priority: 4 - Recommended (Years 6-10)
Correction: Renew System
Qty: 1-Ea.
Estimate: \$484,499.85
Assessor Name: Sonny Satterfield
Date Created: 01/21/2013

Notes: Replace system during next remodel or renovation, domestic hot water is currently furnished for custodial closets only.

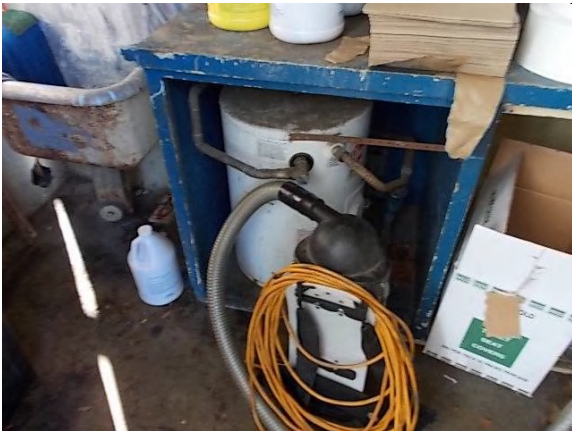
System: D2030 - Sanitary Waste

Location: System typical
Material: System
Distress: Beyond Expected Life
Category: Capital Renewal
Priority: 4 - Recommended (Years 6-10)
Correction: Renew System
Qty: 1-Ea.
Estimate: \$300,724.05
Assessor Name: Sonny Satterfield
Date Created: 01/21/2013

Notes: Replace all above grade sanitary waste and vent piping system during next remodel or renovation; below grade as required.

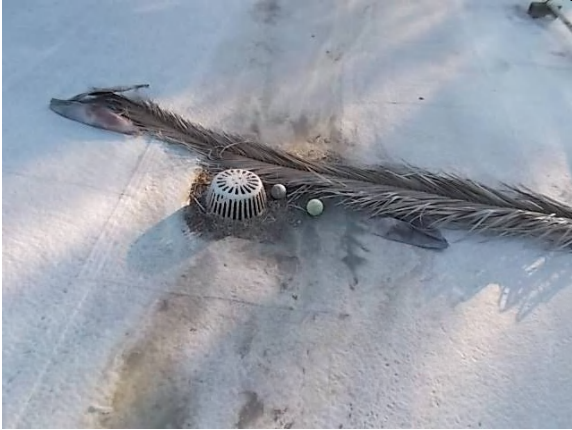
System: D2040 - Rain Water Drainage

Location: Typical for all locations system wide.
Material: System
Distress: Beyond Expected Life
Category: Capital Renewal
Priority: 4 - Recommended (Years 6-10)
Correction: Renew System
Qty: 1-Ea.
Estimate: \$48,728.43
Assessor Name: Sonny Satterfield
Date Created: 01/21/2013

Notes: Replace system during next remodel or renovation.

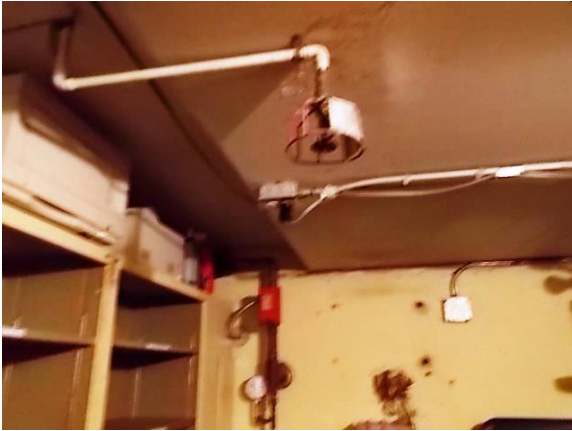
System: D4010 - Sprinklers

Location: System Renewal-Typical for entire building
Material: System
Distress: Beyond Expected Life
Category: Capital Renewal
Priority: 5 - Codes or Standards Compliance
Correction: Renew System
Qty: 1-Ea.
Estimate: \$555,314.29
Assessor Name: Sonny Satterfield
Date Created: 01/21/2013

Notes: Building is only partially fire sprinkled, wet type fire sprinklers are currently located in the storage and electrical closets. Recommend adding building wide fire sprinklers system during next major renovation.

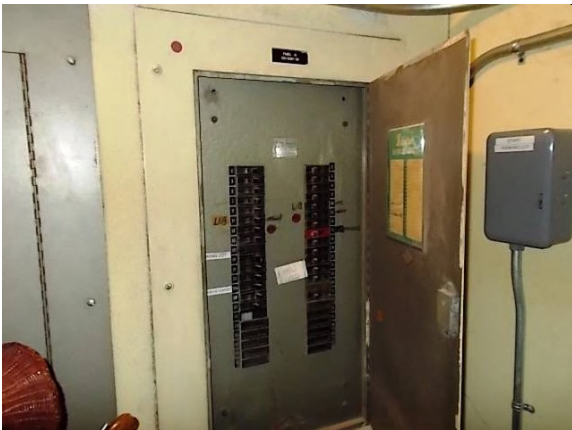
System: D5010 - Electrical Service/Distribution

Location: Typical for all locations system wide.
Material: System
Distress: Beyond Expected Life
Category: Capital Renewal
Priority: 4 - Recommended (Years 6-10)
Correction: Renew System
Qty: 1-Ea.
Estimate: \$448,301.59
Assessor Name: Sonny Satterfield
Date Created: 01/22/2013

Notes: The main electrical panels, distribution panel boards and feeders are mostly original to the building construction date of 1964 and therefore beyond expected life. The system is recommended to be replaced during the next major renovation.

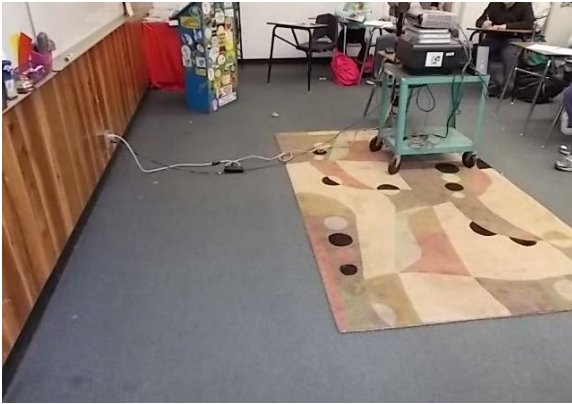
System: D5020 - Branch Wiring

Location: Typical for all locations system wide.
Material: System
Distress: Beyond Expected Life
Category: Capital Renewal
Priority: 4 - Recommended (Years 6-10)
Correction: Renew System
Qty: 1-Ea.
Estimate: \$1,547,475.83
Assessor Name: Sonny Satterfield
Date Created: 01/22/2013

Notes: The branch wiring, electrical panels and devices are mostly original to the building construction date of 1964 and therefore beyond expected life. The system is recommended to be replaced during the next major renovation

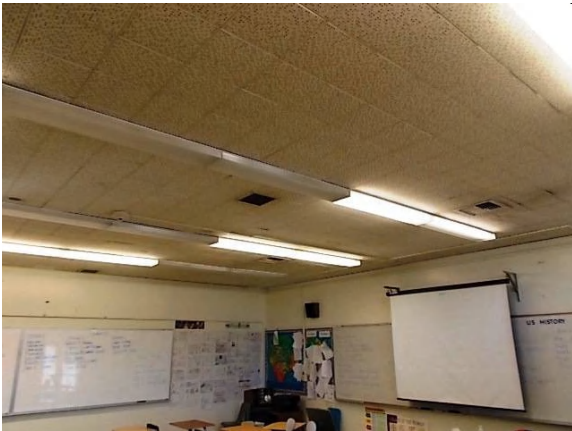
System: D5020 - Lighting

Location: Room #110, Girls/Boys-200 West/East
toilets, Room #201, 216A & B, 215B, Storage
Rms
Material: Fluorescent Lighting
Distress: Beyond Expected Life
Category: Capital Renewal
Priority: 4 - Recommended (Years 6-10)
Correction: Add new fluorescent lighting
Qty: 175-Ea.
Estimate: \$64,260.00
Assessor Name: Sonny Satterfield
Date Created: 01/22/2013

Notes: Replace lighting fixtures during next remodel or renovation. Most of the building has new lighting fixtures with the exception of these rooms.

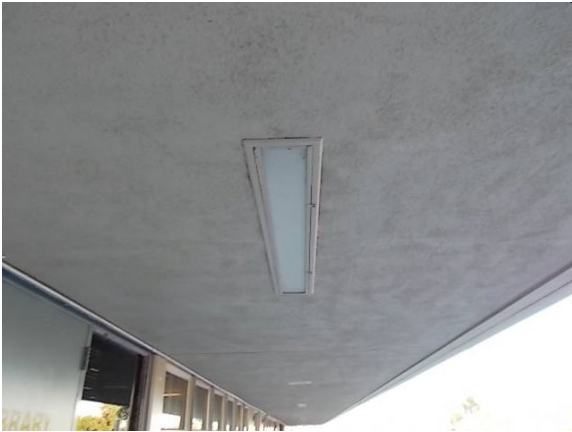
System: D5020 - Lighting

Location: Canopy walkway 1st and 2nd floor and locker pod soffit/ceilings

Material: HP Sodium Fixture, 250 W

Priority: 4 - Recommended (Years 6-10)

Correction: Replace fixture H.P. sodium fixture, 250 W

Notes: Replace existing 1 X 4 recessed fluorescent lighting with energy efficient HPS or LED type fixtures.

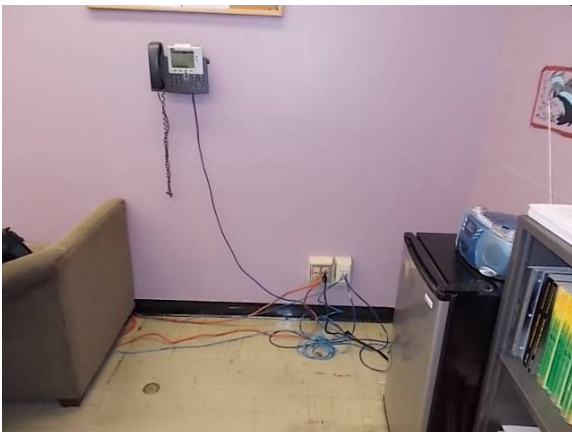
System: D5030920 - LAN System-VOIP

Location: Typical for all locations system wide.

Material: Lan System

Distress: Inadequate

Priority: 4 - Recommended (Years 6-10)

Notes: Most of the existing LAN/VOIP outlets will require new drops or relocation and upgrade. Recommend replacing and enhancing during the next major building remodel.

Correction: Replace LAN System Drop CAT6

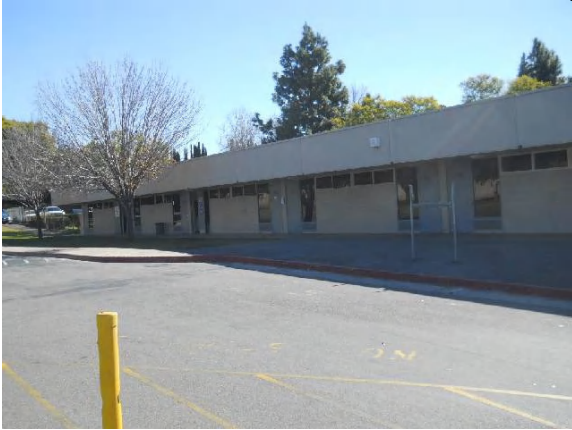
System: B2020 - Exterior Windows

Location: All exterior window systems
Material: System
Distress: Beyond Expected Life
Category: Capital Renewal
Priority: 3 - Necessary/Not Yet Critical (Years 2-5)
Correction: Renew System
Qty: 1-Ea.
Estimate: \$148,361.24
Assessor Name: Dave Cunningham
Date Created: 01/28/2013

Notes: Exterior window system is original construction, not energy efficient and beyond expected service life. Recommend replacement during school renovation.

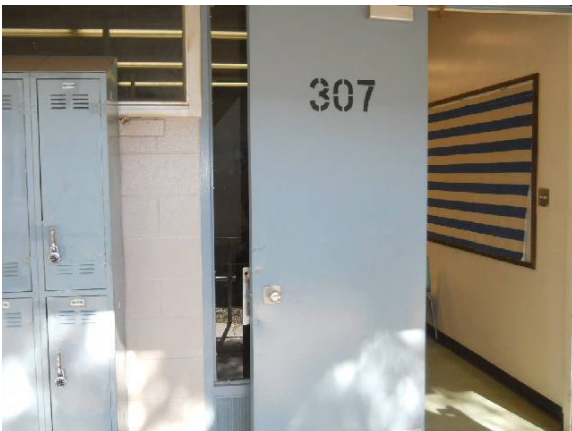
System: B2030 - Exterior Doors

Location: All exterior door systems
Material: System
Distress: Beyond Expected Life
Category: Capital Renewal
Priority: 3 - Necessary/Not Yet Critical (Years 2-5)
Correction: Renew System
Qty: 1-Ea.
Estimate: \$122,139.07
Assessor Name: Dave Cunningham
Date Created: 01/28/2013

Notes: Doors are original construction, beyond service life and not ADA compliant. Provide interior locking hardware at all classroom doors for security. Recommend replacement during school renovations

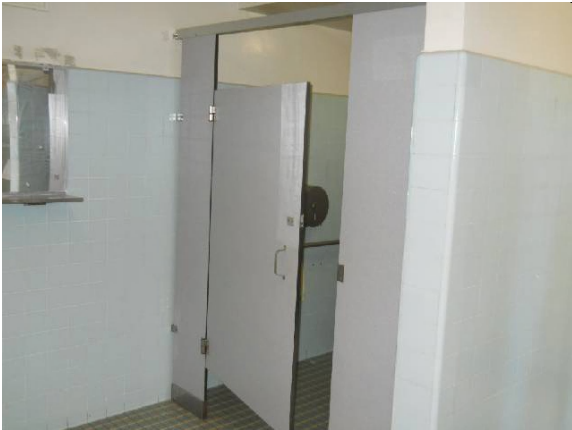
System: C1030 - Fittings

Location: Staff Toilet
Material: Toilet Partitions
Distress: Beyond Service Life
Category: Deferred Maintenance
Priority: 3 - Necessary/Not Yet Critical (Years 2-5)
Correction: Toilet partitions, laminate clad-overhead braced
Qty: 1-Ea.
Estimate: \$1,957.18
Assessor Name: Dave Cunningham
Date Created: 01/28/2013

Notes: Toilet partition is beyond expected service life

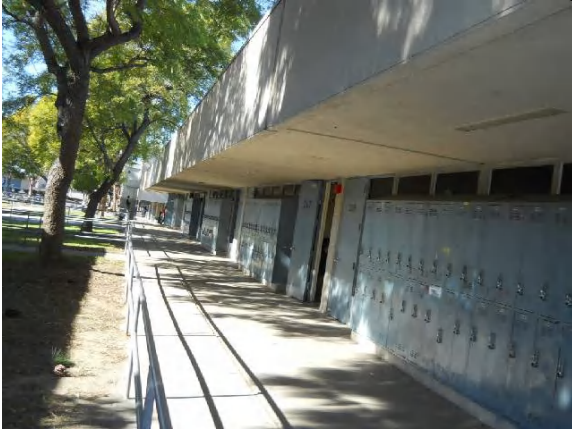
System: C1030 - Fittings

Location: Student lockers
Material: Fixed Furnishings - Lockers
Distress: Beyond Service Life
Category: Capital Renewal
Priority: 4 - Recommended (Years 6-10)
Correction: Student lockers stacked 2-high
Qty: 126-Ea.
Estimate: \$41,791.08
Assessor Name: Dave Cunningham
Date Created: 01/28/2013

Notes: All student lockers are beyond expected service life. Recommend replacement during school renovations

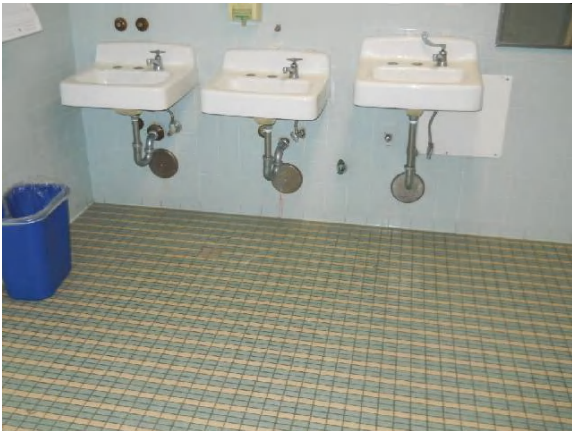
System: C3010 - Wall Finishes

Location: Throughout the building
Material: System
Distress: Beyond Expected Life
Category: Capital Renewal
Priority: 3 - Necessary/Not Yet Critical (Years 2-5)
Correction: Renew System
Qty: 1-Ea.
Estimate: \$157,671.36
Assessor Name: Dave Cunningham
Date Created: 01/28/2013

Notes: Wall finishes; painted drywall, painted stucco, painted CMU, ceramic wall tiles, are beyond expected service life. Recommend replacement / renewal during school renovations

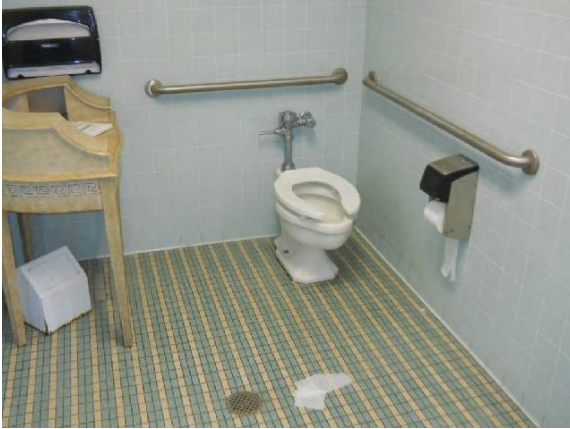
System: C3020210 - Ceramic Tile

Location: Staff Toilet, mens, Womens
Material: System
Distress: Beyond Expected Life
Category: Capital Renewal
Priority: 3 - Necessary/Not Yet Critical (Years 2-5)
Correction: Renew System
Qty: 1-Ea.
Estimate: \$14,495.04
Assessor Name: Dave Cunningham
Date Created: 01/28/2013

Notes: Ceramic floor tiles are original construction, beyond expected service life. Recommend replacement during school renovations

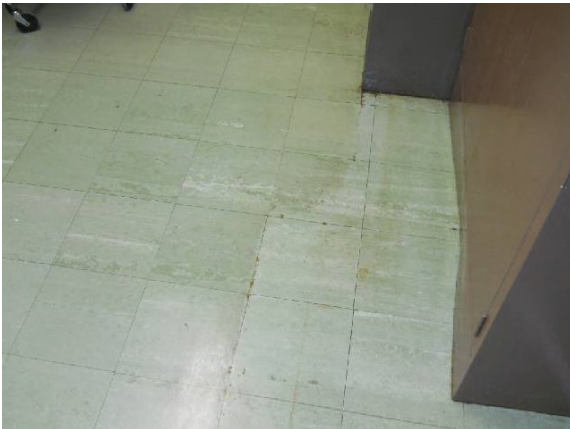
System: C3020410 - VCT - VAT

Location: All classrooms
Material: System
Distress: Beyond Expected Life
Category: Capital Renewal
Priority: 3 - Necessary/Not Yet Critical (Years 2-5)
Correction: Renew System
Qty: 1-Ea.
Estimate: \$86,539.91
Assessor Name: Dave Cunningham
Date Created: 01/28/2013

Notes: Floor covering is VAT, asbestos containing material. Floor covering is original construction and should be abated and replaced during school renovations

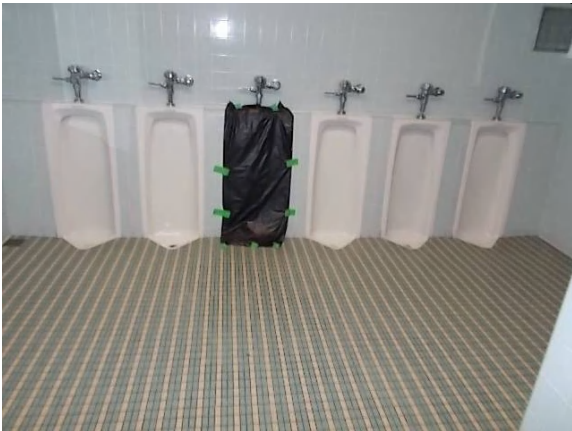
System: D2010 - Plumbing Fixtures

Location: Typical for all locations.
Material: System
Distress: Beyond Service Life
Category: Capital Renewal
Priority: 3 - Necessary/Not Yet Critical (Years 2-5)
Correction: Renew System
Qty: 1-Ea.
Estimate: \$137,380.32
Assessor Name: Sonny Satterfield
Date Created: 01/23/2013

Notes: Plumbing fixtures are mostly original to building construction date of 1964 and therefore are beyond expected life. Recommend replacing system during next remodel or renovation.

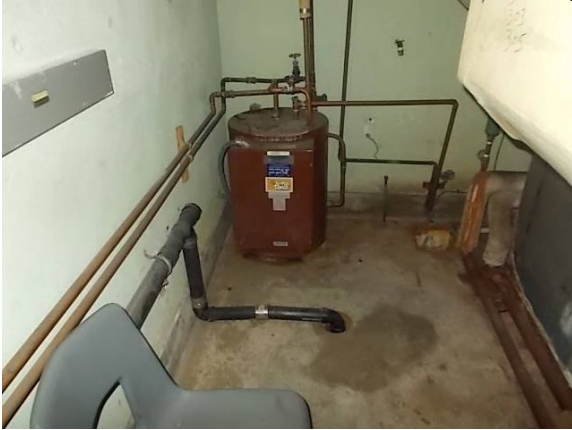
System: D2020 - Domestic Water Distribution

Location: Typical for all required locations system wide.

Notes: Replace system during next remodel or renovation, domestic hot water heater was installed in 1985; piping is mostly original to 1964.

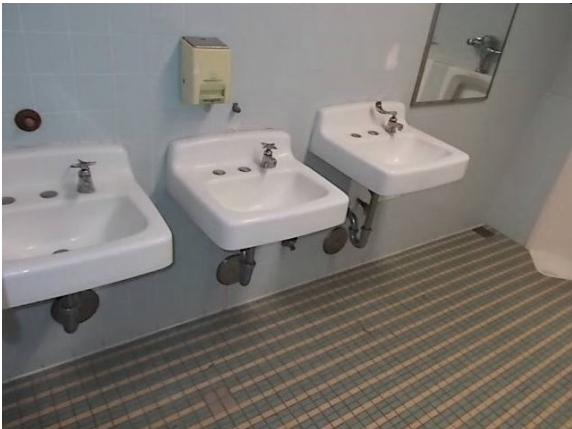
System: D2030 - Sanitary Waste

Location: Typical for all required locations system wide.

Notes: Recommend replacing all above grade sanitary waste and vent piping system during next remodel or renovation; below grade waste piping, recommend video inspection and replace as required.

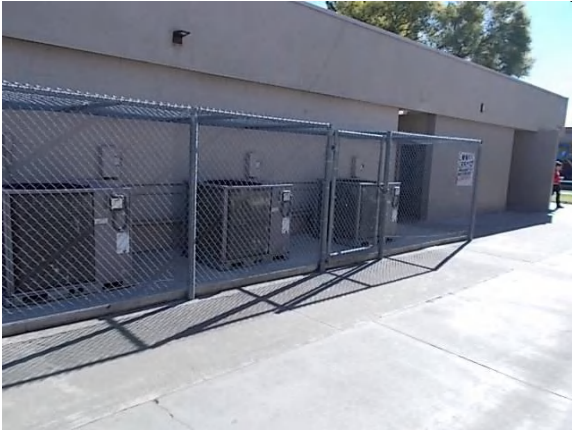
System: D3030 - Cooling Generating Systems

Location: Typical for all locations system wide.
Material: System
Distress: Beyond Expected Life
Category: Capital Renewal
Priority: 4 - Recommended (Years 6-10)
Correction: Renew System
Qty: 1-Ea.
Estimate: \$269,105.76
Assessor Name: Sonny Satterfield
Date Created: 01/23/2013

Notes: HVAC system was partially renewed in 1998; however most of the HVAC air handling units and air distribution duct and exhaust fans were installed in 1964 and beyond expected life. Fresh air supply to all areas is inadequate. An engineering study by a PE is recommended for the HVAC System with recommendations for upgrades and replacement, as required during the next major renovation.

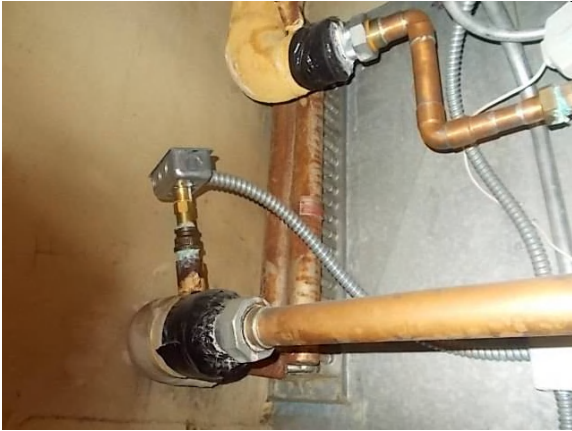
System: D3060 - Controls & Instrumentation

Location: Typical for all locations system wide.
Material: System
Distress: Beyond Expected Life
Category: Capital Renewal
Priority: 4 - Recommended (Years 6-10)
Correction: Renew System
Qty: 1-Ea.
Estimate: \$75,841.92
Assessor Name: Sonny Satterfield
Date Created: 01/23/2013

Notes: HVAC system was partially renewed in 1998; however most of the HVAC air handling units, air distribution duct and exhaust fans were installed in 1964 and beyond expected life. Fresh air supply to all areas is inadequate. An engineering study by a PE is recommended for the HVAC System with recommendations for upgrades and replacement, as required during the next major renovation.

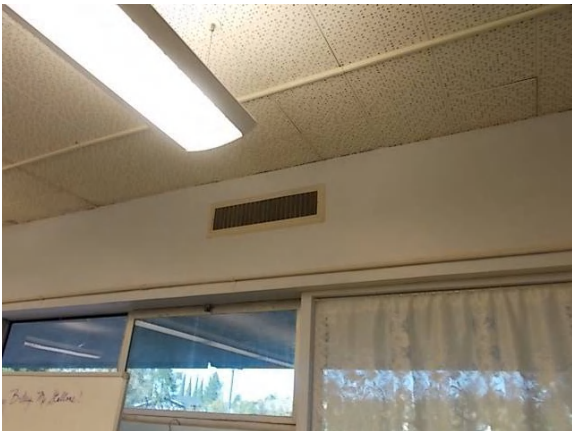
System: D3070 - Systems Testing & Balance

Location: Typical for all locations system wide.
Material: System
Distress: Beyond Expected Life
Category: Capital Renewal
Priority: 4 - Recommended (Years 6-10)
Correction: Renew System
Qty: 1-Ea.
Estimate: \$21,954.24
Assessor Name: Sonny Satterfield
Date Created: 01/23/2013

Notes: HVAC system was partially renewed in 1998; however most of the HVAC air handling units, air distribution duct and exhaust fans were installed in 1964 and beyond expected life. Fresh air supply to all areas is inadequate. An engineering study by a PE is recommended for the HVAC System with recommendations for upgrades and replacement, as required during the next major renovation.

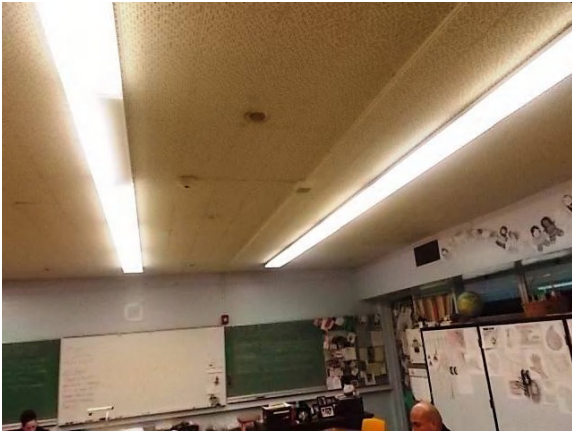
System: D4010 - Sprinklers

Location: Typical for all required locations system wide.

Distress: Missing

Notes: Recommend adding building wide, wet type fire sprinklers system during next major renovation.

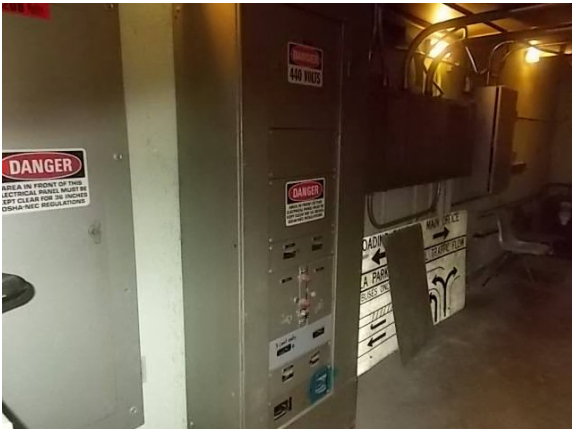
System: D5010 - Electrical Service/Distribution

Location: Typical for all required locations system wide.

Notes: The main electrical panels, distribution panel boards and feeders are mostly original to the building construction date of 1964 and therefore beyond expected life. The system is recommended to be replaced during the next major renovation.

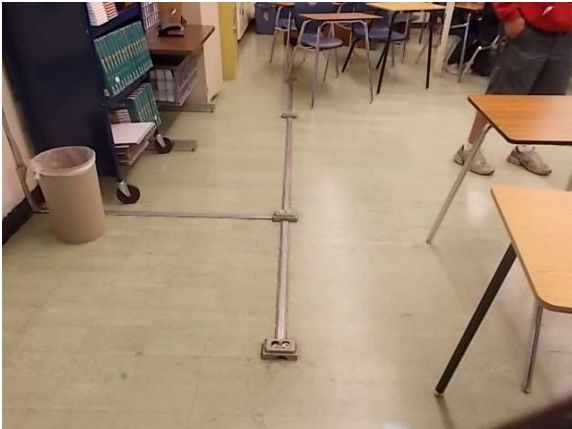
System: D5020 - Branch Wiring

Location: Typical for all required locations system wide.

Notes: The branch wiring, electrical panels and devices are mostly original to the building construction date of 1964 and therefore beyond expected life. The system is recommended to be replaced during the next major renovation.

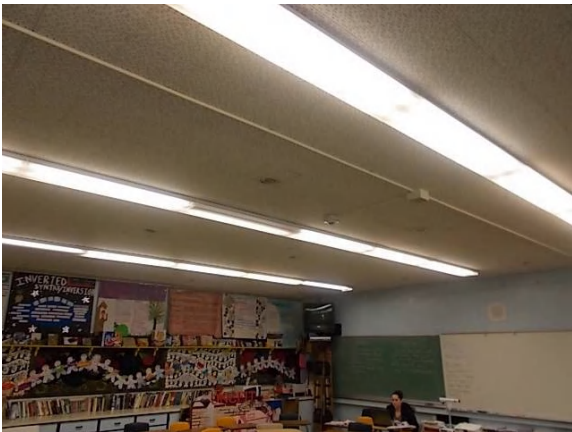
System: D5020 - Lighting

Location: Typical for all required locations system wide. 300 Building Classrooms are typical except for Classroom 301 and Darkroom 301

Notes: Recommend to replace lighting fixtures, switching and related wiring during next remodel or renovation.

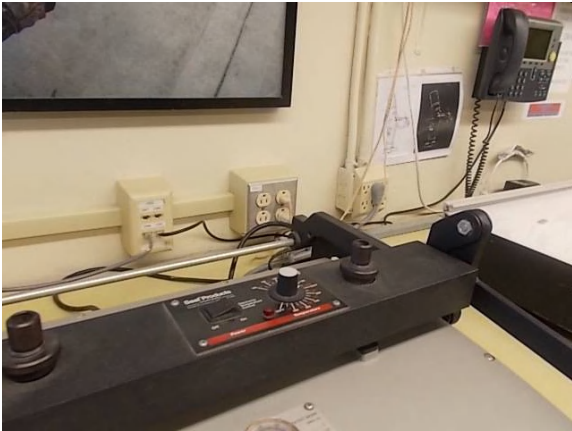
System: D5030920 - LAN System

Location: Typical for all required locations system wide.
Material: Lan System
Distress: Inadequate
Category: Capital Renewal
Priority: 4 - Recommended (Years 6-10)
Correction: Replace LAN System Drop CAT6
Qty: 18-Ea.
Estimate: \$7,062.29
Assessor Name: Sonny Satterfield
Date Created: 01/23/2013

Notes: Most of the existing LAN/VOIP outlets will require new drops or relocation and upgrade. Recommend replacing and enhancing during the next major building remodel.

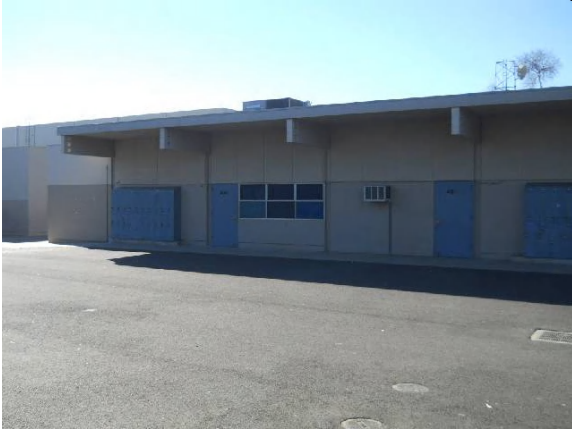
System: B2020 - Exterior Windows

Location: All exterior windows
Material: System
Distress: Beyond Expected Life
Category: Capital Renewal
Priority: 3 - Necessary/Not Yet Critical (Years 2-5)
Correction: Renew System
Qty: 1-Ea.
Estimate: \$28,979.98
Assessor Name: Dave Cunningham
Date Created: 01/28/2013

Notes: All windows are original construction, beyond expected service life. Recommend replacement during school renovations.

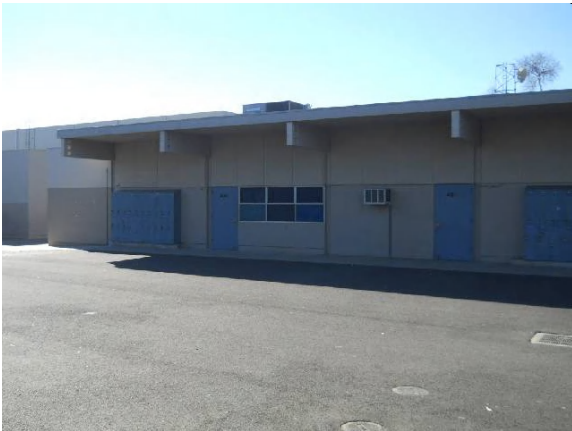
System: B2030 - Exterior Doors

Location: All exterior door systems
Material: System
Distress: Beyond Expected Life
Category: Capital Renewal
Priority: 3 - Necessary/Not Yet Critical (Years 2-5)
Correction: Renew System
Qty: 1-Ea.
Estimate: \$57,258.37
Assessor Name: Dave Cunningham
Date Created: 01/28/2013

Notes: Exterior door system is original construction, beyond expected service life, and not ADA compliant. Provide interior locking hardware at all classroom doors for security. Recommend replacement during school renovations

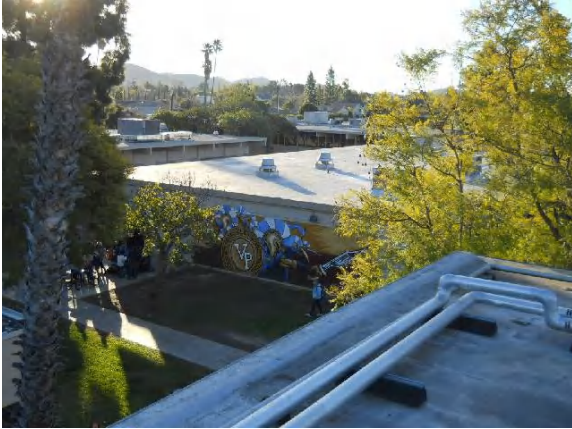
System: B3010105 - Built-Up

Location: Roof
Material: System
Distress: Beyond Expected Life
Category: Capital Renewal
Priority: 3 - Necessary/Not Yet Critical (Years 2-5)
Correction: Renew System
Qty: 1-Ea.
Estimate: \$211,320.81
Assessor Name: Dave Cunningham
Date Created: 01/28/2013

Notes: Roof is beyond expected service life.

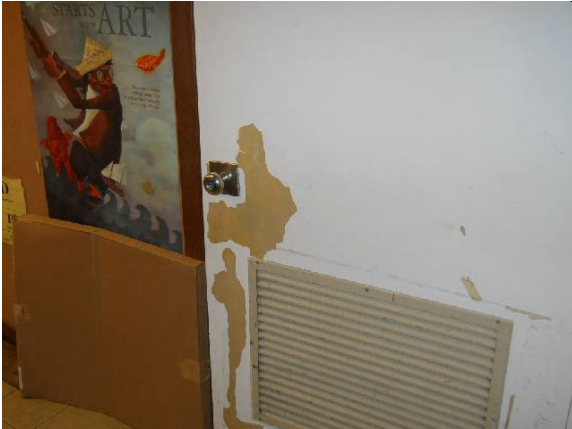
System: C1020 - Interior Doors

Location: All interior door systems
Material: System
Distress: Beyond Expected Life
Category: Capital Renewal
Priority: 3 - Necessary/Not Yet Critical (Years 2-5)
Correction: Renew System
Qty: 1-Ea.
Estimate: \$13,770.55
Assessor Name: Dave Cunningham
Date Created: 01/28/2013

Notes: Interior doors are beyond expected service life, recommend replacement during school renovations.

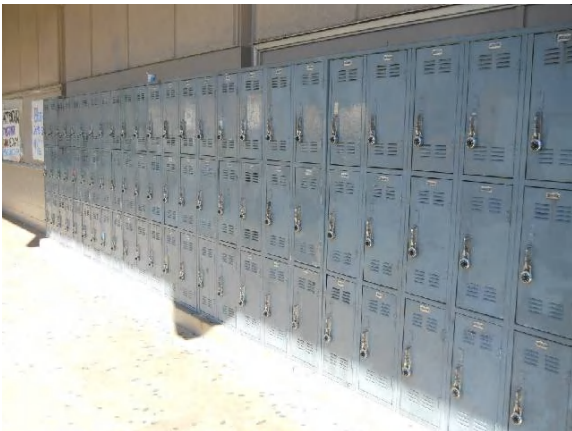
System: C1030 - Fittings

Location: Student lockers, exterior walls and circulation area
Material: Fixed Furnishings - Lockers
Distress: Beyond Service Life
Category: Deferred Maintenance
Priority: 3 - Necessary/Not Yet Critical (Years 2-5)
Correction: Student lockers stacked 2-high
Qty: 225-Ea.
Estimate: \$74,626.92
Assessor Name: Dave Cunningham
Date Created: 01/28/2013

Notes: Student lockers are original and beyond expected service life. Recommend replacement during school renovations

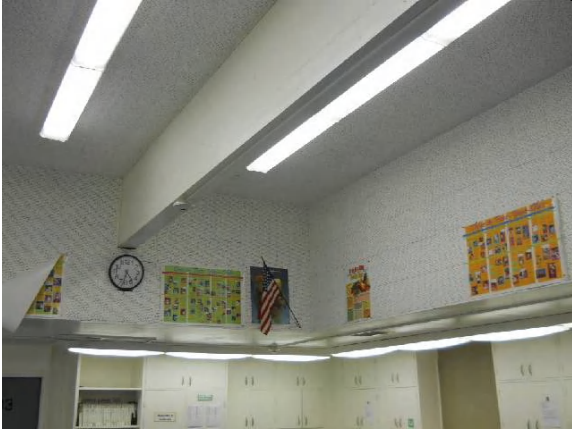
System: C3010 - Wall Finishes

Location: Throughout the building
Material: System
Distress: Beyond Expected Life
Category: Capital Renewal
Priority: 4 - Recommended (Years 6-10)
Correction: Renew System
Qty: 1-Ea.
Estimate: \$116,756.01
Assessor Name: Dave Cunningham
Date Created: 01/28/2013

Notes: All wall finishes are beyond expected service life, need refinished, repainted in all classrooms. Painted CMU, Accoustical panels, Painted drywall. Restrooms were remodeled in 2008.

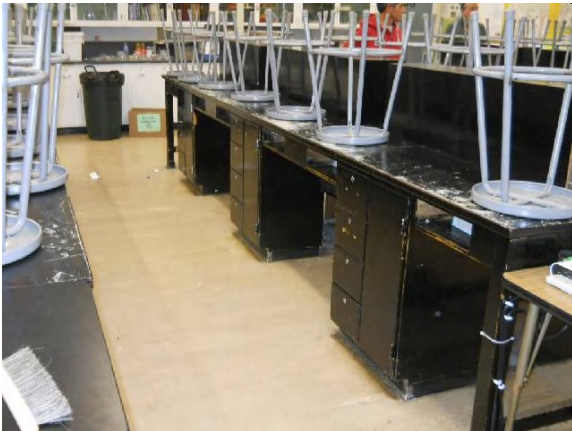
System: C3020410 - VCT - VAT

Location: All classrooms except Home Economics 403 (new VCT 2009)
Material: System
Distress: Beyond Expected Life
Category: Capital Renewal
Priority: 3 - Necessary/Not Yet Critical (Years 2-5)
Correction: Renew System
Qty: 1-Ea.
Estimate: \$63,136.47
Assessor Name: Dave Cunningham
Date Created: 01/28/2013

Notes: Floor coverings are VAT, asbestos containing material, beyond expected useful life. Recommend abatement and replacement during school renovations

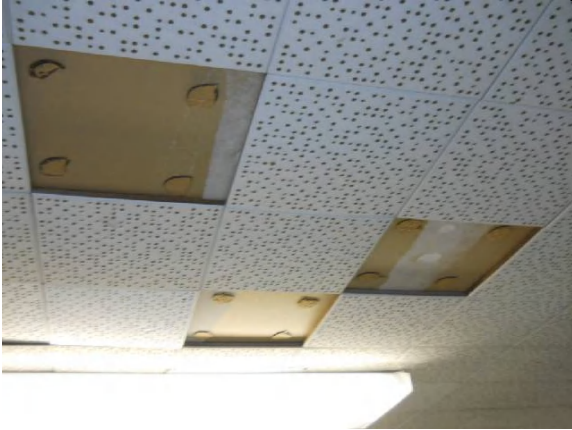
System: C3030 - Ceiling Finishes

Location: Throughout the building
Material: System
Distress: Beyond Expected Life
Category: Capital Renewal
Priority: 3 - Necessary/Not Yet Critical (Years 2-5)
Correction: Renew System
Qty: 1-Ea.
Estimate: \$207,286.04
Assessor Name: Dave Cunningham
Date Created: 01/28/2013

Notes: Glue on tiles, painted hard deck systems, are damaged and are original construction and beyond expected life. Recommend replacement during school renovations

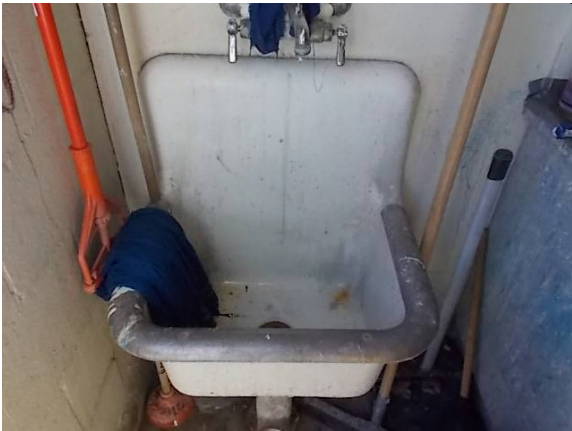
System: D2010 - Plumbing Fixtures

Location: Bldg 400 Custodial Closet
Material: Sink, Iron Enamel
Distress: Beyond Service Life
Category: Capital Renewal
Priority: 5 - Codes or Standards Compliance
Correction: Replace wall mounted janitor's sink and fixtures
Qty: 1-Ea.
Estimate: \$5,081.08
Assessor Name: Sonny Satterfield
Date Created: 01/24/2013

Notes: Relocate janitors sink in custodial closet, which also serves as the 400 Bldg electrical room. Sink is beyond expected life.

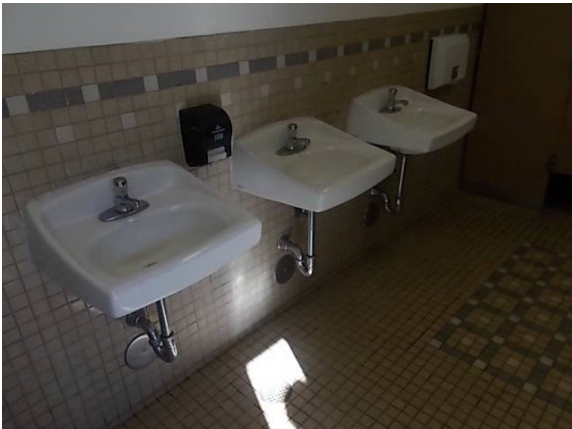
System: D2030 - Sanitary Waste

Location: Typical for all required locations system wide.
Material: System
Distress: Beyond Service Life
Category: Capital Renewal
Priority: 4 - Recommended (Years 6-10)
Correction: Renew System
Qty: 1-Ea.
Estimate: \$56,864.97
Assessor Name: Sonny Satterfield
Date Created: 01/23/2013

Notes: Recommend replacing all above grade sanitary waste and vent piping system during next remodel or renovation; below grade waste piping, recommend video inspection and replace as required.

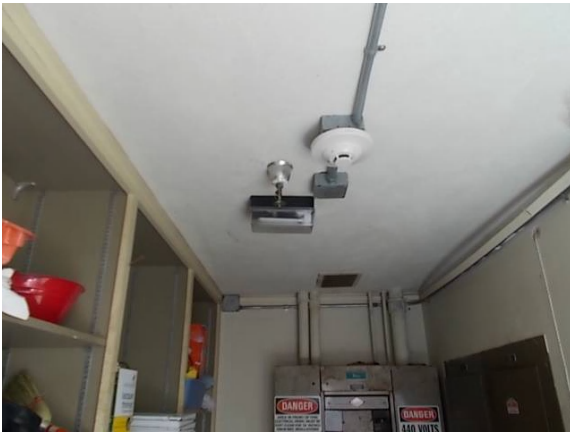
System: D4010 - Sprinklers

Location: Typical for all required locations system wide.
Material: System
Distress: Beyond Expected Life
Category: Capital Renewal
Priority: 5 - Codes or Standards Compliance
Correction: Renew System
Qty: 1-Ea.
Estimate: \$105,052.90
Assessor Name: Sonny Satterfield
Date Created: 01/23/2013

Notes: Building is only partially fire sprinkled, wet type fire sprinklers are located in the storage and electrical closets. Recommend adding building wide, wet type fire sprinklers system during next major renovation.

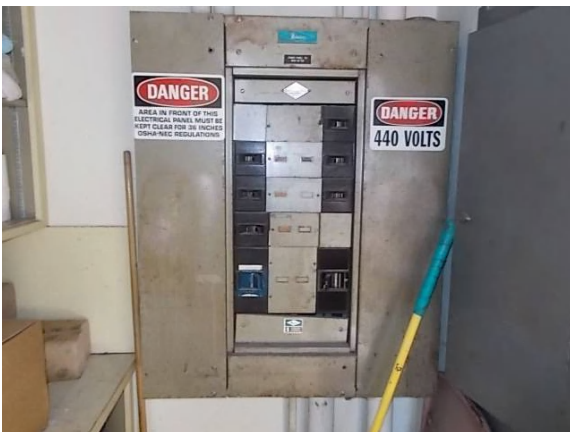
System: D5010 - Electrical Service/Distribution

Location: Typical for all required locations system wide.
Material: System
Distress: Beyond Expected Life
Category: Capital Renewal
Priority: 4 - Recommended (Years 6-10)
Correction: Renew System
Qty: 1-Ea.
Estimate: \$84,982.23
Assessor Name: Sonny Satterfield
Date Created: 01/23/2013

Notes: The main electrical panels, distribution panel boards and feeders are mostly original to the building construction date of 1964 and therefore beyond expected life. The system is recommended to be replaced during the next major renovation.

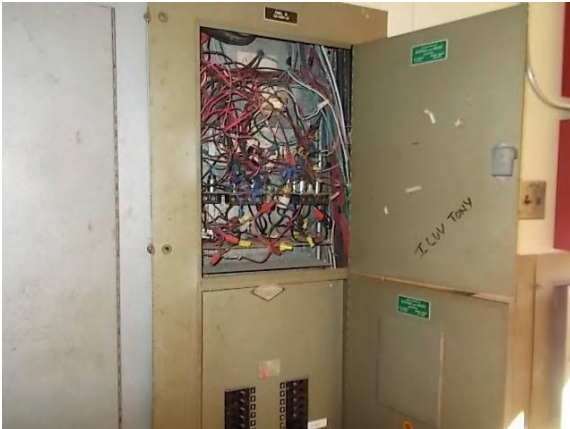
System: D5020 - Branch Wiring

Location: Typical for all required locations system wide.

Notes: The branch wiring, electrical panels and devices are mostly original to the building construction date of 1964 and therefore beyond expected life. The system is recommended to be replaced during the next major renovation.

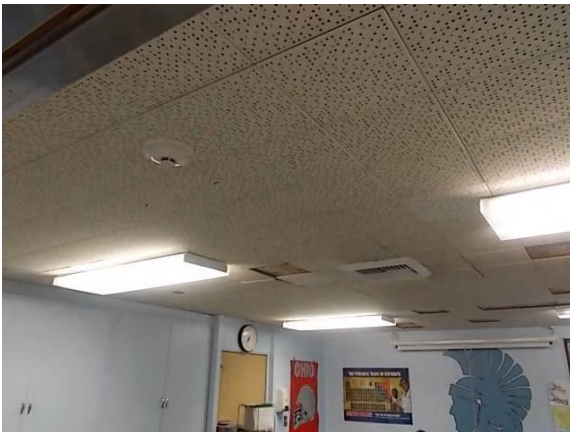
System: D5020 - Lighting

Location: Typical for all locations including canopy walkway lighting.

Distress: Inadequate

Notes: The building light fixtures, lamps and ballast were upgraded to T8 fluorescent type in 2008 in most classrooms; however we recommend replacing all lighting in the building during next remodel or renovation.

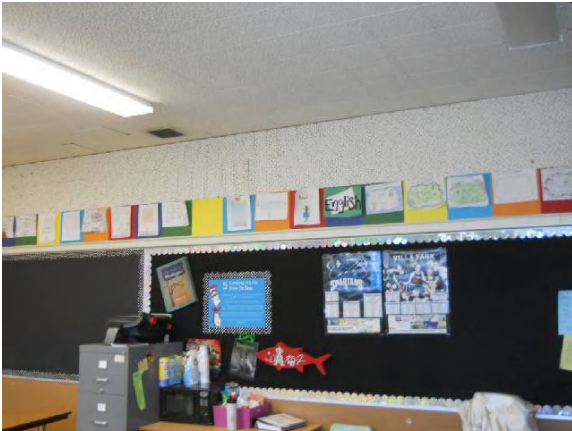
System: E1020 - Institutional Equipment

Location: All Classrooms
Material: Other Institutional Equipment
Distress: Inadequate
Category: Capital Renewal
Priority: 4 - Recommended (Years 6-10)
Correction: Smartboards whiteboards tackboards
Qty: 4-Ea.
Estimate: \$44,640.52
Assessor Name: Dave Cunningham
Date Created: 01/30/2013

Notes: Recommend installation of Smart Board Systems in all classrooms

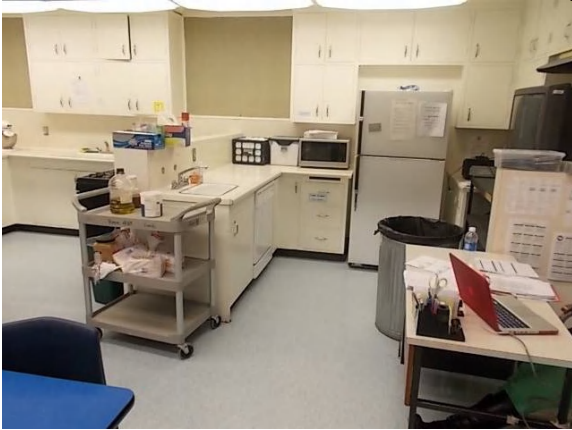
System: E1090 - Other Equipment - Kitchen Equip

Location: Room 403
Material: Kitchen Equipment
Distress: Beyond Expected Life
Category: Capital Renewal
Priority: 4 - Recommended (Years 6-10)
Correction: Home Economics Kitchen Class Set-up
Qty: 9-Ea.
Estimate: \$107,810.22
Assessor Name: Sonny Satterfield
Date Created: 01/23/2013

Notes: Home Economics classroom kitchen equipment is mostly beyond expected life. Recommend replacing during next remodel or renovation.

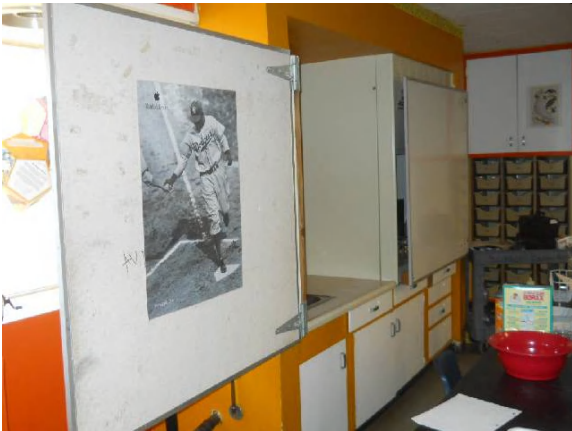
System: E2010 - Fixed Furnishings

Location: Classrooms 400, 401, 402
Material: Fixed Casework
Distress: Beyond Expected Life
Category: Deferred Maintenance
Priority: 3 - Necessary/Not Yet Critical (Years 2-5)
Correction: Replace Casework OUSD
Qty: 190-L.F.
Estimate: \$224,253.50
Assessor Name: Dave Cunningham
Date Created: 01/28/2013

Notes: Built in cabinets / casework in classrooms is original construction and beyond expected service life. Recommend replacement during school renovations

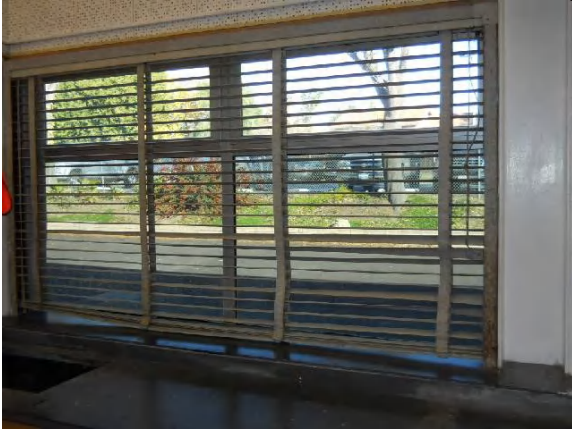
System: B2020 - Exterior Windows

Location: Exterior windows
Material: System
Distress: Beyond Expected Life
Category: Capital Renewal
Priority: 4 - Recommended (Years 6-10)
Correction: Renew System
Qty: 1-Ea.
Estimate: \$16,890.03
Assessor Name: Dave Cunningham
Date Created: 01/28/2013

Notes: Window system is original construction, aged, not energy efficient, and beyond expected service life. Recommend replacement during school renovations.

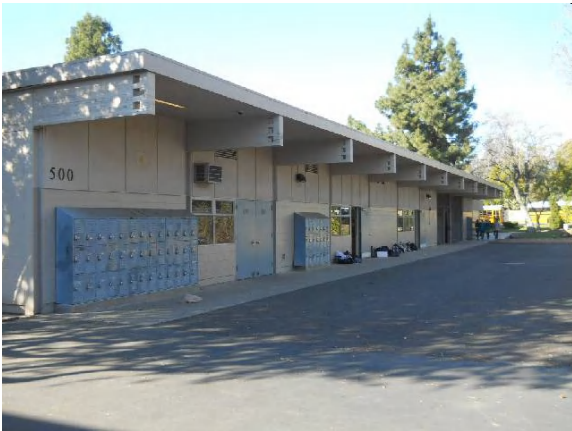
System: B2030 - Exterior Doors

Location: Exterior door system
Material: System
Distress: Beyond Expected Life
Category: Capital Renewal
Priority: 4 - Recommended (Years 6-10)
Correction: Renew System
Qty: 1-Ea.
Estimate: \$62,447.22
Assessor Name: Dave Cunningham
Date Created: 01/28/2013

Notes: The exterior doors are original construction, aged, and not ADA compliant. Provide interior locking hardware at all classroom doors for security. Recommend replacement during school renovations.

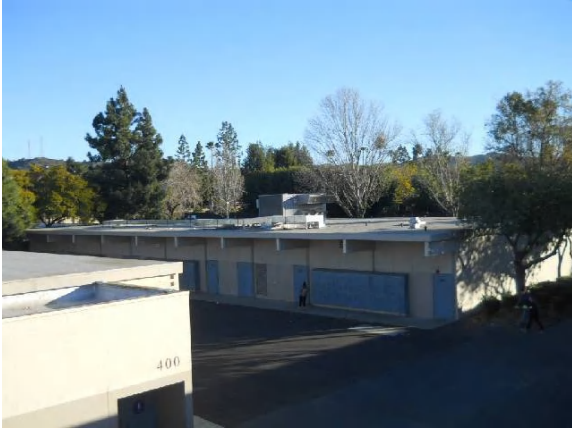
System: B3010105 - Built-Up

Location: Roof
Material: System
Distress: Beyond Expected Life
Category: Capital Renewal
Priority: 3 - Necessary/Not Yet Critical (Years 2-5)
Correction: Renew System
Qty: 1-Ea.
Estimate: \$223,811.60
Assessor Name: Dave Cunningham
Date Created: 01/28/2013

Notes: No roof access. Several reported roof leaks. Roof is 28 years old and beyond expected service life.
Recommend replacement

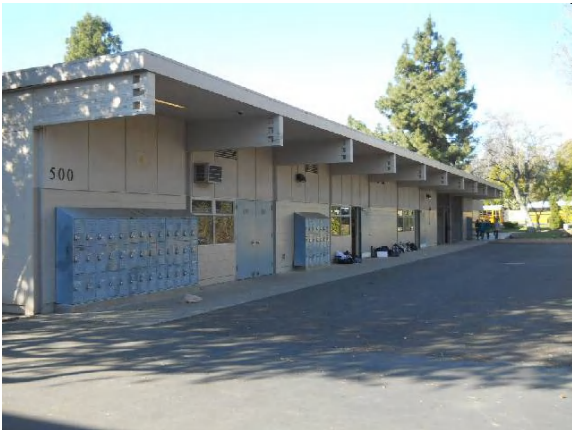
System: C1030 - Fittings

Location: Student Lockers, exterior walls
Material: Fixed Furnishings - Lockers
Distress: Beyond Service Life
Category: Deferred Maintenance
Priority: 3 - Necessary/Not Yet Critical (Years 2-5)
Correction: Student lockers stacked 2-high
Qty: 198-Ea.
Estimate: \$65,671.69
Assessor Name: Dave Cunningham
Date Created: 01/28/2013

Notes: All student lockers are beyond expected service life. Recommend replacement during school renovation

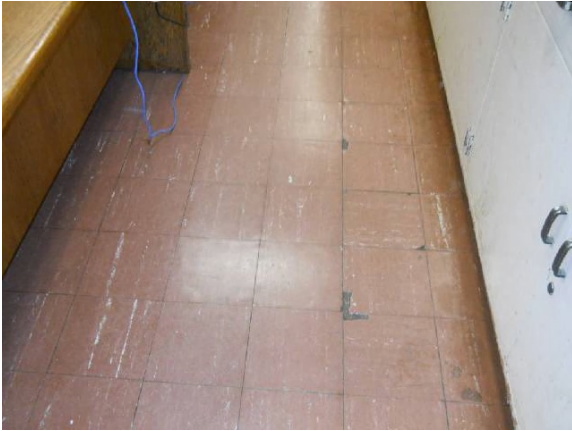
System: C3020410 - VCT - VAT

Location: Throughout the building
Material: System
Distress: Beyond Expected Life
Category: Capital Renewal
Priority: 4 - Recommended (Years 6-10)
Correction: Renew System
Qty: 1-Ea.
Estimate: \$72,211.27
Assessor Name: Dave Cunningham
Date Created: 01/28/2013

Notes: Floors are VAT, asbestos containing material, and are beyond expected service life. Recommend abatement and replacement during school renovations
