Orange Unified School District

Facilities Condition Assessment for:

Villa Park High School
18042 Taft Avenue
Villa Park, CA 92861

Campus Report

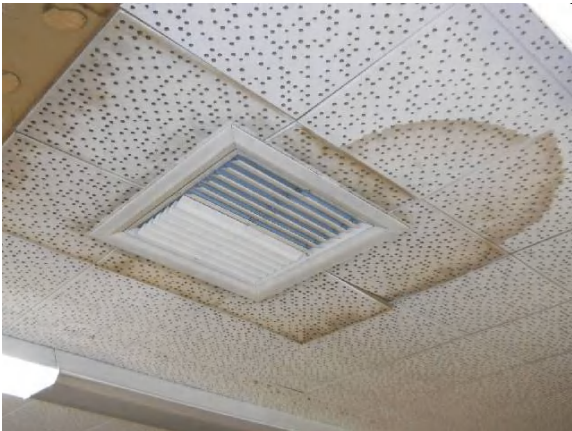
System: C3030 - Ceiling Finishes

Location: Throughout the building
Material: System
Distress: Beyond Expected Life
Category: Capital Renewal
Priority: 3 - Necessary/Not Yet Critical (Years 2-5)
Correction: Renew System
Qty: 1-Ea.
Estimate: \$219,515.79
Assessor Name: Dave Cunningham
Date Created: 01/28/2013

Notes: Ceiling finishes are original construction, beyond expected service life. Recommend replacement during school renovations

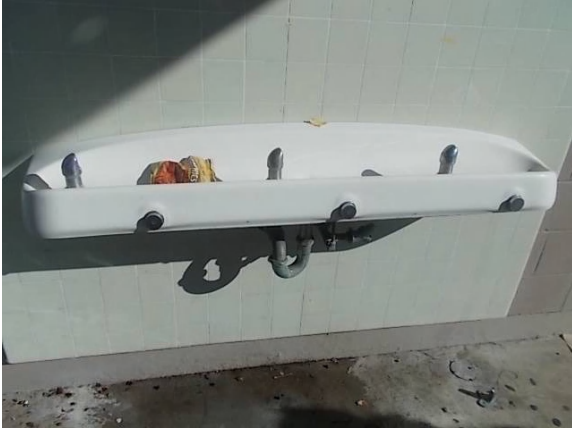
System: D2010 - Plumbing Fixtures

Location: Typical for all required locations system wide.

Notes: Plumbing fixtures are mostly original to building construction date of 1964 and therefore are beyond expected life. Recommend replacing system during next remodel or renovation. Also see science lab casework for additional plumbing fixture deficiencies; the sinks and faucets are included in the casework costs but the rough-in and trim out costs are included here in this deficiency.

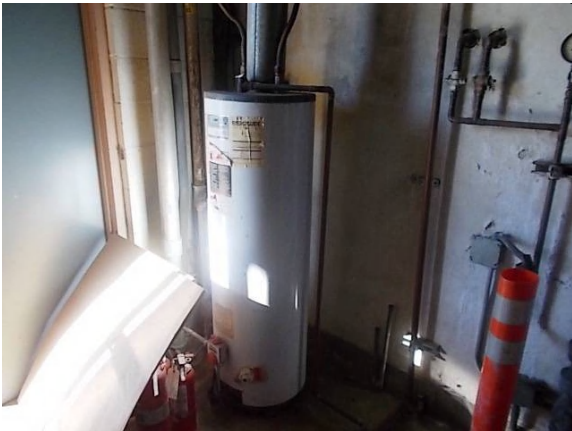
System: D2020 - Domestic Water Distribution

Location: Typical for all required locations system wide.

Notes: Recommend replacing system during next remodel or renovation, domestic hot water heater was installed in 2004 and not deficient; however piping is mostly original to 1964.

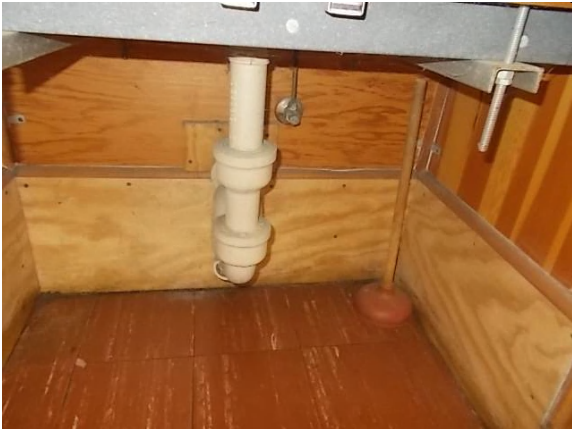
System: D2030 - Sanitary Waste

Location: Typical for all required locations system wide.

Notes: Recommend replacing all above grade sanitary waste and vent piping system during next remodel or renovation; below grade waste piping, recommend video inspection and replace as required.

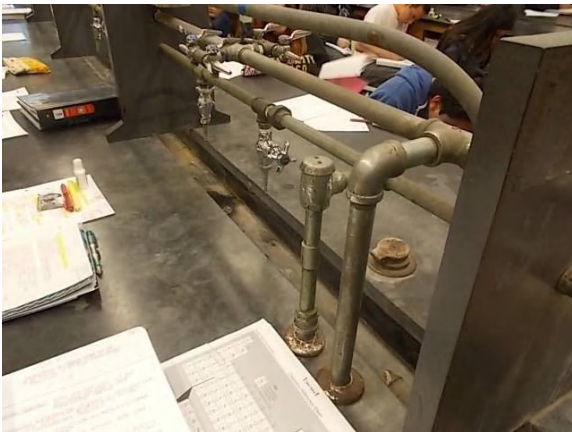
System: D2090 - Other Plumbing Systems-Nat Gas

Location: Typical for all required locations system wide.

Notes: Recommend replacing system during next remodel or renovation; natural gas piping is mostly original to 1964.

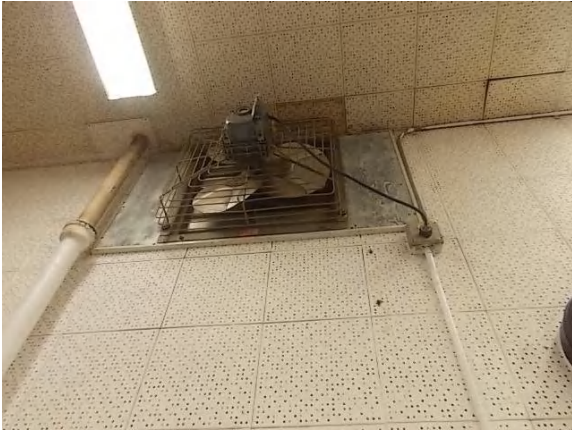
System: D3040 - Distribution Systems

Location: Classroom 503 wall mounted, all other locations; science classrooms missing or roof mounted.

Material: Exhaust Fan

Correction: Replace fan & motor, propeller exh., 1000 CFM exha

Notes: Replace existing exhaust fans and add for missing locations.

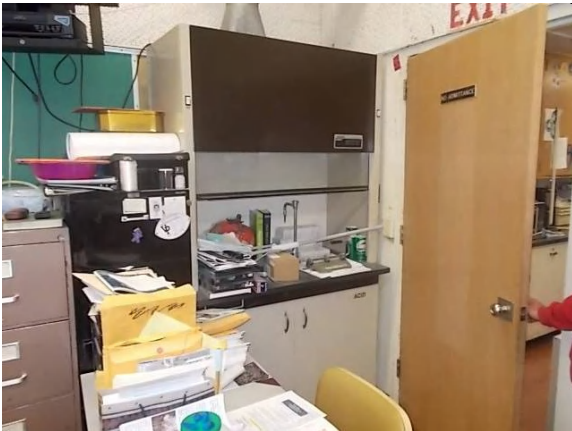
System: D3040 - Distribution Systems

Location: Classroom 504; Science Classrooms 501,502 & 503 missing.

Material: Exhaust Systems

Correction: Replace complex fume hood

Notes: Repace (1) existing and add (3) missing fume hood systems to all Science Classrooms.

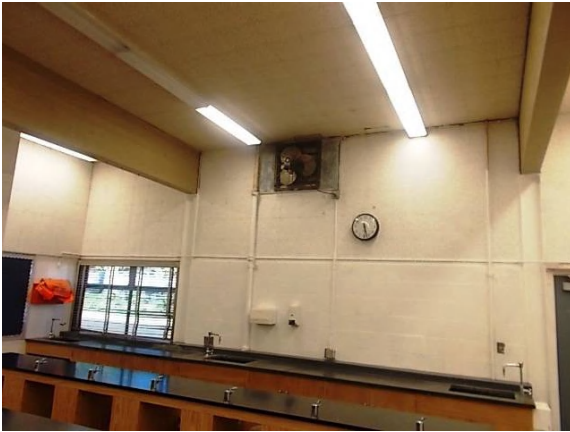
System: D5020 - Lighting

Location: Typical for all required locations system wide.

Notes: The building light fixtures, lamps and ballast were upgraded to T8 fluorescent type in 2008 in most classrooms; however we recommend replacing all lighting in the building during next remodel or renovation.

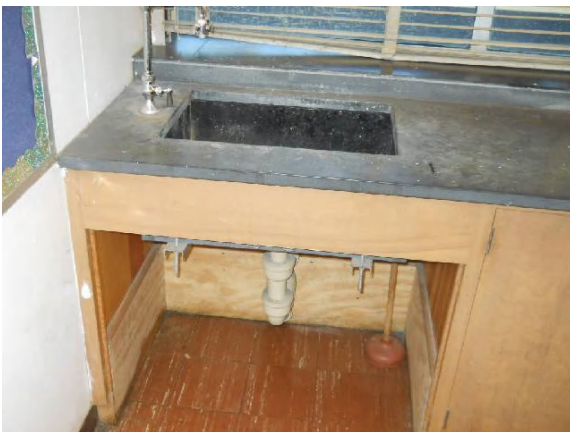
System: E1020 - Institutional Equipment

Location: Science Classrooms; 500, 501, 502, 503, 504

Notes: Science rooms, lab equipment and furnishings are beyond expected service life. Recommend replacement during school renovations

Correction: Replace science laboratory fixed casework

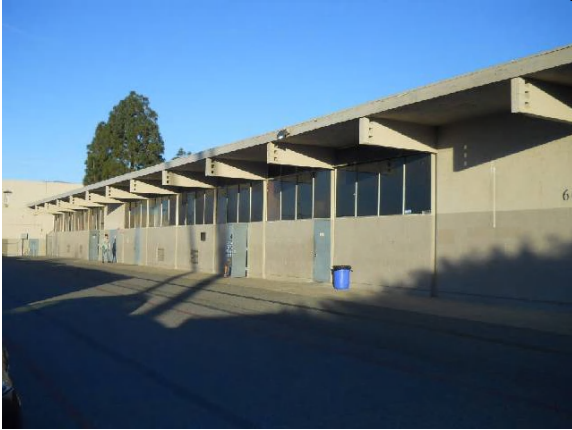
System: B2020 - Exterior Windows

Location: Exterior window system
Material: System
Distress: Beyond Expected Life
Category: Capital Renewal
Priority: 4 - Recommended (Years 6-10)
Correction: Renew System
Qty: 1-Ea.
Estimate: \$117,708.18
Assessor Name: Dave Cunningham
Date Created: 01/28/2013

Notes: All exterior windows are original construction, not energy efficient, and beyond expected service life. Recommend replacement during school renovation

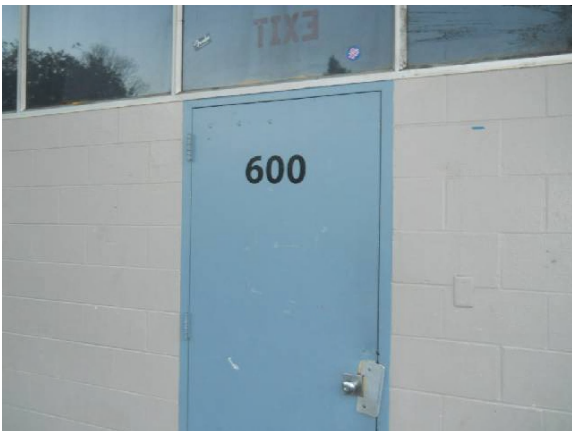
System: B2030 - Exterior Doors

Location: All exterior door systems
Material: System
Distress: Beyond Expected Life
Category: Capital Renewal
Priority: 3 - Necessary/Not Yet Critical (Years 2-5)
Correction: Renew System
Qty: 1-Ea.
Estimate: \$92,396.53
Assessor Name: Dave Cunningham
Date Created: 01/28/2013

Notes: Exterior doors are original construction, not ADA compliant, and beyond expected service life. Provide interior locking hardware at all classroom doors for security. Recommend replacement during school renovations.

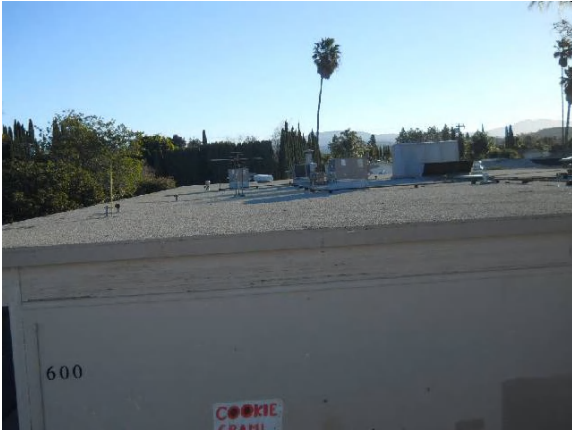
System: B3010105 - Built-Up

Location: Roof
Material: System
Distress: Beyond Expected Life
Category: Capital Renewal
Priority: 3 - Necessary/Not Yet Critical (Years 2-5)
Correction: Renew System
Qty: 1-Ea.
Estimate: \$376,680.65
Assessor Name: Dave Cunningham
Date Created: 01/28/2013

Notes: Roof covering is beyond expected service life, recommend replacement

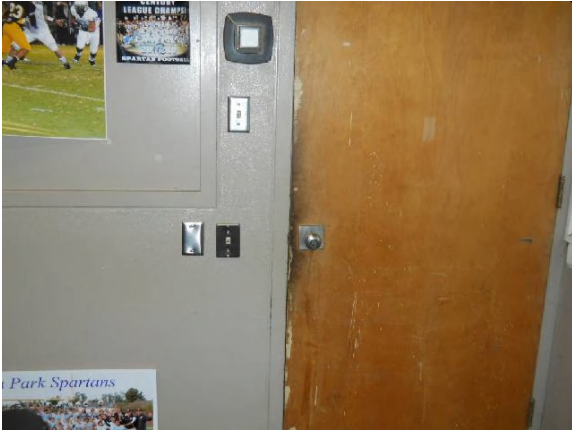
System: C1020 - Interior Doors

Location: All interior doors
Material: System
Distress: Beyond Expected Life
Category: Capital Renewal
Priority: 3 - Necessary/Not Yet Critical (Years 2-5)
Correction: Renew System
Qty: 1-Ea.
Estimate: \$24,467.66
Assessor Name: Dave Cunningham
Date Created: 01/28/2013

Notes: Interior door systems are beyond expected service life. Recommend replacement during school renovations

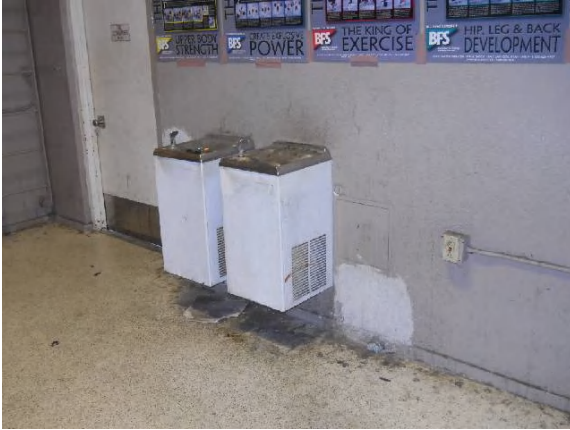
System: C3010 - Wall Finishes

Location: Throughout the building
Material: System
Distress: Beyond Expected Life
Category: Capital Renewal
Priority: 3 - Necessary/Not Yet Critical (Years 2-5)
Correction: Renew System
Qty: 1-Ea.
Estimate: \$208,037.49
Assessor Name: Dave Cunningham
Date Created: 01/28/2013

Notes: Wall finishes; painted CMU, painted stucco, accoustical tiles, ceramic tiles are all original construction, failing, and beyond expected service life. Recommend replacement during school renovations.

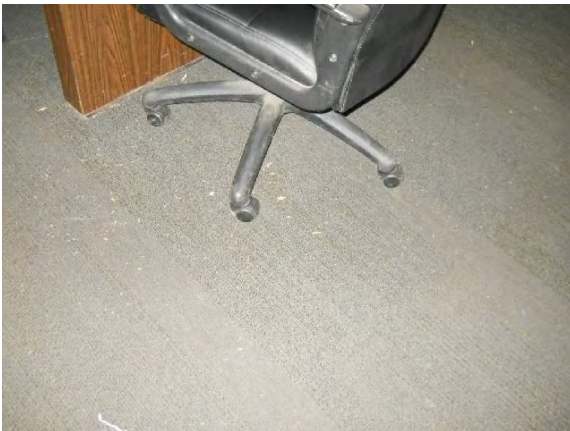
System: C3020210 - Carpet

Location: Office 606, Storage 11, Office 15
Material: System
Distress: Beyond Expected Life
Category: Capital Renewal
Priority: 3 - Necessary/Not Yet Critical (Years 2-5)
Correction: Renew System
Qty: 1-Ea.
Estimate: \$9,922.18
Assessor Name: Dave Cunningham
Date Created: 01/28/2013

Notes: Carpet is worn and beyond useful life. Recommend replacement during school renovation

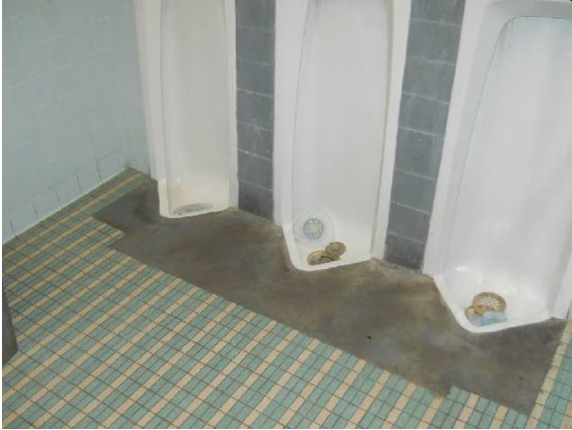
System: C3020210 - Ceramic Tile

Location: Staff Toilet
Material: System
Distress: Beyond Expected Life
Category: Capital Renewal
Priority: 3 - Necessary/Not Yet Critical (Years 2-5)
Correction: Renew System
Qty: 1-Ea.
Estimate: \$6,406.96
Assessor Name: Dave Cunningham
Date Created: 01/28/2013

Notes: Ceramic floortile is original construction, beyond expected service life. Recommend replacement during school renovation

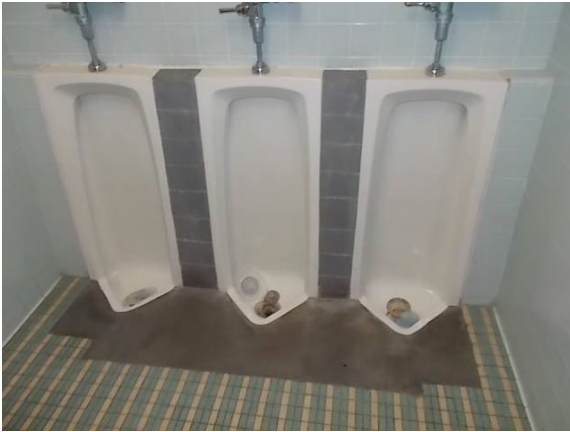
System: D2010 - Plumbing Fixtures

Location: Typical for all required locations system wide.
Material: System
Distress: Beyond Service Life
Category: Capital Renewal
Priority: 4 - Recommended (Years 6-10)
Correction: Renew System
Qty: 1-Ea.
Estimate: \$181,258.20
Assessor Name: Sonny Satterfield
Date Created: 01/24/2013

Notes: Plumbing fixtures are mostly original to building construction date of 1964 and therefore are beyond expected life. Recommend replacing system during next remodel or renovation.

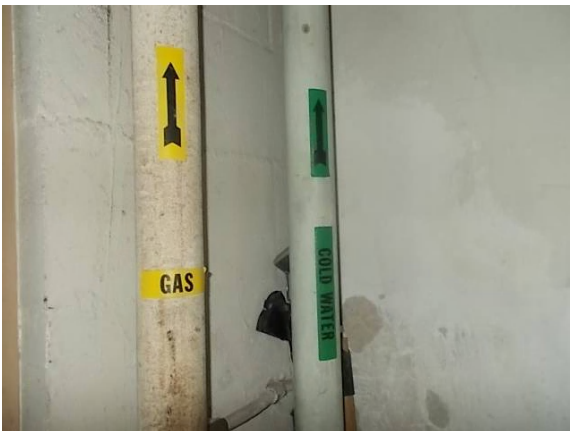
System: D2020 - Domestic Water Distribution

Location: Typical for all required locations system wide.
Material: System
Distress: Beyond Service Life
Category: Capital Renewal
Priority: 4 - Recommended (Years 6-10)
Correction: Renew System
Qty: 1-Ea.
Estimate: \$158,905.23
Assessor Name: Sonny Satterfield
Date Created: 01/24/2013

Notes: Recommend replacing system during next remodel or renovation, domestic hot water heater was installed in 2008 and not deficient; however piping is mostly original to 1964.

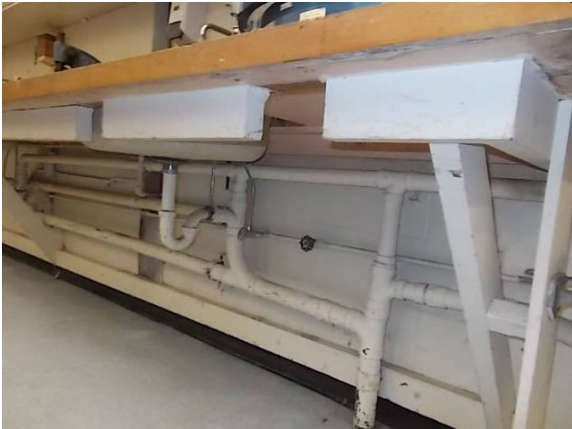
System: D2030 - Sanitary Waste

Location: Typical for all required locations system wide.
Material: System
Distress: Beyond Service Life
Category: Capital Renewal
Priority: 4 - Recommended (Years 6-10)
Correction: Renew System
Qty: 1-Ea.
Estimate: \$101,362.95
Assessor Name: Sonny Satterfield
Date Created: 01/24/2013

Notes: Recommend replacing all above grade sanitary waste and vent piping system during next remodel or renovation; below grade waste piping, recommend video inspection and replace as required.

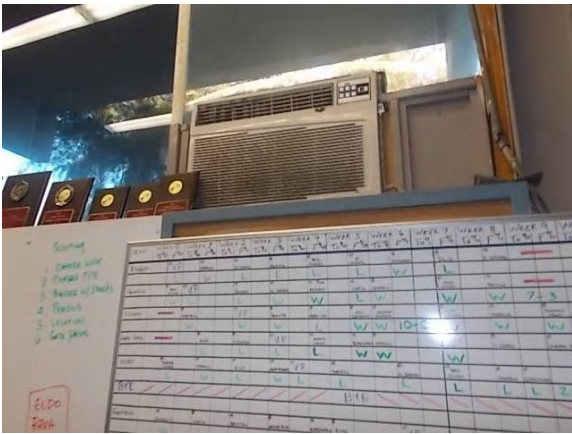
System: D3040 - Distribution Systems

Location: Classrooms 603, 605, 606, toilets al storage and office spaces.

Notes: HVAC system was partially renewed in 2006 with new rooftop package units, controls and duct work; however some of the building spaces and classrooms are not air conditioned. Most of the air distribution duct and exhaust fans were installed in 1964 and beyond expected life. Fresh air supply to all areas is inadequate. An engineering study by a PE is recommended for the HVAC System with recommendations for upgrades and replacement, as required during the next major renovation.

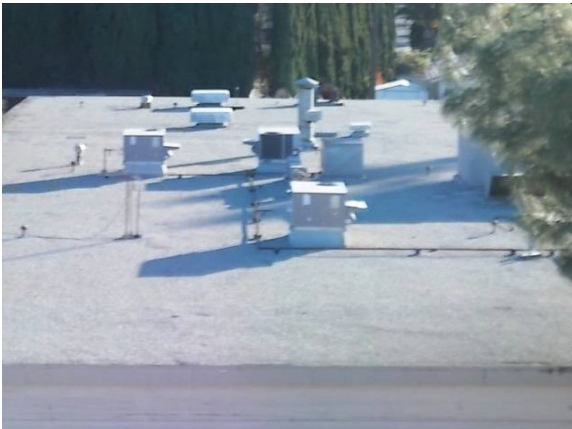
System: D3050 - Terminal & Package Units

Location: Classrooms 603, 605, 606, toilets al storage and office spaces.

Distress: Inadequate

Notes: HVAC system was partially renewed in 2006 with new rooftop package units, controls and duct work; however some of the building spaces and classrooms are not air conditioned. Most of the air distribution duct and exhaust fans were installed in 1964 and beyond expected life. Fresh air supply to all areas is inadequate. An engineering study by a PE is recommended for the HVAC System with recommendations for upgrades and replacement, as required during the next major renovation.

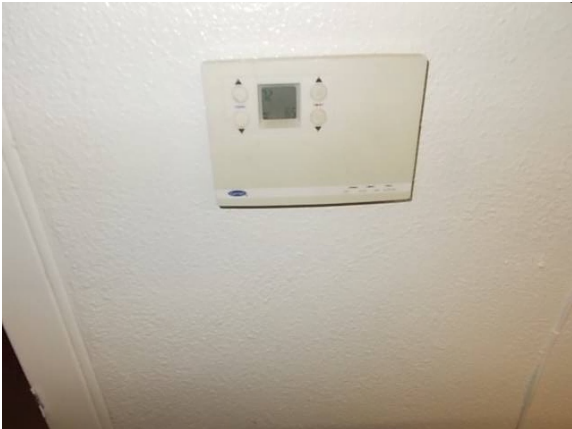
System: D3060 - Controls & Instrumentation

Location: Typical for all required locations system wide.
Material: System
Distress: Beyond Service Life
Category: Capital Renewal
Priority: 4 - Recommended (Years 6-10)
Correction: Renew System
Qty: 1-Ea.
Estimate: \$99,813.73
Assessor Name: Sonny Satterfield
Date Created: 01/24/2013

Notes: HVAC system was partially renewed in 2006 with new rooftop package units and controls; however some of the building spaces and classrooms are not air conditioned. Most of the air distribution duct and exhaust fans were installed in 1964 and beyond expected life. Fresh air supply to all areas is inadequate. An engineering study by a PE is recommended for the HVAC System with recommendations for upgrades and replacement, as required during the next major renovation.

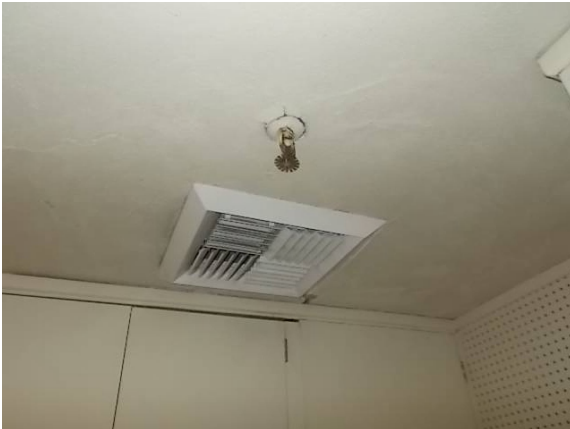
System: D4010 - Sprinklers

Location: Typical for all required locations system wide.
Material: System
Distress: Beyond Service Life
Category: Capital Renewal
Priority: 5 - Codes or Standards Compliance
Correction: Renew System
Qty: 1-Ea.
Estimate: \$187,414.82
Assessor Name: Sonny Satterfield
Date Created: 01/24/2013

Notes: Building is only partially fire sprinkled, wet type fire sprinklers are located in the storage and electrical closets. Recommend adding building wide, wet type fire sprinklers system during next major renovation.

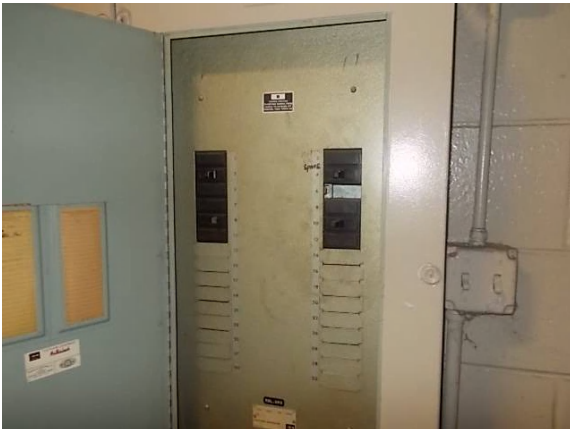
System: D5010 - Electrical Service/Distribution

Location: Typical for all required locations system wide
Material: System
Distress: Beyond Expected Life
Category: Capital Renewal
Priority: 4 - Recommended (Years 6-10)
Correction: Renew System
Qty: 1-Ea.
Estimate: \$151,380.47
Assessor Name: Sonny Satterfield
Date Created: 01/24/2013

Notes: The main electrical panels, distribution panel boards and feeders are mostly original to the building construction date of 1964 and therefore beyond expected life. The system is recommended to be replaced during the next major renovation.

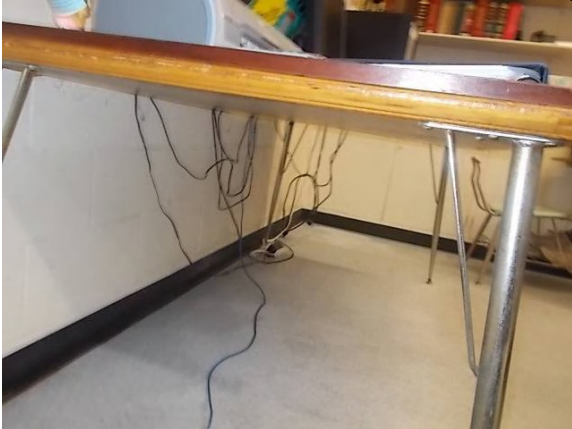
System: D5030920 - LAN System

Location: Typical for all required locations system wide.
Material: Lan System
Distress: Inadequate
Category: Capital Renewal
Priority: 4 - Recommended (Years 6-10)
Correction: Replace LAN System Drop CAT6
Qty: 24-Ea.
Estimate: \$9,416.39
Assessor Name: Sonny Satterfield
Date Created: 01/24/2013

Notes: Most of the existing LAN/VOIP outlets will require new drops or relocation and upgrade. Recommend replacing and enhancing during the next major building remodel.

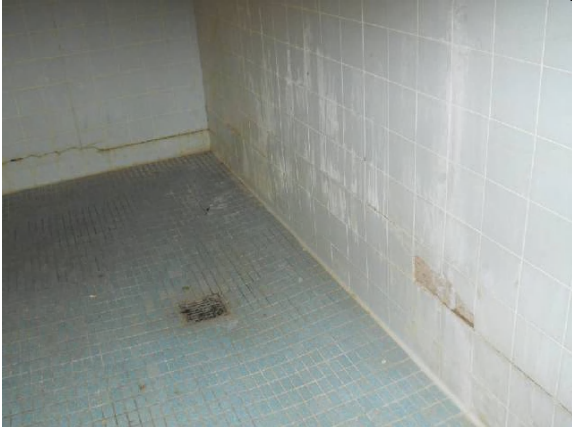
System: B2010 - Exterior Walls

Location: Exterior walls, Gym shower areas, lower level
Material: Study Engineering Analysis
Distress: Damaged
Category: Deferred Maintenance
Priority: 3 - Necessary/Not Yet Critical (Years 2-5)
Correction: Conduct study/analysis
Qty: 1-Each
Estimate: \$34,010.16
Assessor Name: Dave Cunningham
Date Created: 01/29/2013

Notes: Structural cracking along exterior walls of gym showers. Recommend an Engineering study to determine cause and repair.

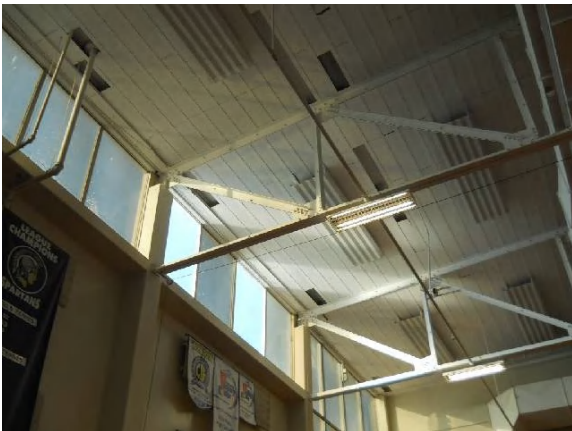
System: B2020 - Exterior Windows

Location: Exterior window system
Material: System
Distress: Beyond Expected Life
Category: Capital Renewal
Priority: 3 - Necessary/Not Yet Critical (Years 2-5)
Correction: Renew System
Qty: 1-Ea.
Estimate: \$320,049.10
Assessor Name: Dave Cunningham
Date Created: 01/29/2013

Notes: Exterior window system is original construction, numerous leaks reported. System is beyond expected service life. Recommend replacement during school renovations

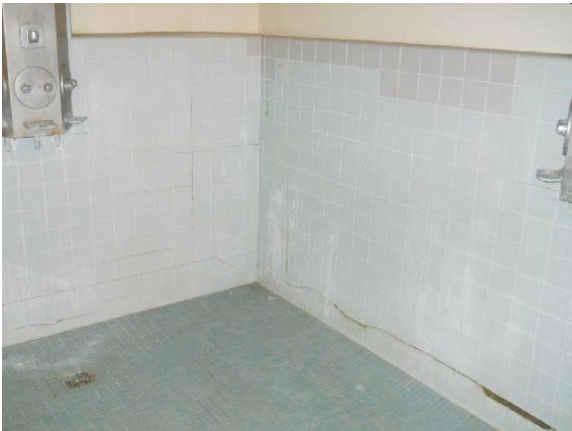
System: C3010 - Wall Finishes

Location: Throughout the building
Material: System
Distress: Beyond Expected Life
Category: Capital Renewal
Priority: 3 - Necessary/Not Yet Critical (Years 2-5)
Correction: Renew System
Qty: 1-Ea.
Estimate: \$386,213.10
Assessor Name: Dave Cunningham
Date Created: 01/29/2013

Notes: All wall surfaces, painted CMU, painted Stucco, painted drywall, Ceramic tiles, ... are worn, damaged, and beyond expected service life. Recommend replacement during school renovations.

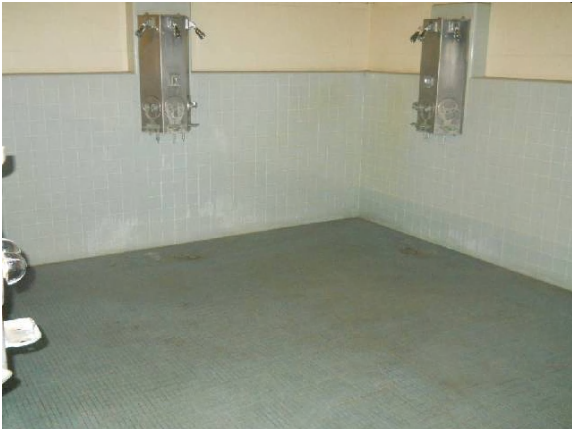
System: C3020210 - Ceramic Tile

Location: Toilet 4, 22, Showers 7,8,9, Dressing 21, 23
Material: System
Distress: Beyond Expected Life
Category: Capital Renewal
Priority: 3 - Necessary/Not Yet Critical (Years 2-5)
Correction: Renew System
Qty: 1-Ea.
Estimate: \$80,190.00
Assessor Name: Dave Cunningham
Date Created: 01/29/2013

Notes: Ceramic floor tiles are original construction, damaged and beyond expected service life. Recommend replacement during school renovations

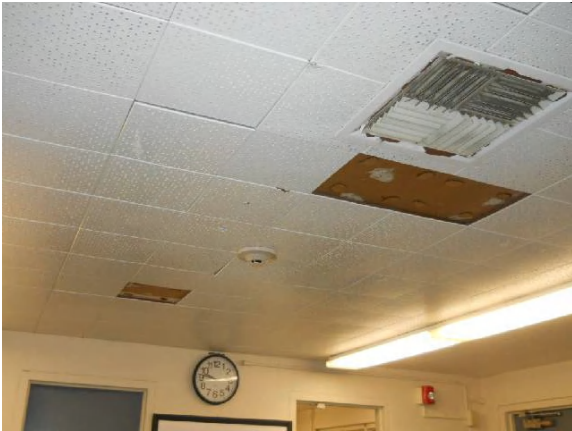
System: C3030 - Ceiling Finishes

Location: Throughout the building
Material: System
Distress: Beyond Expected Life
Category: Capital Renewal
Priority: 3 - Necessary/Not Yet Critical (Years 2-5)
Correction: Renew System
Qty: 1-Ea.
Estimate: \$685,746.23
Assessor Name: Dave Cunningham
Date Created: 01/29/2013

Notes: All ceiling finishes; Accoustical grid and tile systems, glue on tiles, painted hard deck stucco systems, are showing damage and all are beyond expected service life. Recommend replacement during school renovations

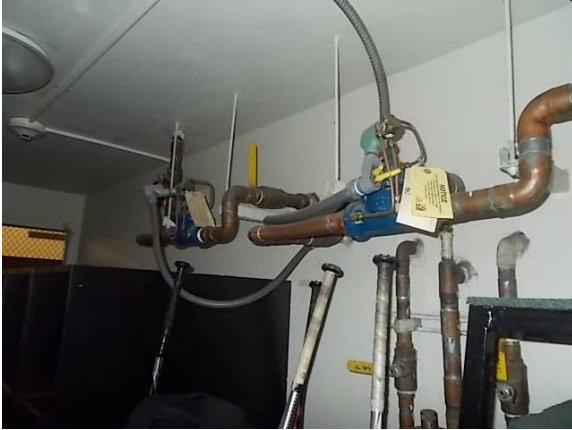
System: D2020 - Domestic Water Distribution

Location: Gym-mechanical room
Material: System
Distress: Beyond Expected Life
Category: Capital Renewal
Priority: 4 - Recommended (Years 6-10)
Correction: Renew System
Qty: 1-Ea.
Estimate: \$294,917.04
Assessor Name: Sonny Satterfield
Date Created: 01/25/2013

Notes: Recommend replacing system during next remodel or renovation, domestic hot water heater and storage tanks were replaced in 2005 and currently working properly; however most domestic water piping is beyond expected life.

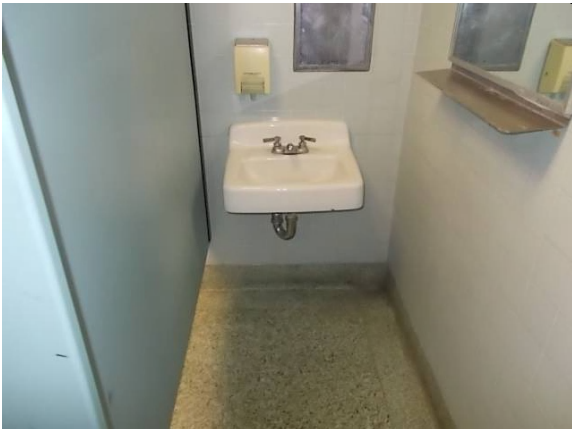
System: D2030 - Sanitary Waste

Location: Typical for all required locations system wide.
Material: System
Distress: Beyond Expected Life
Category: Capital Renewal
Priority: 4 - Recommended (Years 6-10)
Correction: Renew System
Qty: 1-Ea.
Estimate: \$188,234.01
Assessor Name: Sonny Satterfield
Date Created: 01/25/2013

Notes: Recommend replacing all above grade sanitary waste and vent piping system during next remodel or renovation; below grade waste piping, recommend video inspection and replace as required.

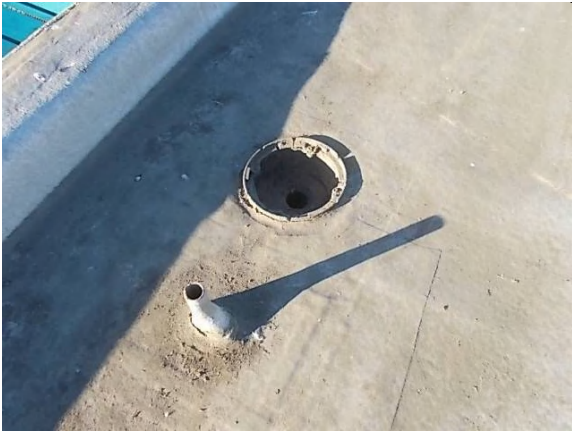
System: D2040 - Rain Water Drainage

Location: Typical for all required locations system wide.

Notes: Replace system during next major remodel or renovation.

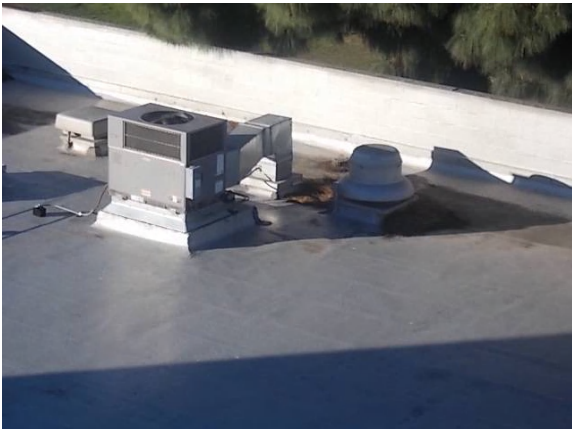
System: D3030 - Cooling Generating Systems

Location: Typical for all required locations system wide.

Notes: The GYM HVAC system was partially renewed in 2006-08; however most of the building spaces, large and small gymnasiums are not air conditioned, they have heat only and fresh air supply is inadequate. Most of the air distribution duct and exhaust fans were installed in 1964 and beyond expected life. Fresh air supply to all areas is inadequate. An engineering study by a PE is recommended for the HVAC System with recommendations for upgrades and replacement, as required during the next major renovation.

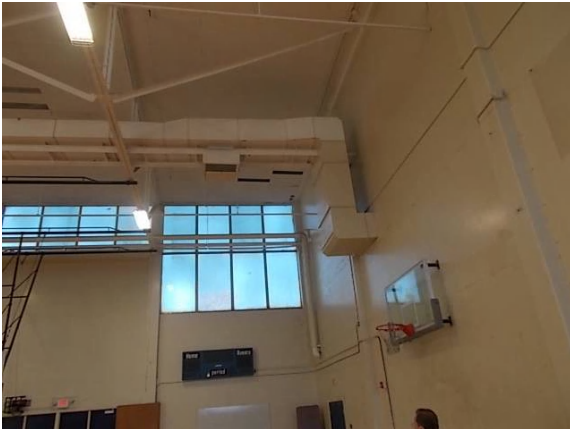
System: D3040 - Distribution Systems

Location: Typical for all required locations system wide.

Notes: The GYM HVAC system was partially renewed in 2006-08; however most of the building spaces, large and small gymnasiums are not air conditioned, they have heat only and fresh air supply is inadequate. Most of the air distribution duct and exhaust fans were installed in 1964 and beyond expected life. Fresh air supply to all areas is inadequate. An engineering study by a PE is recommended for the HVAC System with recommendations for upgrades and replacement, as required during the next major renovation.

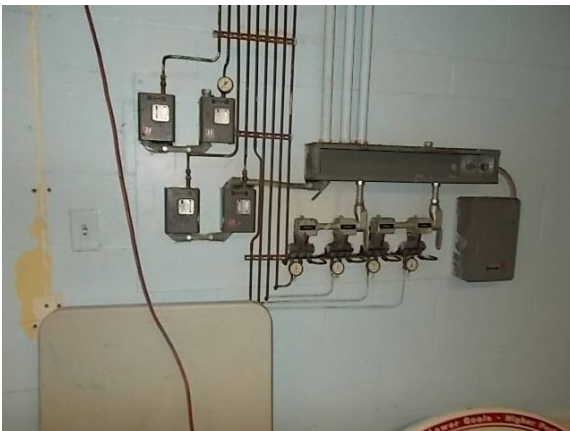
System: D3060 - Controls & Instrumentation

Location: Typical for all required locations system wide.

Notes: The GYM HVAC system was partially renewed in 2006-08; however most of the building spaces, large and small gymnasiums are not air conditioned, they have heat only and fresh air supply is inadequate. Most of the air distribution duct and exhaust fans were installed in 1964 and beyond expected life. Fresh air supply to all areas is inadequate. An engineering study by a PE is recommended for the HVAC System with recommendations for upgrades and replacement, as required during the next major renovation.

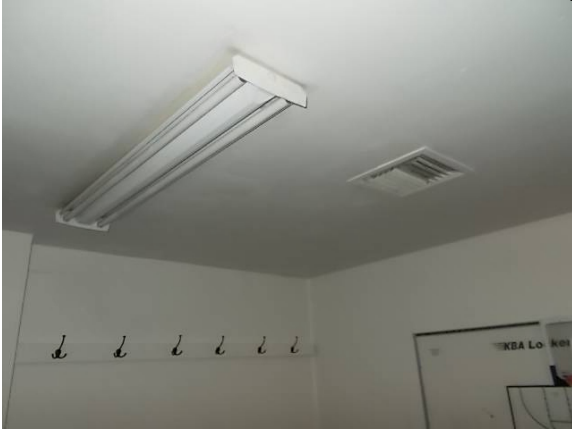
System: D3070 - Systems Testing & Balance

Location: Typical for all required locations system wide.

Notes: The GYM HVAC system was partially renewed in 2006-08; however most of the building spaces, large and small gymnasiums are not air conditioned, they have heat only and fresh air supply is inadequate. Most of the air distribution duct and exhaust fans were installed in 1964 and beyond expected life. Fresh air supply to all areas is inadequate. An engineering study by a PE is recommended for the HVAC System with recommendations for upgrades and replacement, as required during the next major renovation.

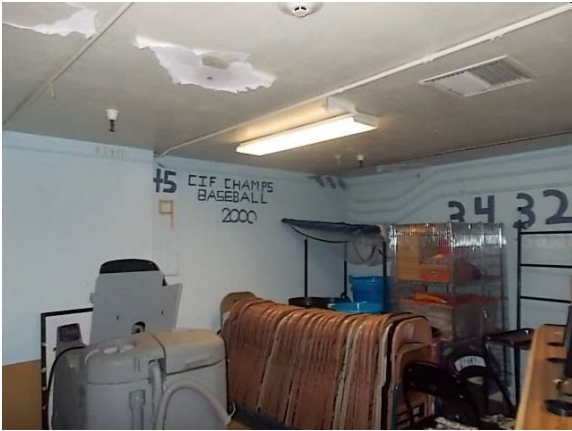
System: D4010 - Sprinklers

Location: Typical for all required locations system wide.

Notes: Building is only partially fire sprinkled, wet type fire sprinklers are located in the trainers office and storage closets. Recommend adding building wide, wet type fire sprinklers system during next major renovation.

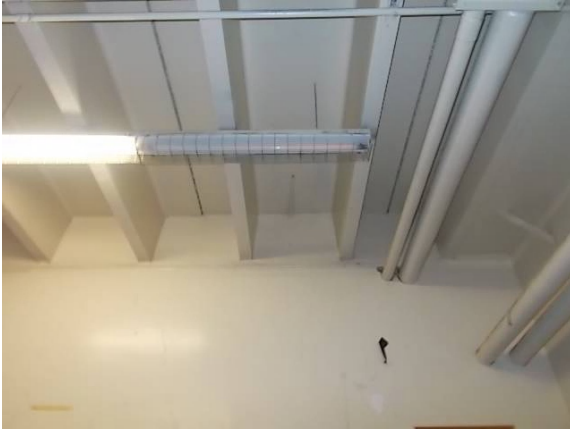
System: D5020 - Lighting

Location: All spaces and rooms except the large and small gymnasiums.

Notes: Both large and small gymnasiums have new high bay type fluorescent light fixtures installed in 2008. All other spaces in the building are recommended to have new lighting installed during the next major remodel or renovation. This would include interior fluorescent fixtures, exit lights, emergency egress and task lighting as required.

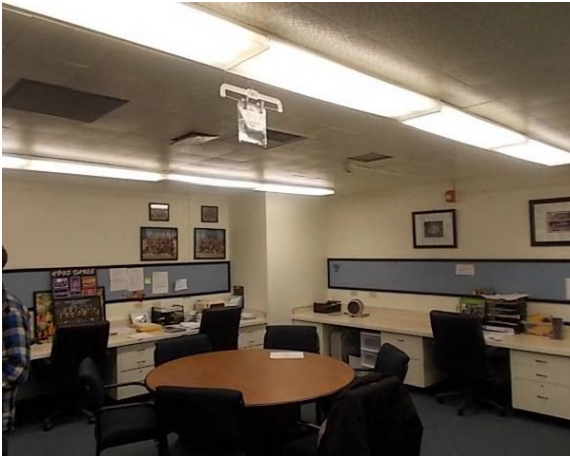
System: D5030920 - LAN System

Location: Typical for all required locations system wide.

Distress: Inadequate

Notes: Most of the existing LAN/VOIP outlets will require new drops or relocation and upgrade. Recommend replacing and enhancing during the next major building remodel.

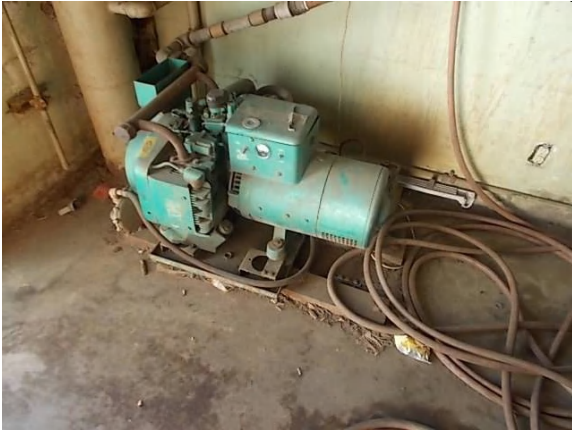
System: D5090 - Other Electrical Systems

Location: Gym-Mech/Electrical Room
Material: System
Distress: Beyond Expected Life
Category: Code Compliance
Priority: 1 - Currently Critical (Immediate)
Correction: Renew System
Qty: 1-Ea.
Estimate: \$63,086.60
Assessor Name: Sonny Satterfield
Date Created: 01/25/2013

Notes: Emergency generator is believed to be not operable and emergency lighting system for building is inadequate. Recommend replacing emergency lighting generator with a new larger capacity generator and/or new modern type egress lighting system.

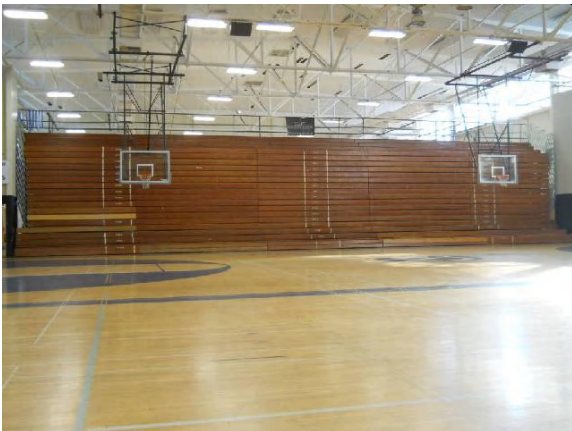
System: E2010 - Fixed Furnishings

Location: Gym
Material: Fixed Furnishings - Bleachers telescoping
Distress: Beyond Expected Life
Category: Capital Renewal
Priority: 4 - Recommended (Years 6-10)
Correction: Gym bleachers telescoping minimum
Qty: 2,200-Seat
Estimate: \$819,466.56
Assessor Name: Dave Cunningham
Date Created: 01/29/2013

Notes: Gym bleachers are beyond expected service life. Recommend replacement during school renovations

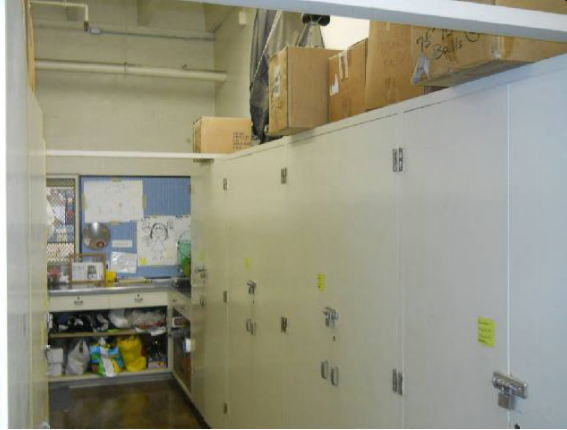
System: E2010 - Fixed Furnishings

Location: Equipment storage rooms (2)
Material: Fixed Casework
Distress: Beyond Expected Life
Category: Deferred Maintenance
Priority: 4 - Recommended (Years 6-10)
Correction: Replace Casework OUSD
Qty: 200-L.F.
Estimate: \$236,056.32
Assessor Name: Dave Cunningham
Date Created: 01/29/2013

Notes: Equipment storage room built in storage is old, damaged, and beyond expected life. Recommend replacement during school renovation.

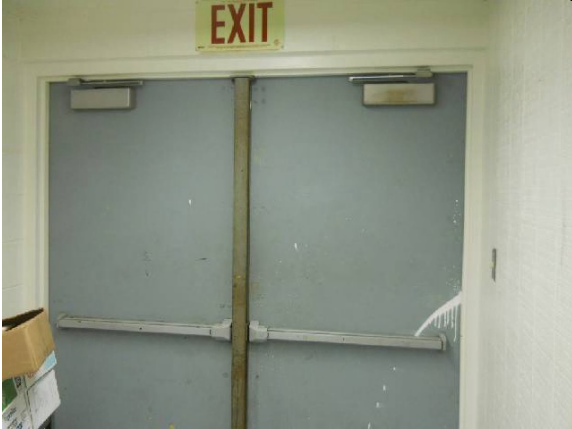
System: B2030 - Exterior Doors

Location: All exterior doors
Material: System
Distress: Beyond Expected Life
Category: Capital Renewal
Priority: 3 - Necessary/Not Yet Critical (Years 2-5)
Correction: Renew System
Qty: 1-Ea.
Estimate: \$77,625.35
Assessor Name: Dave Cunningham
Date Created: 01/29/2013

Notes: Exterior door system is original construction, beyond expected service life. Provide interior locking hardware at all classroom doors for security. Recommend replacement during school renovation.

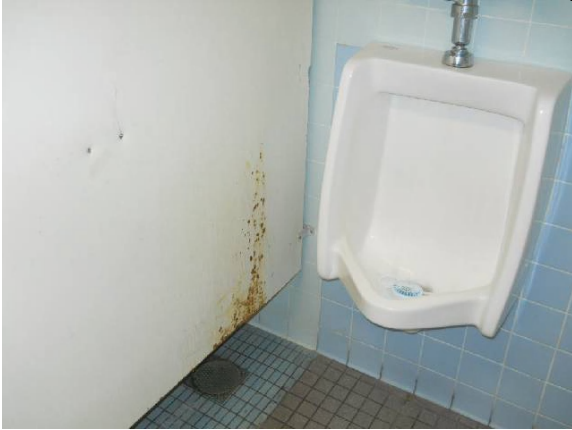
System: C1030 - Fittings

Location: Mens Toilet, Womens Toilet
Material: Toilet Partitions
Distress: Beyond Expected Life
Category: Deferred Maintenance
Priority: 4 - Recommended (Years 6-10)
Correction: Toilet partitions, laminate clad-overhead braced
Qty: 3-Ea.
Estimate: \$5,871.53
Assessor Name: Dave Cunningham
Date Created: 01/29/2013

Notes: Restroom partitions and toilet accessories are old, damaged, rusted, and beyond expected service life. Recommend replacement during school renovations.

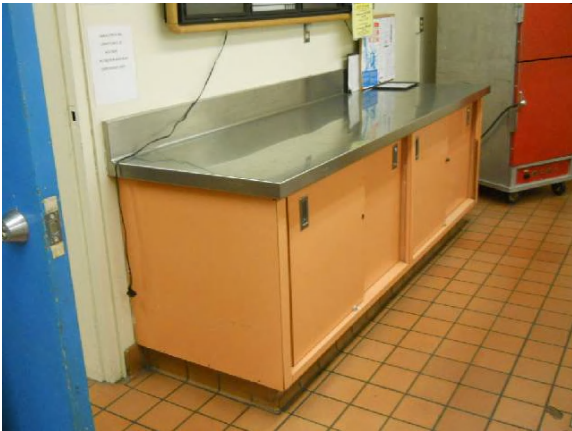
System: C3020210 - Tile & Coverings - Quarry Tile

Location: Kitchen, serving line, dishwash room
Material: System
Distress: Beyond Expected Life
Category: Capital Renewal
Priority: 4 - Recommended (Years 6-10)
Correction: Renew System
Qty: 1-Ea.
Estimate: \$59,269.48
Assessor Name: Dave Cunningham
Date Created: 01/29/2013

Notes: Quarry tile system is beyond expected service life. Recommend replacement during school renovation.

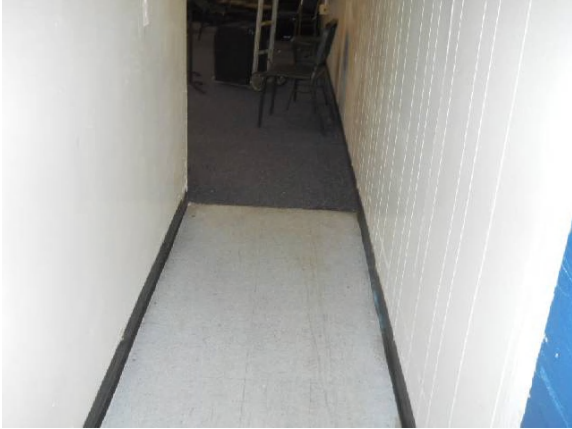
System: C3020410 - VCT

Location: All VCT floor covering; offices, hallways
Material: System
Distress: Beyond Expected Life
Category: Capital Renewal
Priority: 4 - Recommended (Years 6-10)
Correction: Renew System
Qty: 1-Ea.
Estimate: \$20,671.20
Assessor Name: Dave Cunningham
Date Created: 01/29/2013

Notes: VCT floor covering is beyond expected service life. Recommend replacement during school renovation

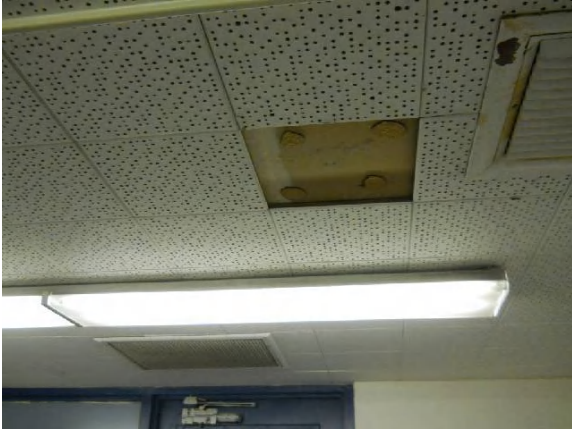
System: C3030 - Ceiling Finishes

Location: Throughout the building
Material: System
Distress: Beyond Expected Life
Category: Capital Renewal
Priority: 3 - Necessary/Not Yet Critical (Years 2-5)
Correction: Renew System
Qty: 1-Ea.
Estimate: \$476,723.95
Assessor Name: Dave Cunningham
Date Created: 01/29/2013

Notes: Ceiling finishes; grid and accoustical, painted drywall, painted stucco, and glue on tiles are all beyond expected service life. Recommend replacement/repairs as required during school renovations.

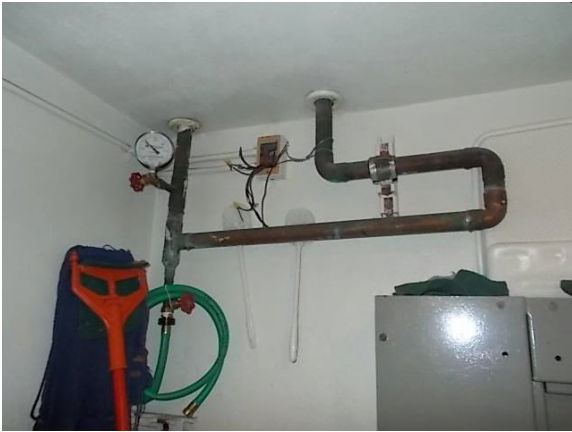
System: D2020 - Domestic Water Distribution

Location: Typical for all required locations system wide.

Priority: 4 - Recommended (Years 6-10)

Notes: Replace system during next remodel or renovation.

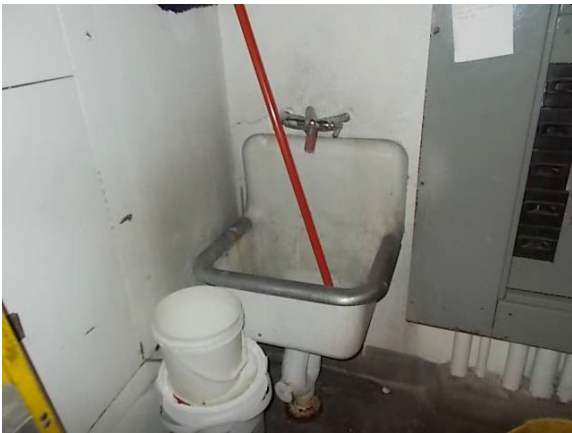
System: D2030 - Sanitary Waste

Location: Typical for all required locations system wide.

Priority: 4 - Recommended (Years 6-10)

Notes: Recommend replacing all above grade sanitary waste and vent piping system during next remodel or renovation; below grade waste piping, recommend video inspection and replace as required.

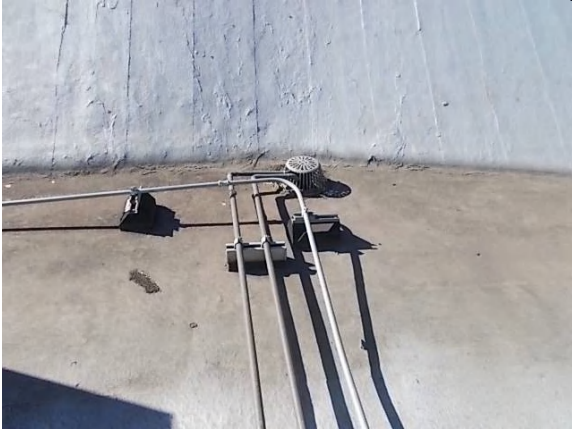
System: D2040 - Rain Water Drainage

Location: Typical for all locations
Material: System
Distress: Beyond Expected Life
Category: Capital Renewal
Priority: 4 - Recommended (Years 6-10)
Correction: Renew System
Qty: 1-Ea.
Estimate: \$21,214.67
Assessor Name: Sonny Satterfield
Date Created: 01/25/2013

Notes: Replace system during next major remodel or renovation.

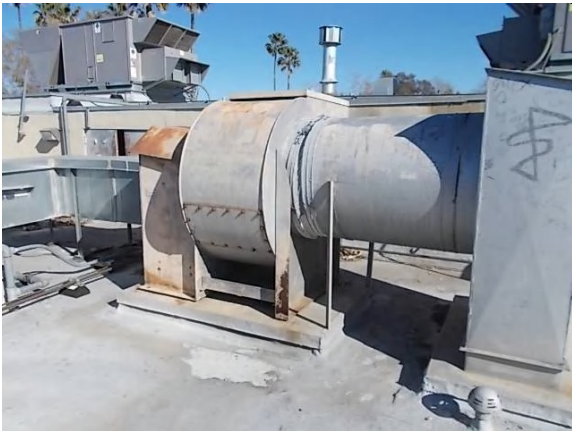
System: D3040 - Distribution Systems

Location: Kitchen Hood/Roof Exhaust & MUA
Material: Hoods and Exhaust Systems
Distress: Beyond Expected Life
Category: Capital Renewal
Priority: 4 - Recommended (Years 6-10)
Correction: Install kitchen hood and exhaust system
Qty: 1-Ea.
Estimate: \$118,606.90
Assessor Name: Sonny Satterfield
Date Created: 01/25/2013

Notes: Kitchen Hood/Roof Exhaust & MUA Fans are beyond expected life. Recommend replacing components during next remodel or renovation.

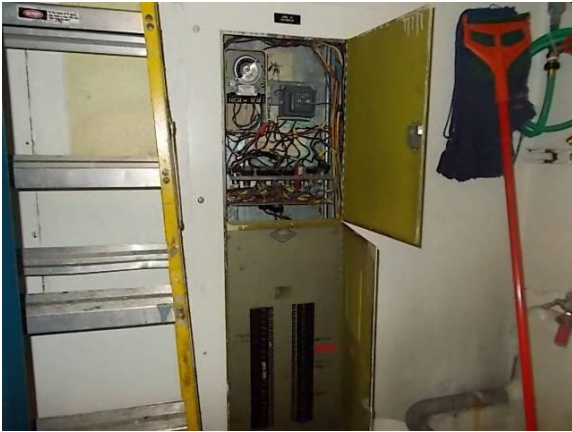
System: D5020 - Branch Wiring

Location: Typical for all required locations system wide.

Priority: 4 - Recommended (Years 6-10)

Notes: The branch wiring, electrical panels and devices are mostly original to the building construction date of 1964 and therefore beyond expected life. The system is recommended to be replaced during the next major renovation.

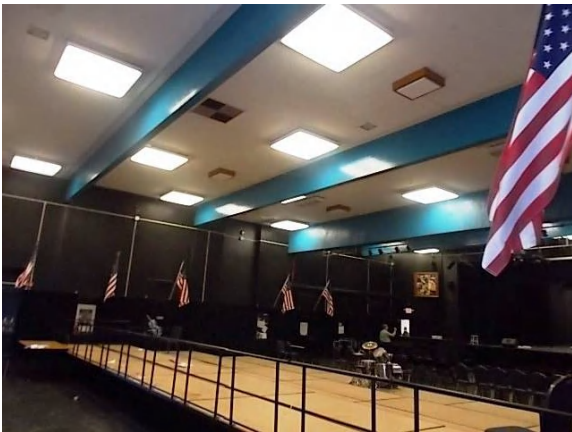
System: D5020 - Lighting

Location: Typical for all locations

Priority: 4 - Recommended (Years 6-10)

Notes: Most of the lighting fixtures have been retrofitted with T8 lamps and electronic ballasts but the fixtures are dated to 1964 and therefore beyond expected life. The instrumental music and drama classrooms have new light fixtures, however it is recommended to replace all lighting, wiring and controls during next major remodel or renovation.

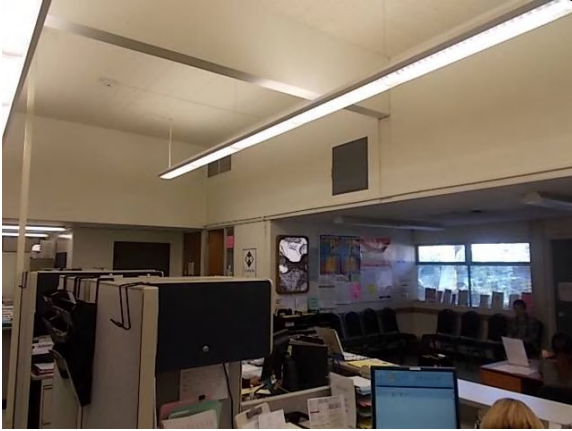
System: D5030920 - LAN System

Location: Typical for all locations
Material: Lan System
Distress: Inadequate
Category: Capital Renewal
Priority: 4 - Recommended (Years 6-10)
Correction: Replace LAN System Drop CAT6
Qty: 24-Ea.
Estimate: \$9,416.39
Assessor Name: Sonny Satterfield
Date Created: 01/25/2013

Notes: Most of the existing LAN/VOIP outlets will require new drops or relocation and upgrade. Recommend replacing and enhancing during the next major building remodel.

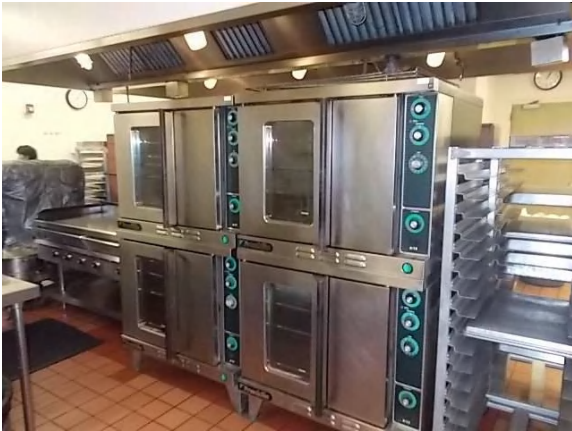
System: E1090 - Other Equipment - Food Service/Kitchen

Location: Kitchen-Typical for all food service equipment
Material: System
Distress: Beyond Expected Life
Category: Capital Renewal
Priority: 4 - Recommended (Years 6-10)
Correction: Renew System
Qty: 1-Ea.
Estimate: \$270,638.58
Assessor Name: Sonny Satterfield
Date Created: 01/25/2013

Notes: Most of the kitchen food service equipment is original to the building construction date of 1964. Recommend replacing and upgrading system during next remodel or renovation.

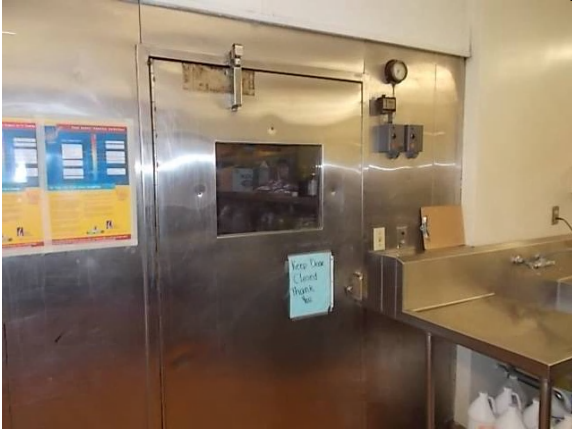
System: E1090 - Other Equipment - Walk-in Cooler/Freezer

Location: Kitchen
Material: System
Distress: Beyond Expected Life
Category: Capital Renewal
Priority: 4 - Recommended (Years 6-10)
Correction: Renew System
Qty: 1-Ea.
Estimate: \$46,700.45
Assessor Name: Sonny Satterfield
Date Created: 01/25/2013

Notes: Kitchen walk-in cooler is dated original to building construction date of 1964 and therefore are beyond expected life. Recommend replacing during next remodel or renovation.

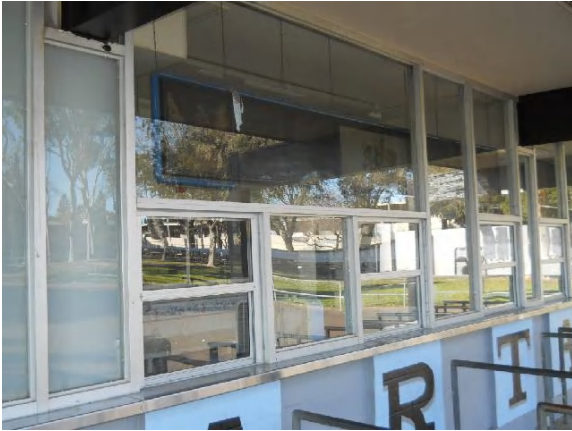
System: B2020 - Exterior Windows

Location: Exterior windows
Material: System
Distress: Beyond Expected Life
Category: Capital Renewal
Priority: 3 - Necessary/Not Yet Critical (Years 2-5)
Correction: Renew System
Qty: 1-Ea.
Estimate: \$7,761.60
Assessor Name: Dave Cunningham
Date Created: 01/28/2013

Notes: Exterior window system is original construction and beyond expected service life. Recommend replacement during school renovation

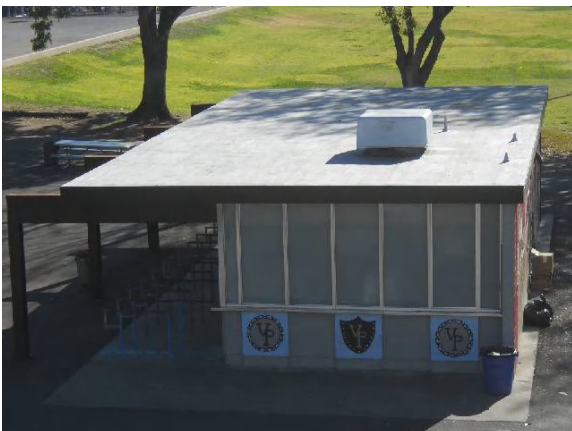
System: B3020 - Roof Openings

Location: Roof
Material: System
Distress: Missing
Category: Capital Renewal
Priority: 2 - Potentially Critical (Year 1)
Correction: Renew System
Qty: 1-Ea.
Estimate: \$865.94
Assessor Name: Dave Cunningham
Date Created: 01/28/2013

Notes: No safe access to roof for maintenance personnel. Install internal ladder and hatch or external roof ladder with cage and lock.

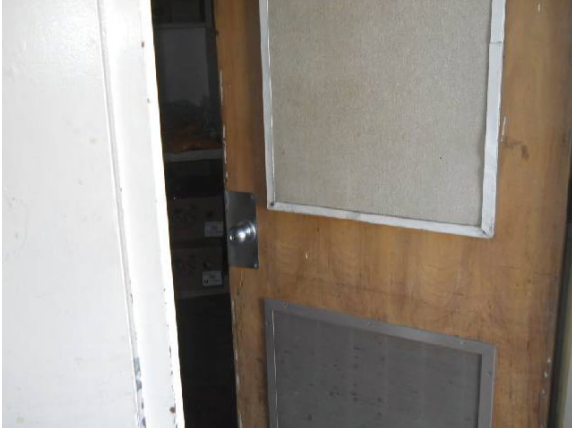
System: C1020 - Interior Doors

Location: Storage room
Material: System
Distress: Beyond Expected Life
Category: Capital Renewal
Priority: 3 - Necessary/Not Yet Critical (Years 2-5)
Correction: Renew System
Qty: 1-Ea.
Estimate: \$1,828.22
Assessor Name: Dave Cunningham
Date Created: 01/28/2013

Notes: Interior door is beyond service life, recommend replacement.
