Orange Unified School District

Facilities Condition Assessment for:

Villa Park High School
18042 Taft Avenue
Villa Park, CA 92861

Campus Report

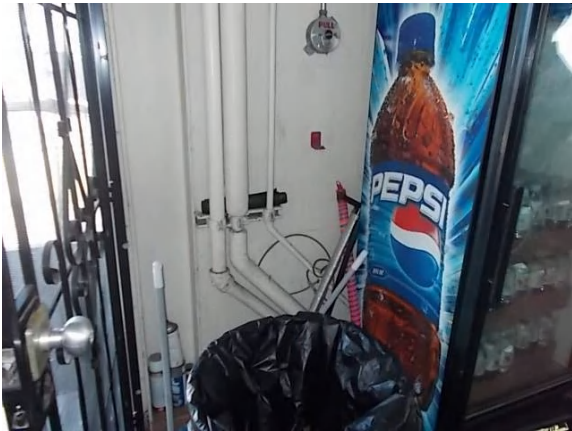
System: D2020 - Domestic Water Distribution

Location: Typical for all locations
Material: System
Distress: Beyond Expected Life
Category: Capital Renewal
Priority: 4 - Recommended (Years 6-10)
Correction: Renew System
Qty: 1-Ea.
Estimate: \$6,302.74
Assessor Name: Sonny Satterfield
Date Created: 01/25/2013

Notes: Recommend replacing system during next remodel or renovation.

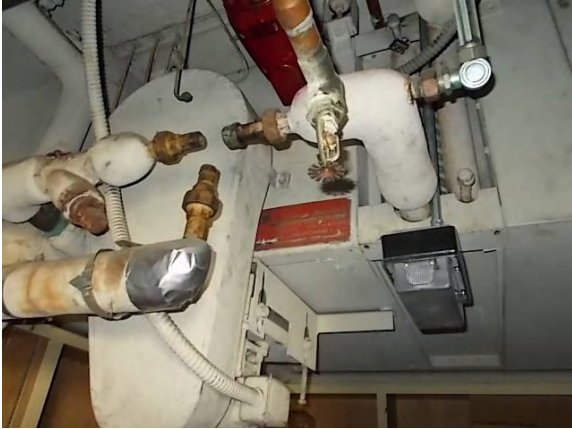
System: D3050 - Terminal & Package Units

Location: Roof
Material: System
Distress: Beyond Expected Life
Category: Capital Renewal
Priority: 4 - Recommended (Years 6-10)
Correction: Renew System
Qty: 1-Ea.
Estimate: \$31,338.30
Assessor Name: Sonny Satterfield
Date Created: 01/25/2013

Notes: Recommend replacing existing heat only units with roof top package unit with A/C and gas heat.

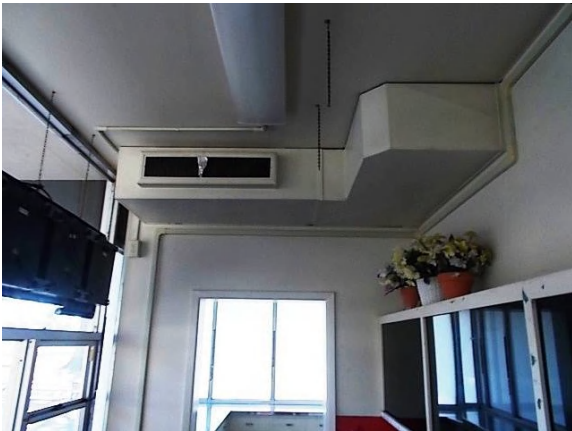
System: D4010 - Sprinklers

Location: Missing
Material: System
Distress: Missing
Category: Code Compliance
Priority: 5 - Codes or Standards Compliance
Correction: Renew System
Qty: 1-Ea.
Estimate: \$5,447.76
Assessor Name: Sonny Satterfield
Date Created: 01/25/2013

Notes: Recommend adding wet type fire sprinklers system during next major renovation.

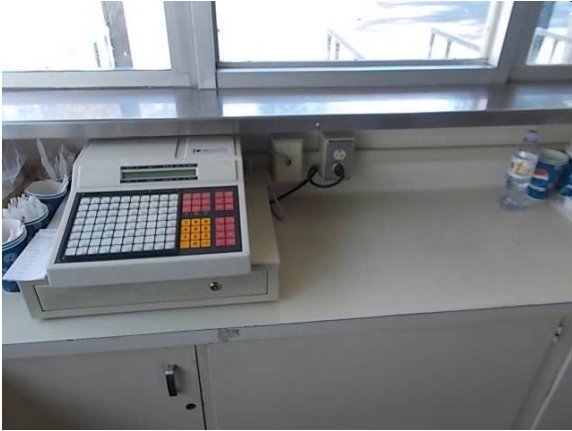
System: D5030 - Communications and Security

Location: Typical for all locations
Material: System
Distress: Missing
Category: Capital Renewal
Priority: 4 - Recommended (Years 6-10)
Correction: Renew System
Qty: 1-Ea.
Estimate: \$5,316.22
Assessor Name: Sonny Satterfield
Date Created: 01/25/2013

Notes: Fire Alarm, LAN/Tele, Security is either missing or needing upgrades. Recommend replacing and enhancing during the next major building remodel.

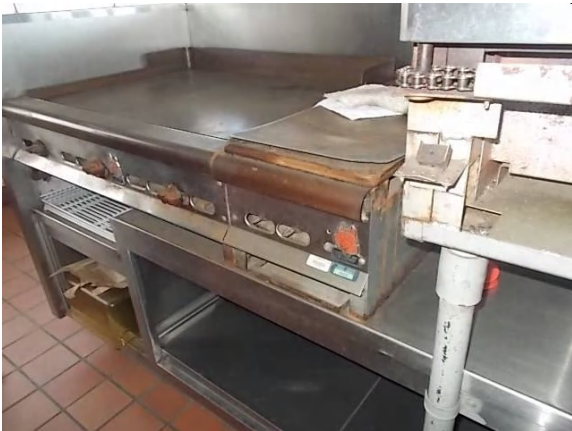
System: E1090 - Other Equipment - Kitchen Food Service

Location: Typical for all
Material: System
Distress: Beyond Expected Life
Category: Capital Renewal
Priority: 4 - Recommended (Years 6-10)
Correction: Renew System
Qty: 1-Ea.
Estimate: \$24,728.65
Assessor Name: Sonny Satterfield
Date Created: 01/25/2013

Notes: Recommend replacing kitchen equipment during next remodel or renovation.

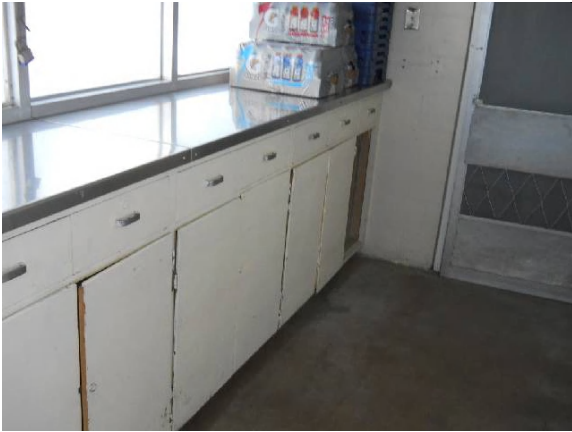
System: E2010 - Fixed Furnishings

Location: Throughout the building. Approx 80 l.f. of built in casework

Notes: Built in serving and storage cabinets are original construction and beyond expected service life. Recommend replacement during school renovations

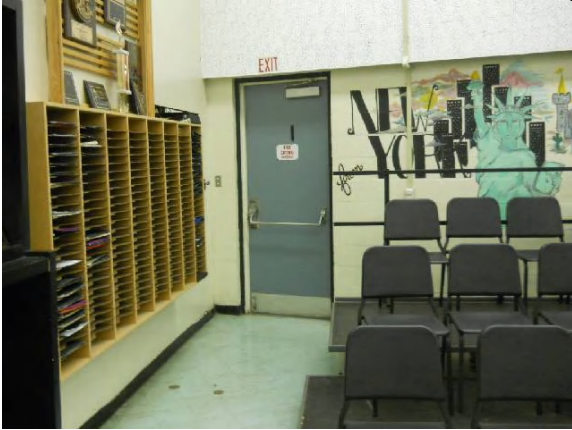
System: B2030 - Exterior Doors

Location: All exterior doors
Material: System
Distress: Beyond Expected Life
Category: Capital Renewal
Priority: 3 - Necessary/Not Yet Critical (Years 2-5)
Correction: Renew System
Qty: 1-Ea.
Estimate: \$54,672.55
Assessor Name: Dave Cunningham
Date Created: 01/29/2013

Notes: Exterior door system is original construction, beyond expected useful life. Provide interior locking hardware at all classroom doors for security. Recommend replacement during school renovations.

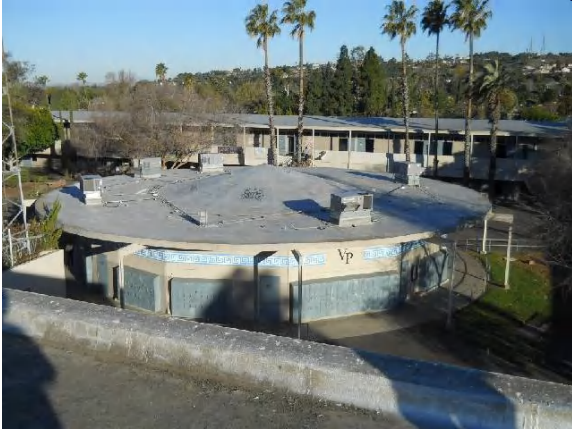
System: B3020 - Roof Openings

Location: Roof
Material: System
Distress: Missing
Category: Deferred Maintenance
Priority: 2 - Potentially Critical (Year 1)
Correction: Renew System
Qty: 1-Ea.
Estimate: \$8,439.55
Assessor Name: Dave Cunningham
Date Created: 01/29/2013

Notes: No safe access to roof for maintenance personnel. Add roof ladder

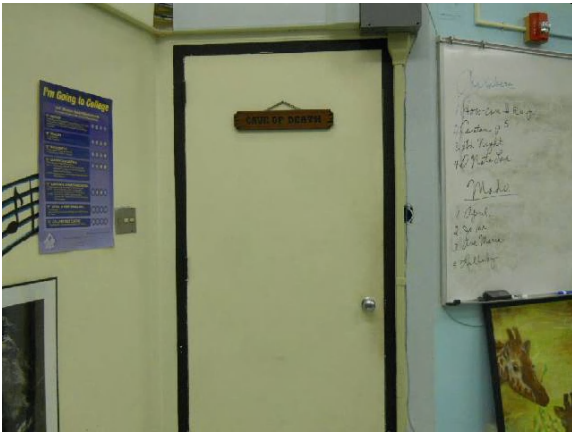
System: C1020 - Interior Doors

Location: All interior doors
Material: System
Distress: Beyond Expected Life
Category: Capital Renewal
Priority: 3 - Necessary/Not Yet Critical (Years 2-5)
Correction: Renew System
Qty: 1-Ea.
Estimate: \$16,808.44
Assessor Name: Dave Cunningham
Date Created: 01/29/2013

Notes: All interior doors are original construction, beyond expected service life. Recommend replacement during school renovations

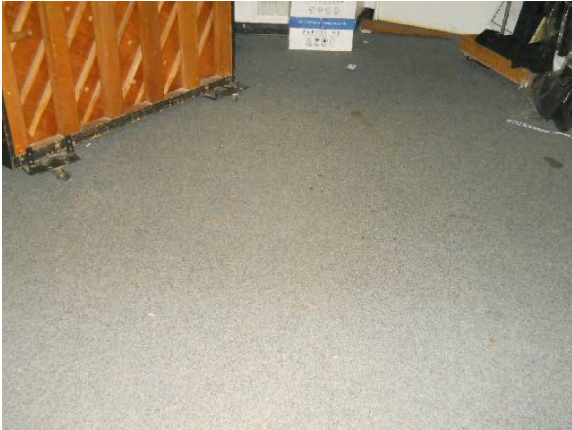
System: C3020210 - Carpet

Location: Practice room
Material: System
Distress: Beyond Expected Life
Category: Capital Renewal
Priority: 3 - Necessary/Not Yet Critical (Years 2-5)
Correction: Renew System
Qty: 1-Ea.
Estimate: \$3,415.10
Assessor Name: Dave Cunningham
Date Created: 01/29/2013

Notes: Carpet is beyond useful life. Recommend replacement during school renovations.

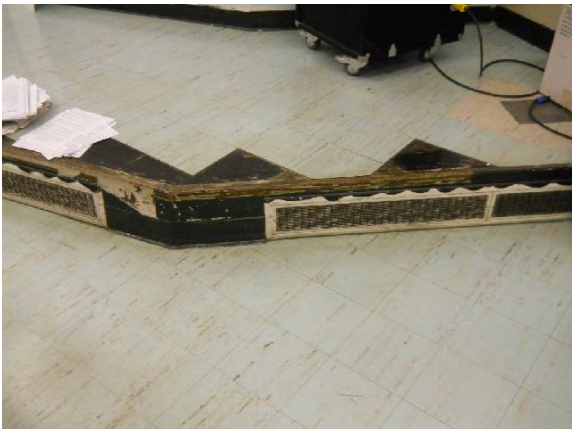
System: C3020410 - VCT

Location: Music Classroom R1
Material: Vinyl
Distress: Beyond Service Life
Category: Deferred Maintenance
Priority: 1 - Currently Critical (Immediate)
Correction: Replace VCT Flooring and Resilient Base
Qty: 1,351-S.F.
Estimate: \$4,163.24
Assessor Name: Dave Cunningham
Date Created: 01/29/2013

Notes: VAT tile is beyond expected life in this classroom. Recommend replacement during school renovations

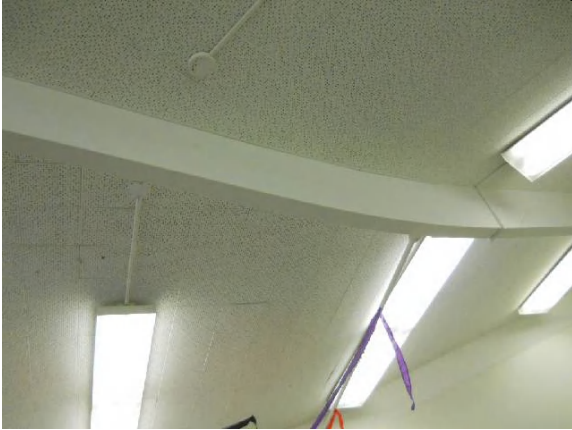
System: C3030 - Ceiling Finishes

Location: Throughout the building
Material: System
Distress: Beyond Expected Life
Category: Capital Renewal
Priority: 3 - Necessary/Not Yet Critical (Years 2-5)
Correction: Renew System
Qty: 1-Ea.
Estimate: \$221.40
Assessor Name: Dave Cunningham
Date Created: 01/29/2013

Notes: Ceiling finishes, glue on tile and spray on acoustic finishes are beyond expected useful life. Recommend replacement during school renovations.

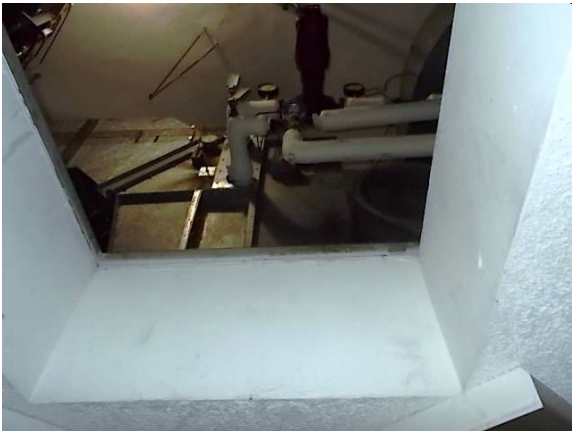
System: D3040 - Distribution Systems

Location: R-1 Classroom attic space
Material: Air Handling Unit
Distress: Damaged
Category: Deferred Maintenance
Priority: 4 - Recommended (Years 6-10)
Correction: Replace air handling unit
Qty: 1-Ea.
Estimate: \$5,508.00
Assessor Name: Sonny Satterfield
Date Created: 01/26/2013

Notes: Remove abandoned air handling unit and piping located in attic space above classroom R1. Recommend removing system during next remodel or renovation.

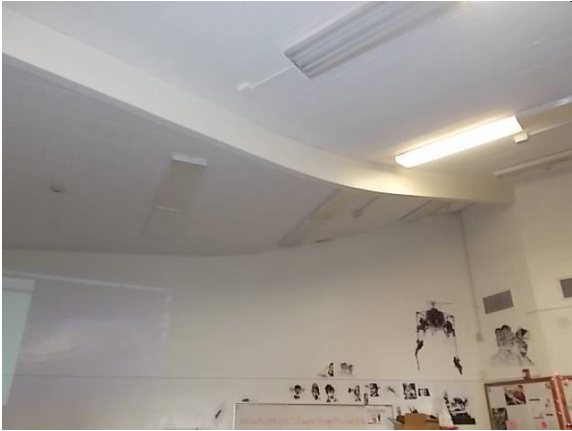
System: D4010 - Sprinklers

Location: Typical for all required locations system wide.
Material: System
Distress: Missing
Category: Code Compliance
Priority: 5 - Codes or Standards Compliance
Correction: Renew System
Qty: 1-Ea.
Estimate: \$70,444.08
Assessor Name: Sonny Satterfield
Date Created: 01/26/2013

Notes: Recommend adding building wide, wet type fire sprinklers system during next major renovation.

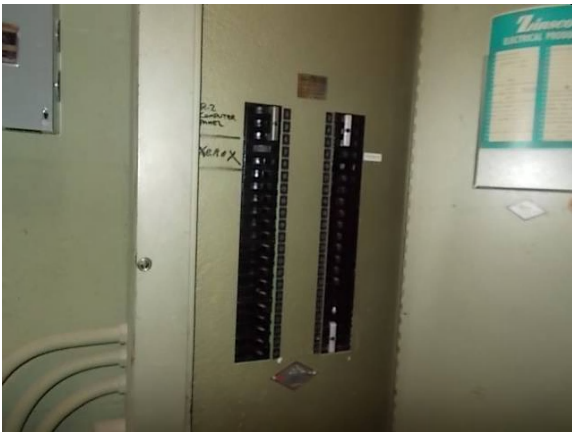
System: D5010 - Electrical Service/Distribution

Location: Typical for all required locations system wide.
Material: System
Distress: Beyond Expected Life
Category: Capital Renewal
Priority: 4 - Recommended (Years 6-10)
Correction: Renew System
Qty: 1-Ea.
Estimate: \$56,972.49
Assessor Name: Sonny Satterfield
Date Created: 01/26/2013

Notes: The main electrical switchgear, distribution panel boards and feeders are mostly original to the building construction date of 1964 and therefore beyond expected life. The system is recommended to be replaced during the next major renovation.

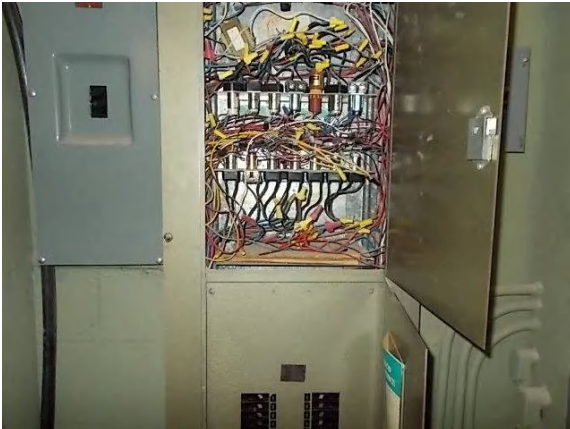
System: D5020 - Branch Wiring

Location: Typical for all required locations system wide.
Material: System
Distress: Beyond Expected Life
Category: Capital Renewal
Priority: 4 - Recommended (Years 6-10)
Correction: Renew System
Qty: 1-Ea.
Estimate: \$209,696.26
Assessor Name: Sonny Satterfield
Date Created: 01/26/2013

Notes: The branch wiring, electrical panels and devices are mostly original to the building construction date of 1964 and therefore beyond expected life. The system is recommended to be replaced during the next major renovation. A/V floor boxes and floor outlets have been abandoned in some classrooms, also recommend replacing as required.

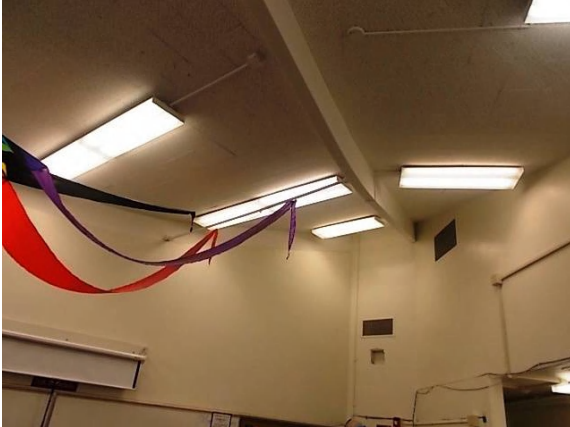
System: D5020 - Lighting

Location: Typical for all required locations system wide.
Material: System
Distress: Beyond Expected Life
Category: Capital Renewal
Priority: 4 - Recommended (Years 6-10)
Correction: Renew System
Qty: 1-Ea.
Estimate: \$129,516.47
Assessor Name: Sonny Satterfield
Date Created: 01/26/2013

Notes: Recommend to replace all lighting fixtures, switching and related wiring during next remodel or renovation.

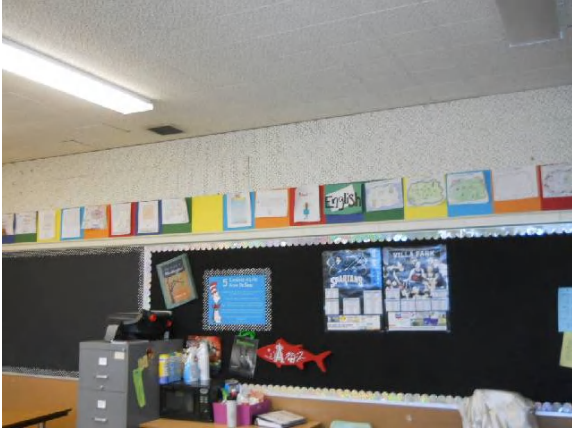
System: E1020 - Institutional Equipment

Location: All Classrooms
Material: Other Institutional Equipment
Distress: Inadequate
Category: Capital Renewal
Priority: 4 - Recommended (Years 6-10)
Correction: Smartboards whiteboards tackboards
Qty: 4-Ea.
Estimate: \$44,640.52
Assessor Name: Dave Cunningham
Date Created: 01/30/2013

Notes: Recommend installation of Smart Board Systems in all classrooms

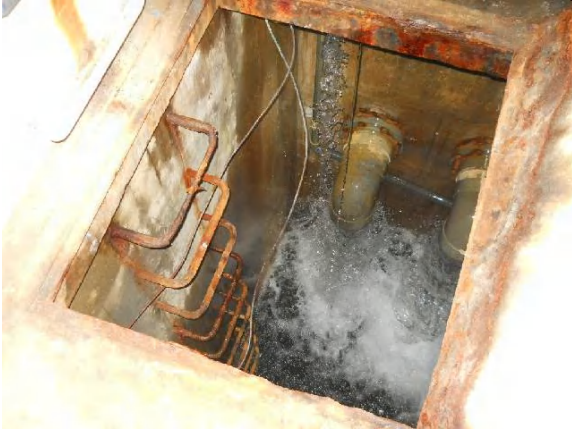
System: B1010 - Floor Construction

Location: Floor
Material: Floor Construction Concrete
Distress: Failing
Category: Deferred Maintenance
Priority: 3 - Necessary/Not Yet Critical (Years 2-5)
Correction: Floor Access Hatch
Qty: 2-Ea.
Estimate: \$6,468.91
Assessor Name: Dave Cunningham
Date Created: 01/29/2013

Notes: Floor access hatches to basement level water tanks are rusted and should be replaced

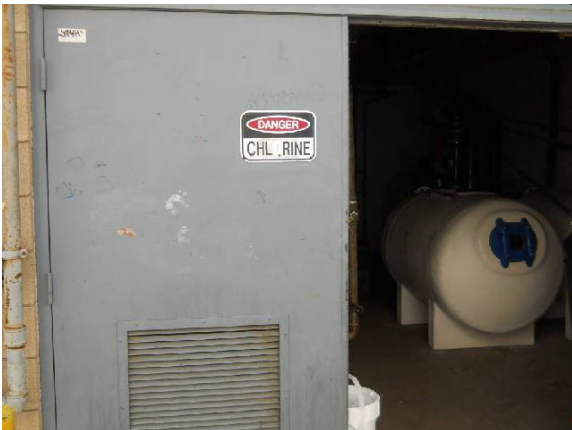
System: B2030 - Exterior Doors

Location: Exterior doors
Material: System
Distress: Beyond Expected Life
Category: Capital Renewal
Priority: 4 - Recommended (Years 6-10)
Correction: Renew System
Qty: 1-Ea.
Estimate: \$11,642.40
Assessor Name: Dave Cunningham
Date Created: 01/28/2013

Notes: Doors are original construction and beyond expected service life. Recommend replacement during school renovations.

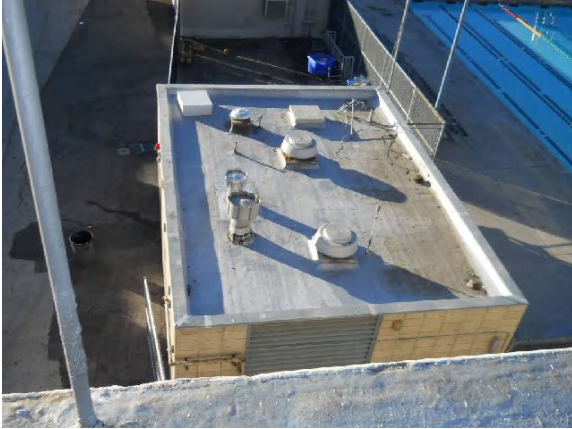
System: B3010105 - Built-Up

Location: Roof
Material: System
Distress: Beyond Expected Life
Category: Capital Renewal
Priority: 4 - Recommended (Years 6-10)
Correction: Renew System
Qty: 1-Ea.
Estimate: \$12,953.95
Assessor Name: Dave Cunningham
Date Created: 01/28/2013

Notes: Roof is beyond expected service life. No reported leaks at this time. Recommend replacement during school renovations

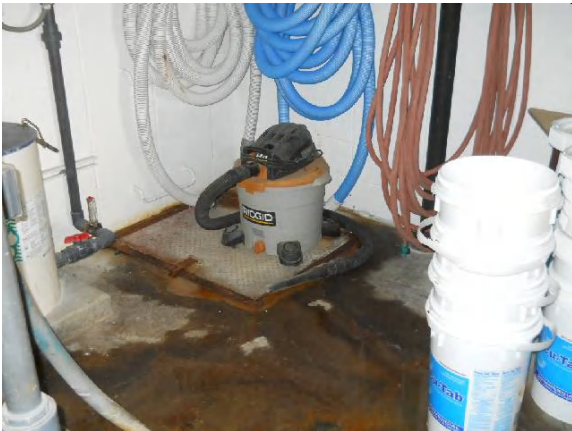
System: C3010 - Wall Finishes

Location: Interior walls
Material: System
Distress: Beyond Expected Life
Category: Capital Renewal
Priority: 3 - Necessary/Not Yet Critical (Years 2-5)
Correction: Renew System
Qty: 1-Ea.
Estimate: \$2,851.20
Assessor Name: Dave Cunningham
Date Created: 01/28/2013

Notes: Painted CMU, repaint as necessary.

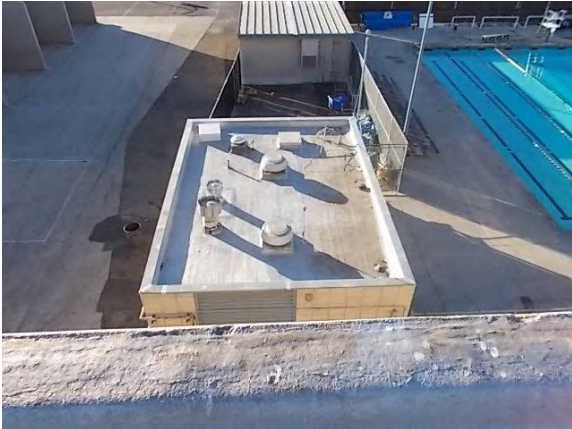
System: D3040 - Distribution Systems - Exhaust Fans

Location: Typical for all required locations system wide.

Notes: The exhaust fans were installed in 1977 and beyond expected life. An engineering study by a PE is recommended for the HVAC System with recommendations for upgrades and replacement, as required during the next major renovation.

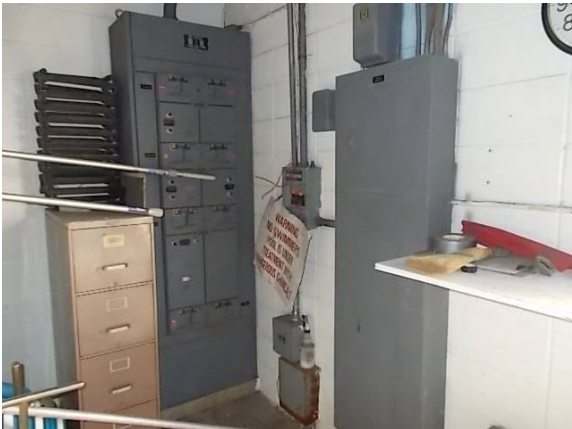
System: D5010 - Electrical Service/Distribution

Location: Typical for all required locations system wide.
Material: System
Distress: Beyond Expected Life
Category: Capital Renewal
Priority: 4 - Recommended (Years 6-10)
Correction: Renew System
Qty: 1-Ea.
Estimate: \$24,567.84
Assessor Name: Sonny Satterfield
Date Created: 01/25/2013

Notes: The main electrical switchgear, distribution panel boards and feeders are mostly original to the building construction date of 1977 and therefore beyond expected life. The system is recommended to be replaced during the next major renovation.

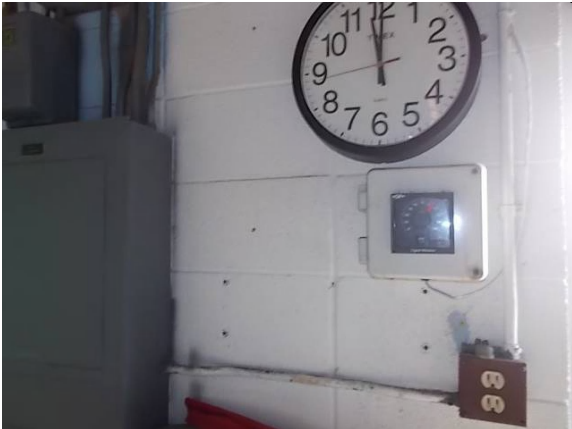
System: D5020 - Branch Wiring

Location: Typical for all required locations system wide.

Notes: The branch wiring, electrical panels and devices are mostly original to the building construction date of 1977 and therefore beyond expected life. The system is recommended to be replaced during the next major renovation.

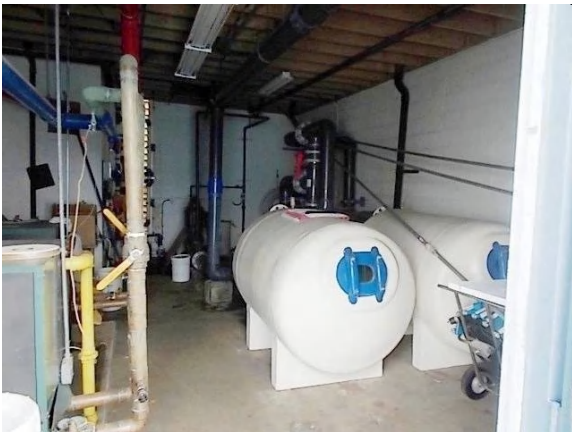
System: D5020 - Lighting

Location: Typical for all locations.

Notes: Recommend replacing all lighting in the building during next remodel or renovation.

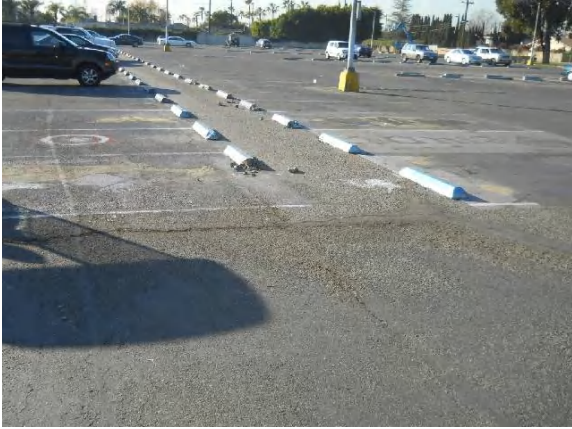
System: G2020 - Parking Lots

Location: Student parking lot
Material: Asphalt Paving parking lot
Distress: Failing
Category: Deferred Maintenance
Priority: 3 - Necessary/Not Yet Critical (Years 2-5)
Correction: Asphalt seal coat minor repairs paint stripes
Qty: 182,000-S.F.
Estimate: \$211,948.73
Assessor Name: Dave Cunningham
Date Created: 01/29/2013

Notes: Parking surface is deteriorating. Recommend minor repairs (20%), sealcoat, paint stripes, and replace all precast concrete parking barriers

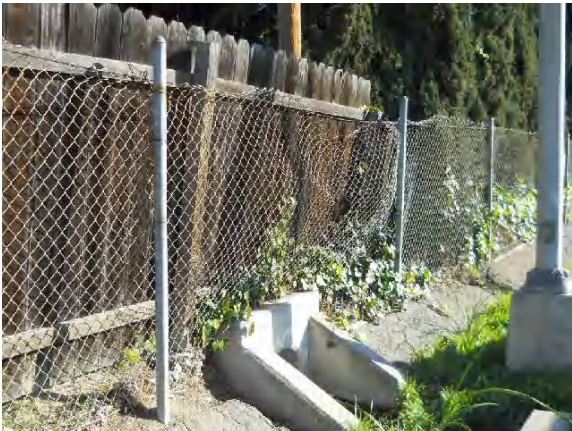
System: G2040105 - Fence & Guardrails

Location: Fence, east side between staff parking lot and housing
Material: Chain Link Fence and Gate Repairs
Distress: Damaged
Category: Deferred Maintenance
Priority: 3 - Necessary/Not Yet Critical (Years 2-5)
Correction: Minor chain link fence repairs (per 10 L.F.)
Qty: 5-Ea.
Estimate: \$1,000.30
Assessor Name: Dave Cunningham
Date Created: 01/31/2013

Notes: Fence falling, holes in fence, damage

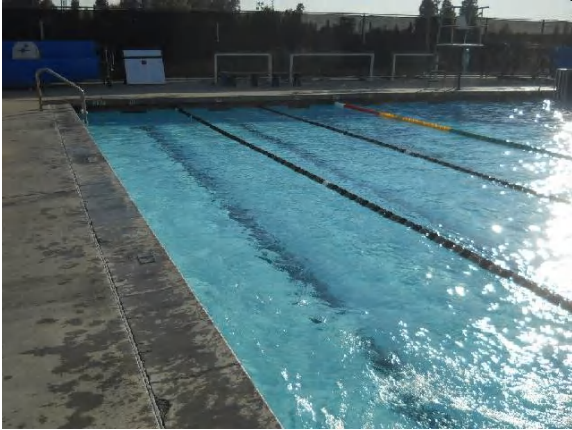
System: G2040920 - Swimming Pools

Location: Pool
Material: Swimming Pool
Distress: Beyond Service Life
Category: Capital Renewal
Priority: 4 - Recommended (Years 6-10)
Correction: Swimming pool competition length
Qty: 1-Ea.
Estimate: \$1,020,960.00
Assessor Name: Dave Cunningham
Date Created: 01/29/2013

Notes: Recommend replacement of swimming pool with new competition length pool.

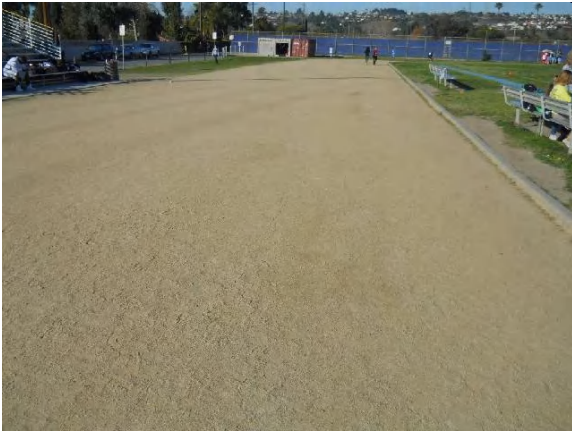
System: G2040940 - Playing Fields

Location: Playing field, track
Material: Running Track
Distress: Beyond Service Life
Category: Capital Renewal
Priority: 3 - Necessary/Not Yet Critical (Years 2-5)
Correction: Running Track competition grade
Qty: 1-Ea.
Estimate: \$1,487,111.04
Assessor Name: Dave Cunningham
Date Created: 01/29/2013

Notes: Track, long jump, system has failed. Dirt track without lanes. Recommend construction of a competition track and field system. Re-sod the soccer field inside the track.

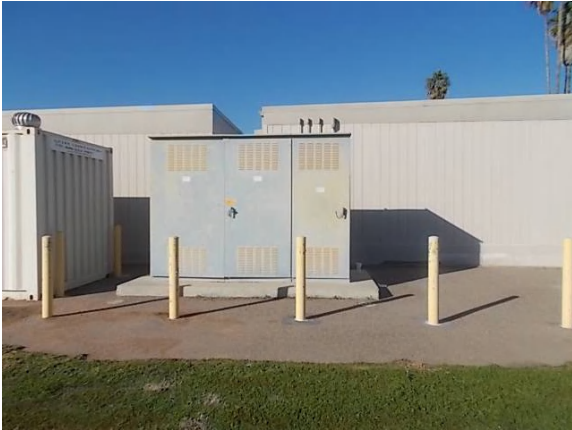
System: G4010 - Electrical Distribution

Location: Main Electrical Distrubution and UG feeders to buildings.
Material: System
Distress: Beyond Service Life
Category: Capital Renewal
Priority: 4 - Recommended (Years 6-10)
Correction: Renew System
Qty: 1-Ea.
Estimate: \$566,151.90
Assessor Name: Sonny Satterfield
Date Created: 01/24/2013

Notes: Site electrical incoming power switchgear, panels, equipment and underground feeders to buildings are beyond expected life; all are recommended to be replaced as part of the next major renovation.

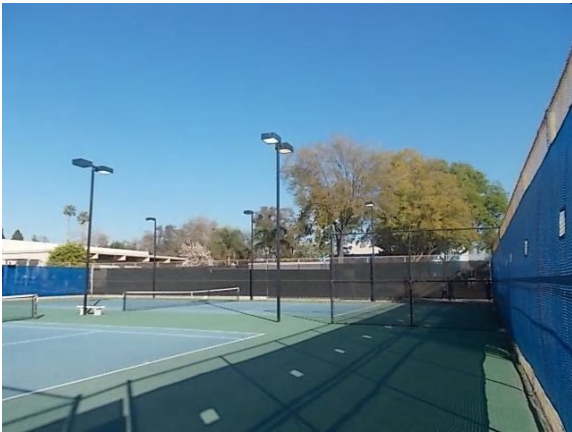
System: G4020 - Site Lighting

Location: Existing and additional site pole light locations
Material: Outdoor Pole Lights
Distress: Inadequate
Category: Capital Renewal
Priority: 1 - Currently Critical (Immediate)
Correction: Replace light pole, 2 fixtures (conc. base not inc)
Qty: 20-Ea.
Estimate: \$363,543.84
Assessor Name: Sonny Satterfield
Date Created: 01/24/2013

Notes: All existing site pole lighting fixtures were replaced with LED type fixtures in 2012, except the tennis courts. Site is recommended for additional site pole fixtures and tennis court replacements; in order to provide adequate night time security for vehicle and pedestrian traffic and additional athletic field lighting.

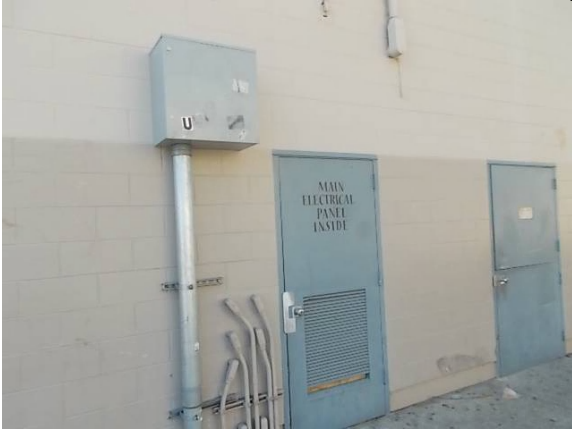
System: G4030 - Site Communications and Security

Location: Site cabling and all service building locations for communications backbone and security service cabling.

Material: Site Communications

Distress: Inadequate

Priority: 4 - Recommended (Years 6-10)

Correction: Replace communications and security cabling

Notes: Recommend upgrades and replacing as needed all communications and security cabling and equipment for enhancements.
